the **play inspection** company

Annual Inspection

Weston Colville Parish Council

Brinkley Road Play Area

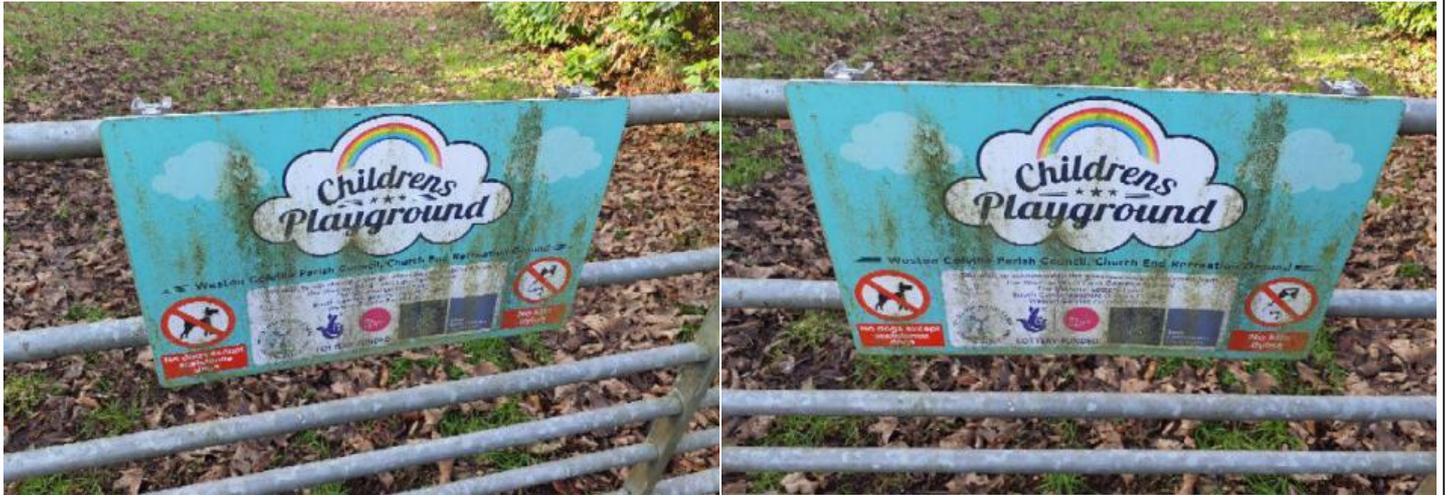
Item: Ancillary Items - Sign
Manufacturer: Not Identified

Finding: There is algae or moss on the surface of the equipment

Action: Clean and treat appropriately

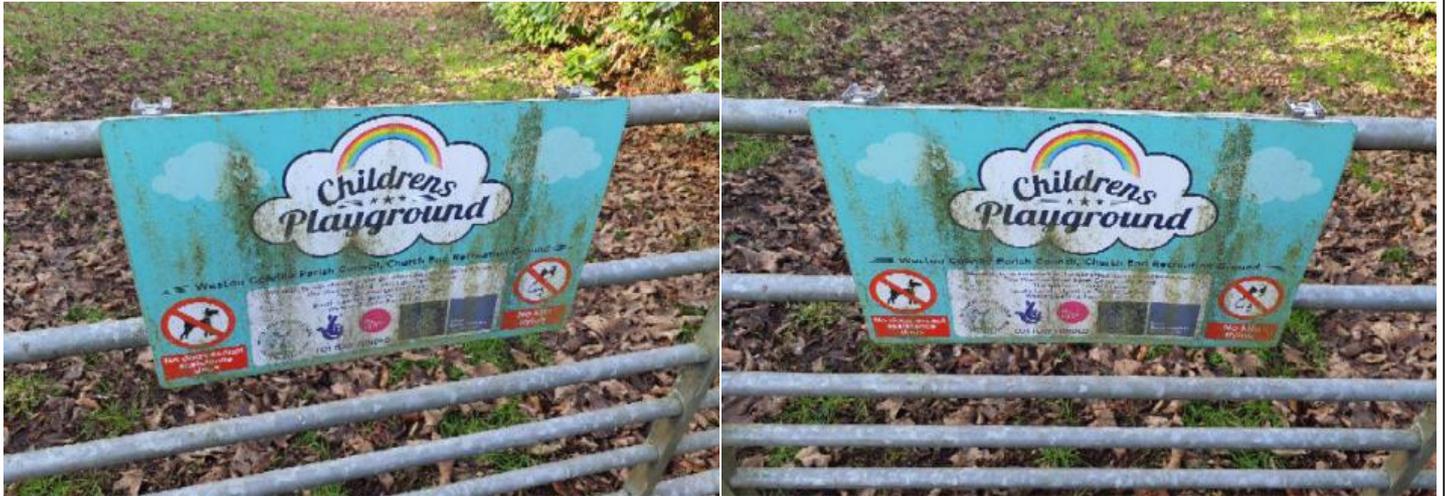
Item: Ancillary Items - Sign
Manufacturer: Not Identified

Finding: BS EN 1176 Part 7 recommends that signage shall include emergency contact details and contact details of owner / operator for reporting maintenance issues
Action: Provide additional information

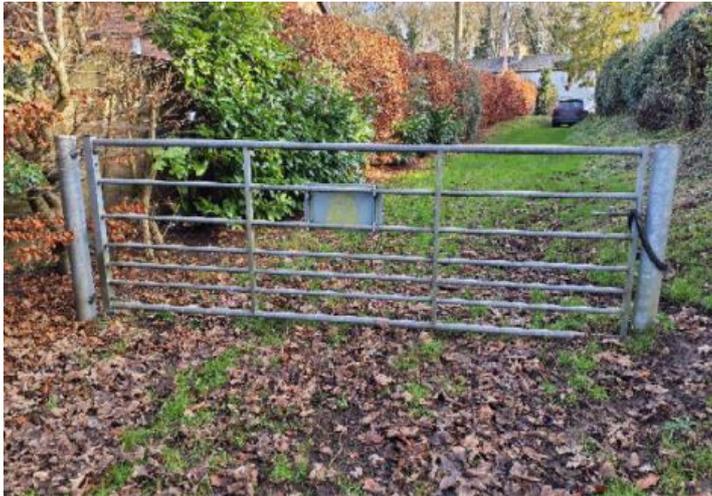
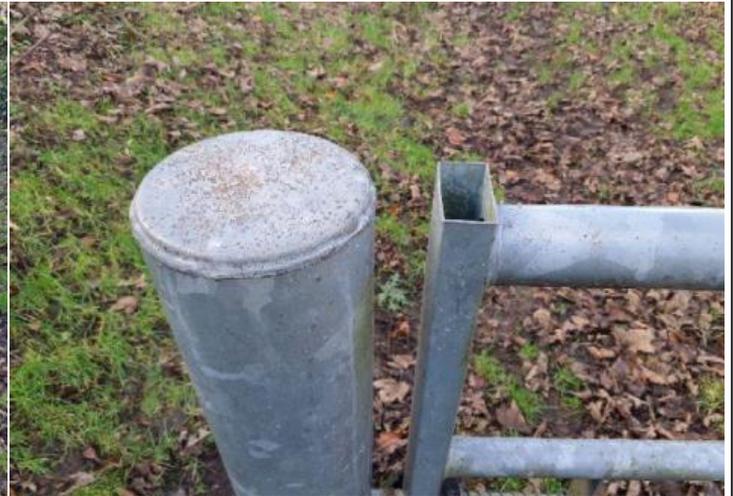
Item: Gates - Gate - Maintenance
Manufacturer: Not Identified

Finding: There is / are post or end caps missing / damaged on the item
Action: Replace missing / damaged post or end caps

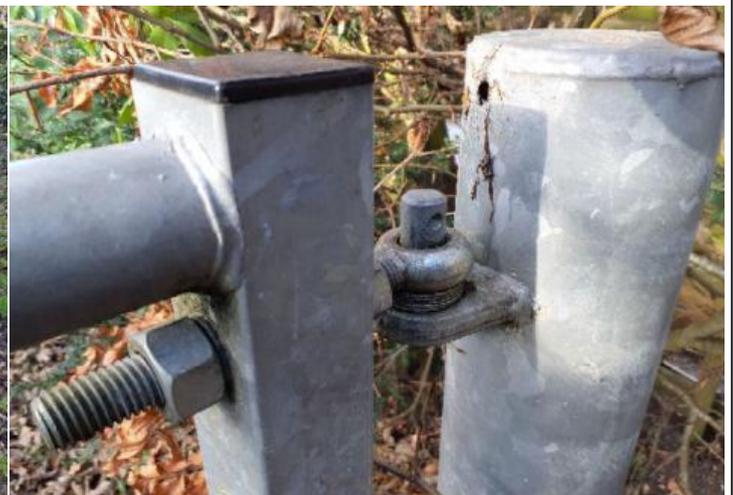
Item: Gates - Gate - Maintenance
Manufacturer: Not Identified

Finding: The gate is not secured to the hinges and can be lifted off
Action: Secure the gate

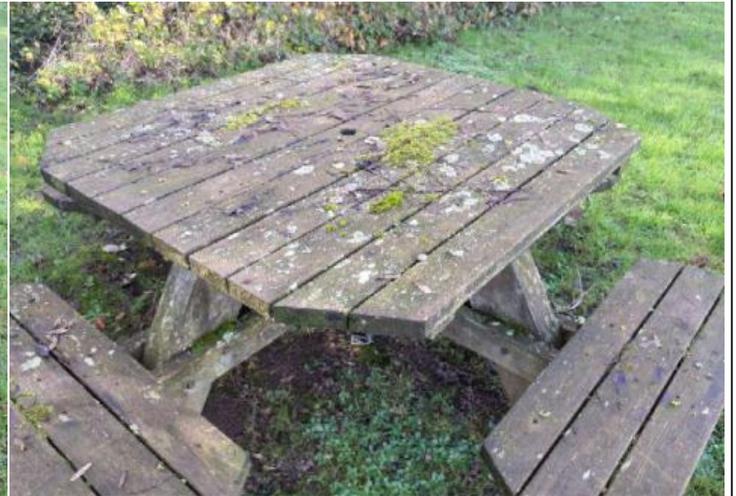
Item: Ancillary Items - Picnic Table
Manufacturer: Not Identified

Finding: There is algae or moss on the surface of the equipment

Action: Clean and treat appropriately

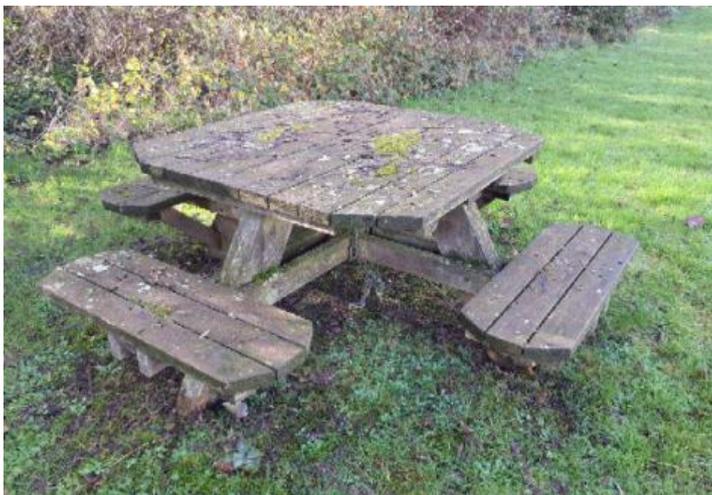
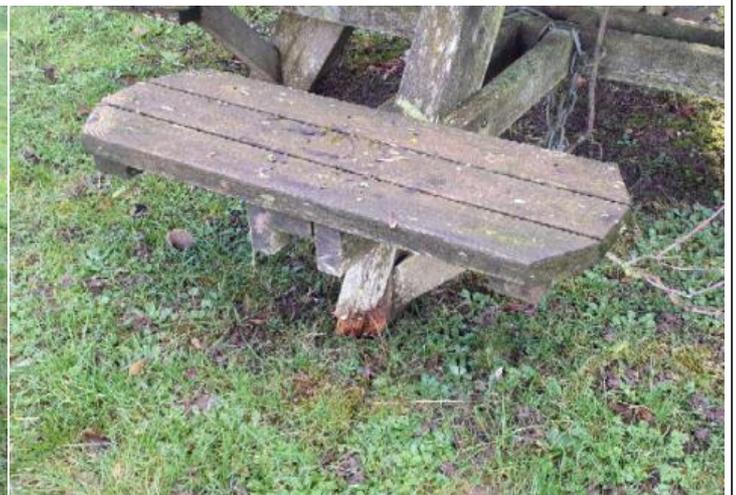
Item: Ancillary Items - Picnic Table
Manufacturer: Not Identified

Finding: There are areas or parts of the timber on the structure that have rotted

Action: Replace all affected timbers

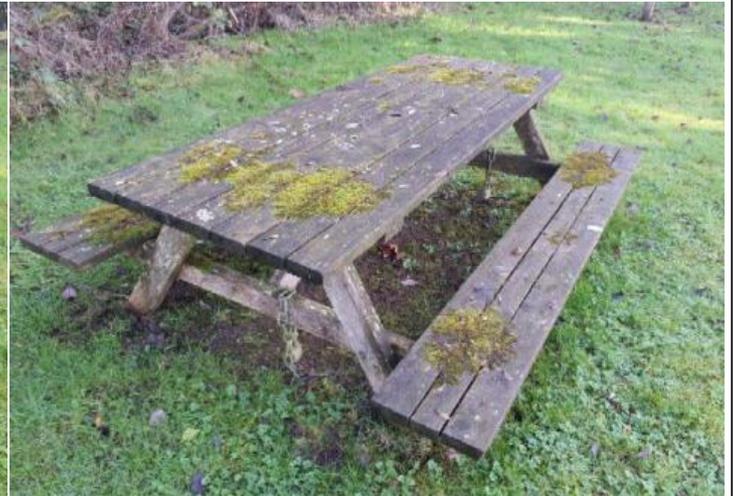
Item: Ancillary Items - Picnic Table
Manufacturer: Not Identified

Finding: There is algae or moss on the surface of the equipment

Action: Clean and treat appropriately

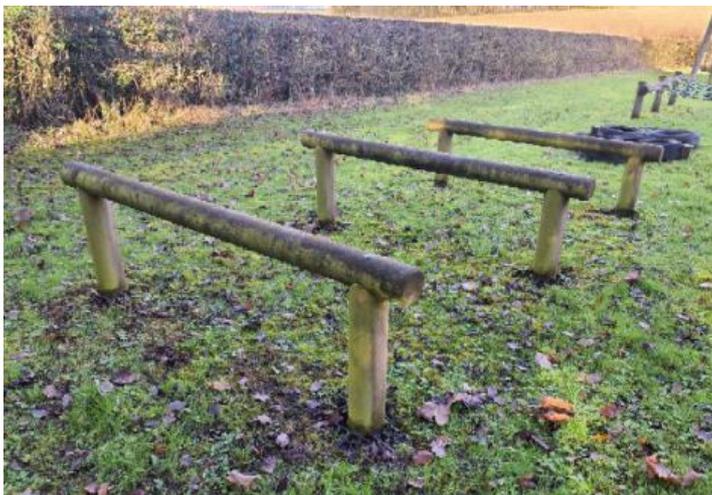
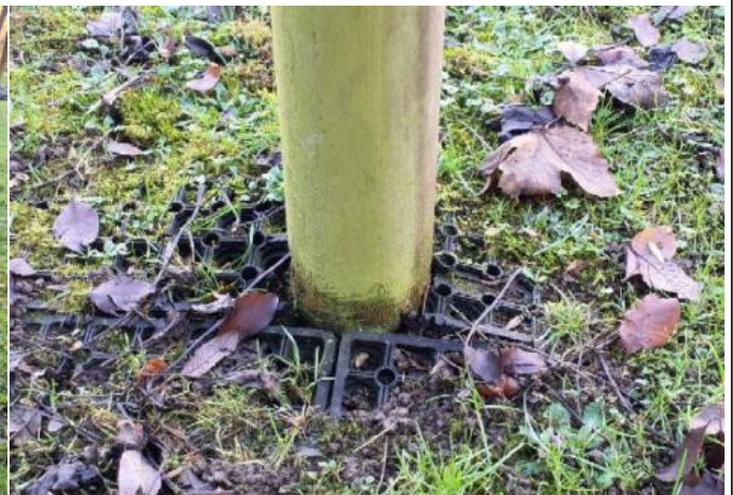
Item: Activity Equipment - Up and Under Bars
Manufacturer: Not Identified

Finding: There is some strimmer / machinery damage apparent on the posts, this can penetrate the preservative applied to the timber and accelerate the rotting process

Action: Monitor for any deterioration (rot) and replace as required

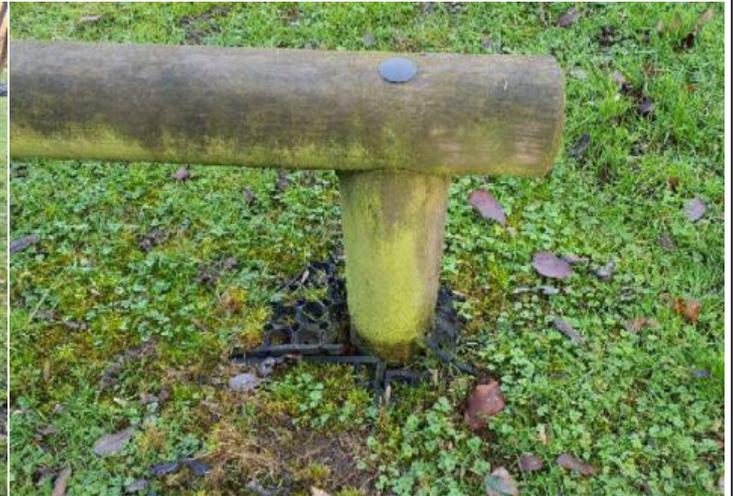
Item: Activity Equipment - Up and Under Bars
Manufacturer: Not Identified

Finding: There are gaps opening between the grass mat tiles

Action: Provide additional ties or secure / reinstate surface tiles

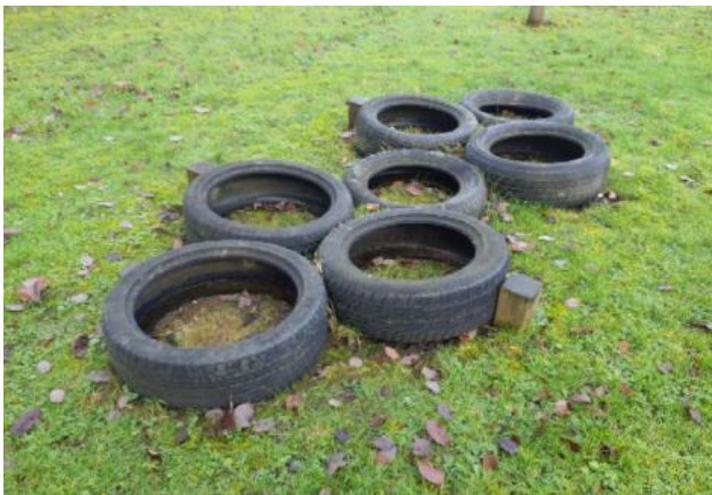
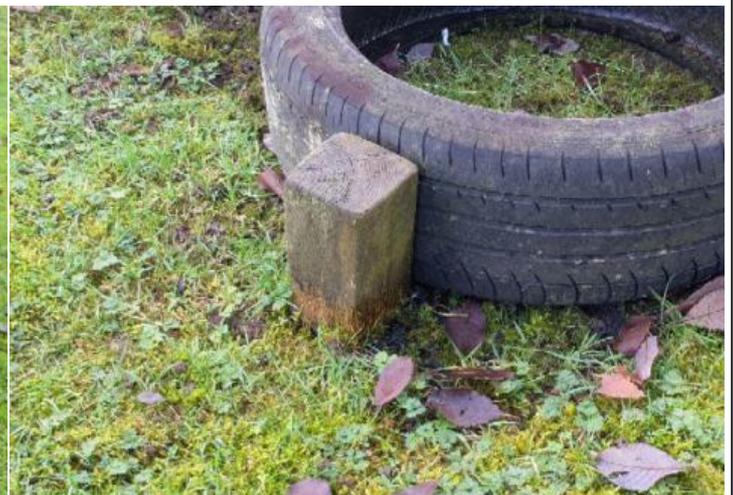
Item: Activity Equipment - Tyre Trail
Manufacturer: Not Identified

Finding: There is some strimmer / machinery damage apparent on the posts, this can penetrate the preservative applied to the timber and accelerate the rotting process

Action: Monitor for any deterioration (rot) and replace as required

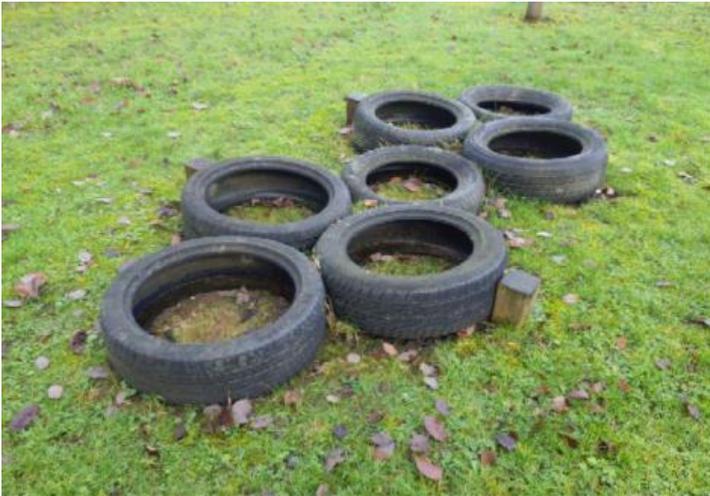
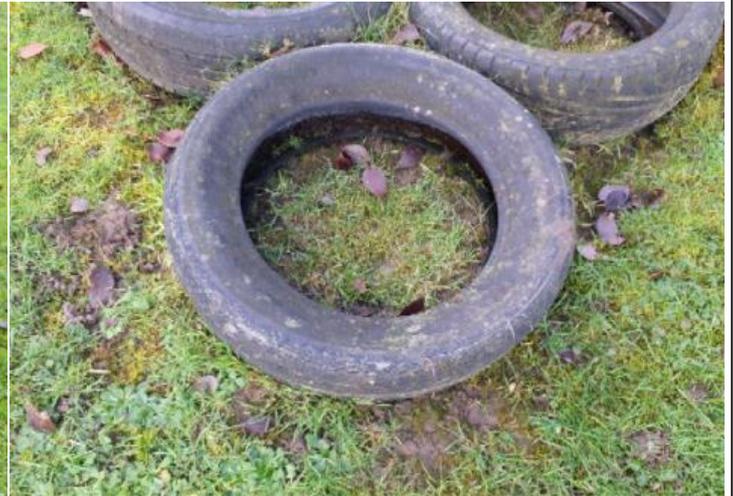
Finding: The item has been damaged

Action: Monitor for any further deterioration and replace as required

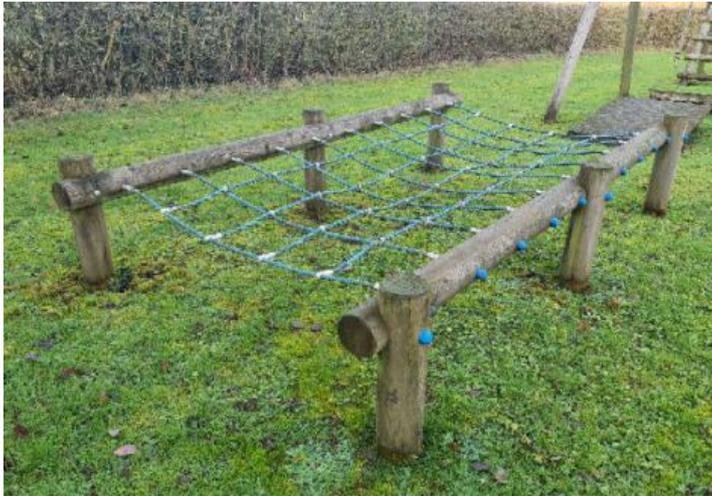
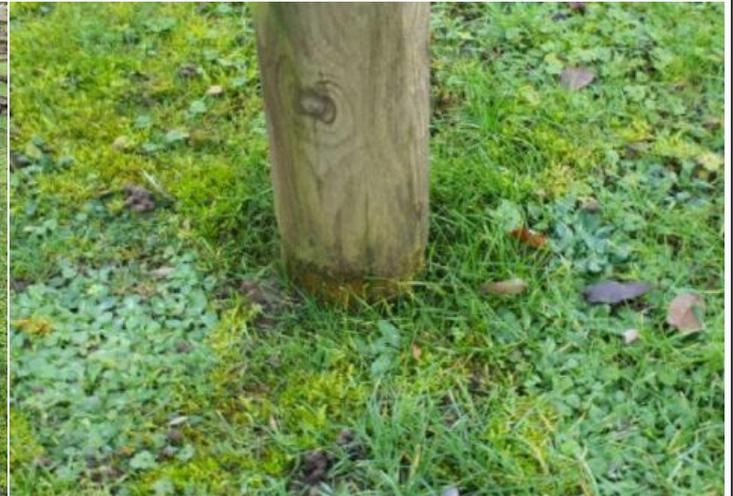
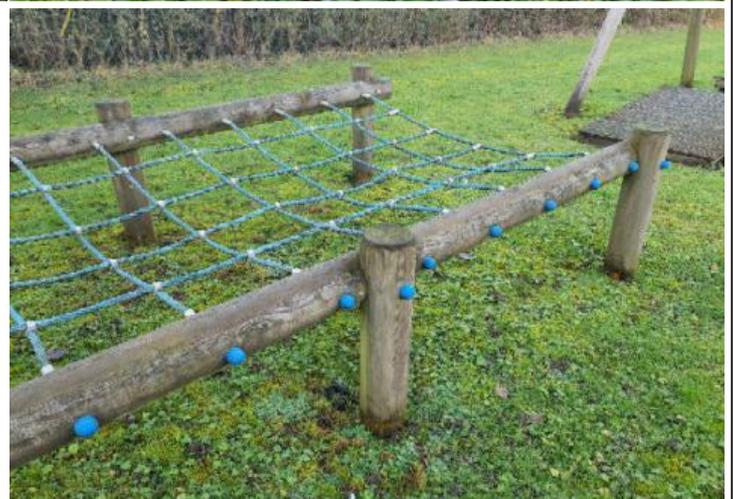
Finding: There is some strimmer / machinery damage apparent on the posts, this can penetrate the preservative applied to the timber and accelerate the rotting process

Action: Monitor for any deterioration (rot) and replace as required

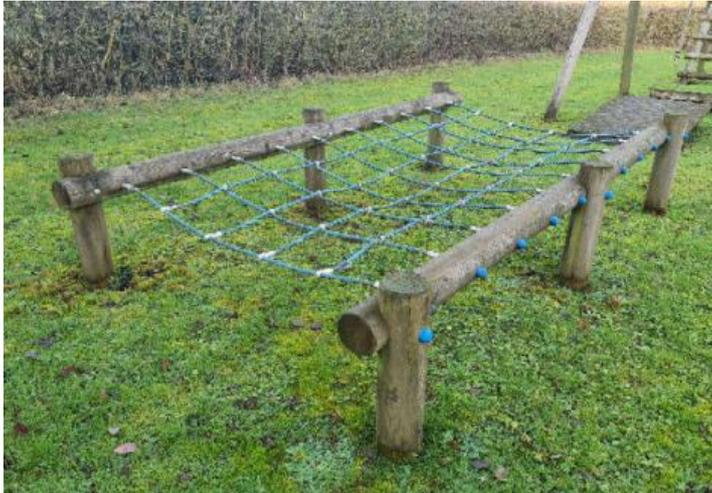
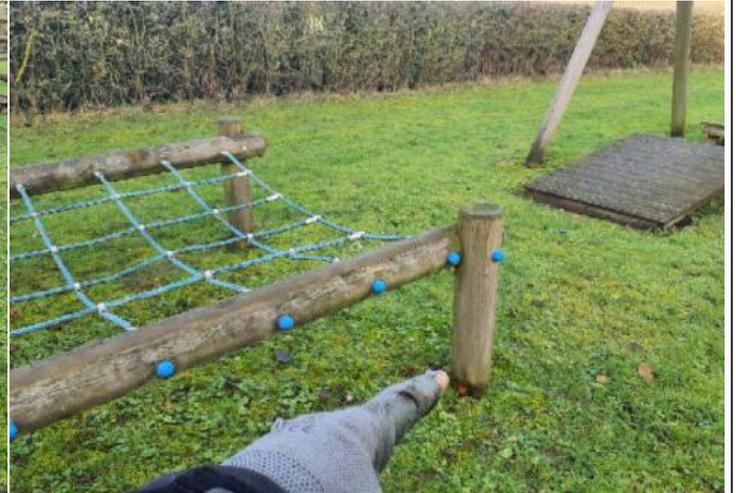
Finding: There are areas or parts of the timber on the structure that have rotted

Action: Replace all affected timbers

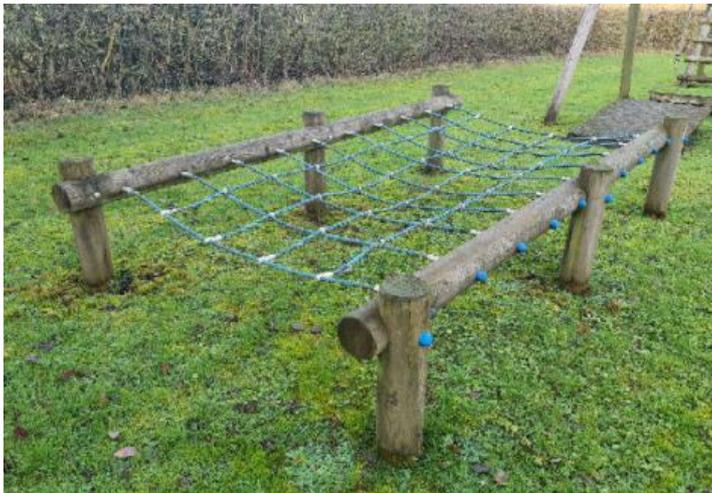
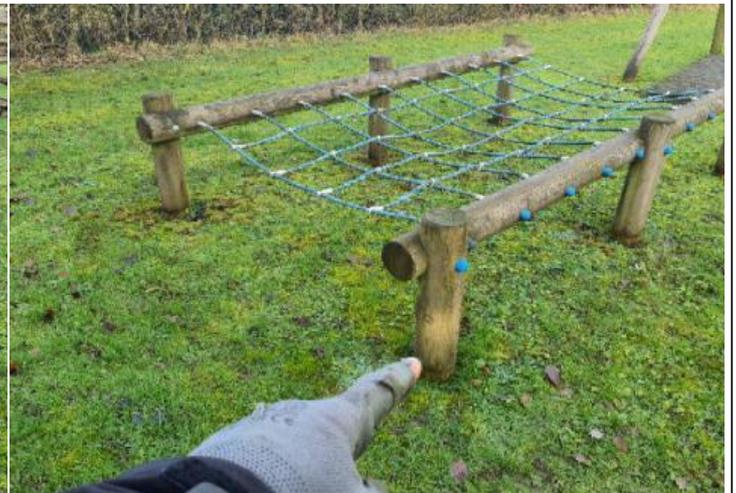
Finding: There is some evidence of rot in the timber

Action: Monitor for any further deterioration and replace as required

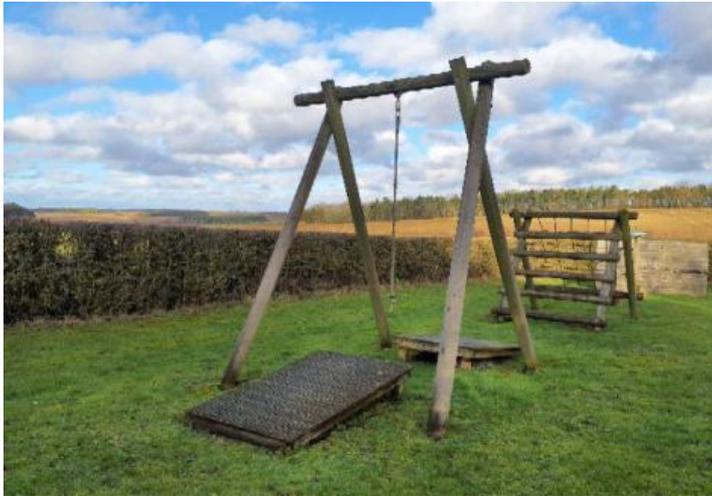
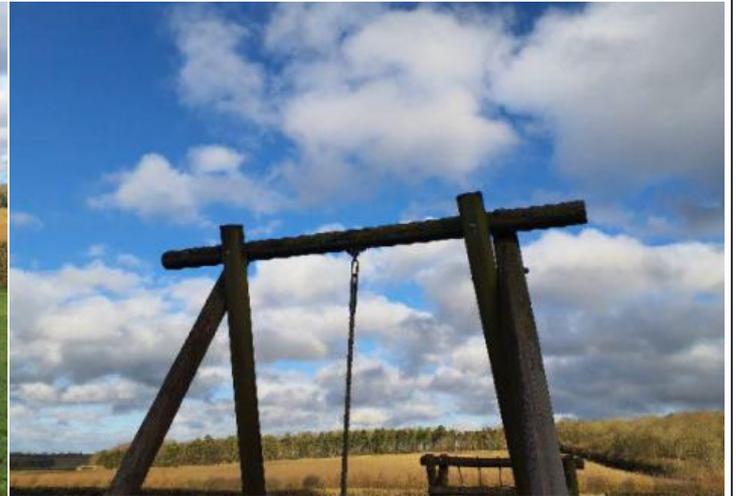
Finding: NOTE - The fixings or components for this item were in excess of 2.5m above the standing surface and could not be fully accessed by the inspector. We have completed a visual inspection of the fixings from ground level but a maintenance inspection should be undertaken to assess the condition, security and wear of the components at intervals in accordance with the manufacturers recommendations.

Action: Inspect in accordance with the manufacturers recommendations

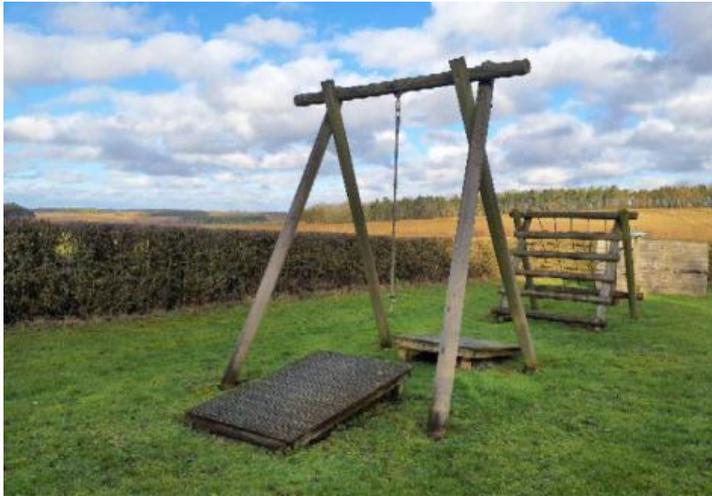
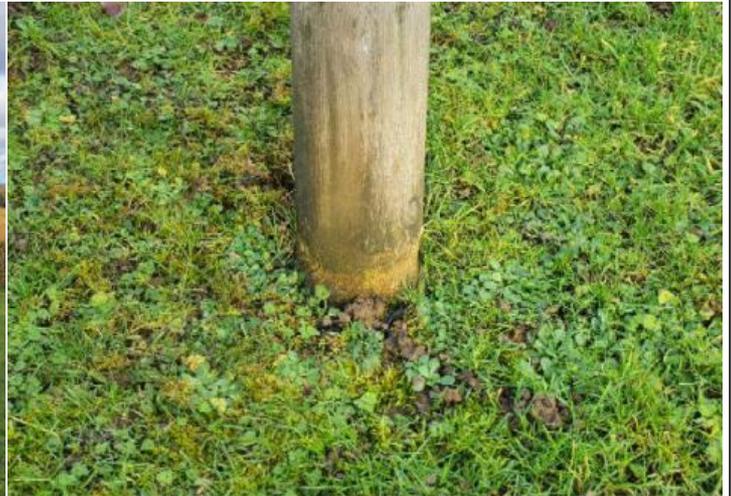
Finding: There is some strimmer / machinery damage apparent on the posts, this can penetrate the preservative applied to the timber and accelerate the rotting process

Action: Monitor for any deterioration (rot) and replace as required

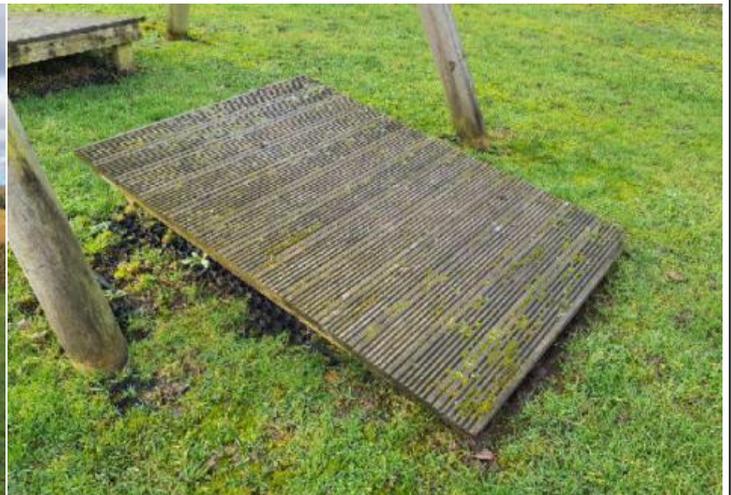
Finding: There is algae or moss on the surface of the equipment

Action: Clean and treat appropriately

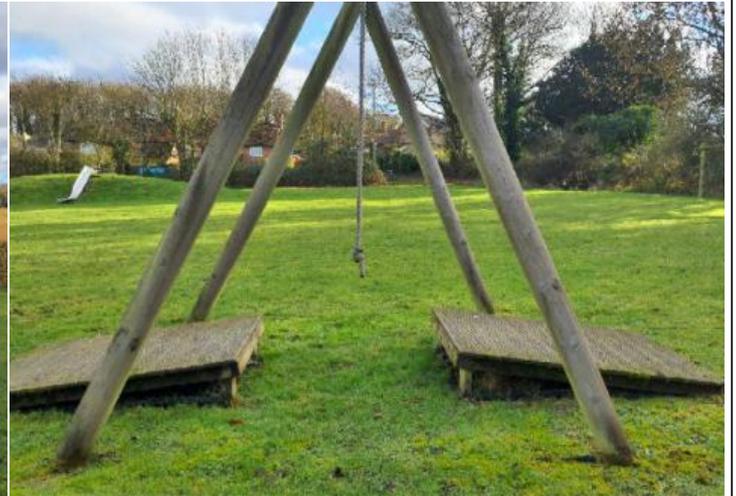
Finding: The platforms form a hard object within the impact area of the equipment in contravention of the requirements of BS EN 1176 Part 1

Action: Monitor use and consider the provision of an impact attenuating surface

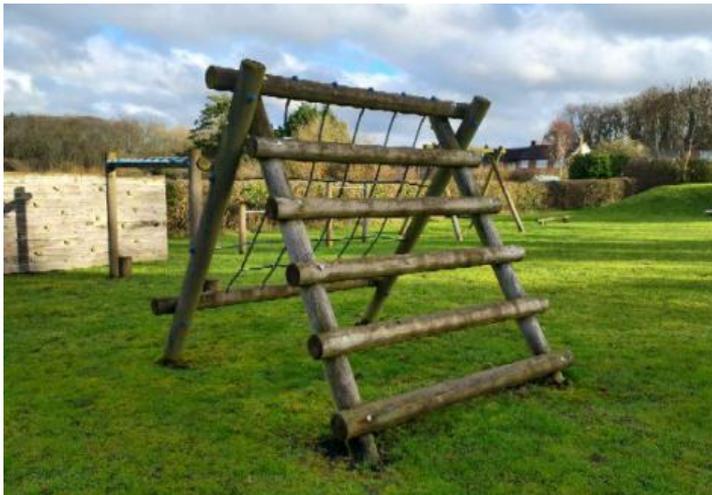
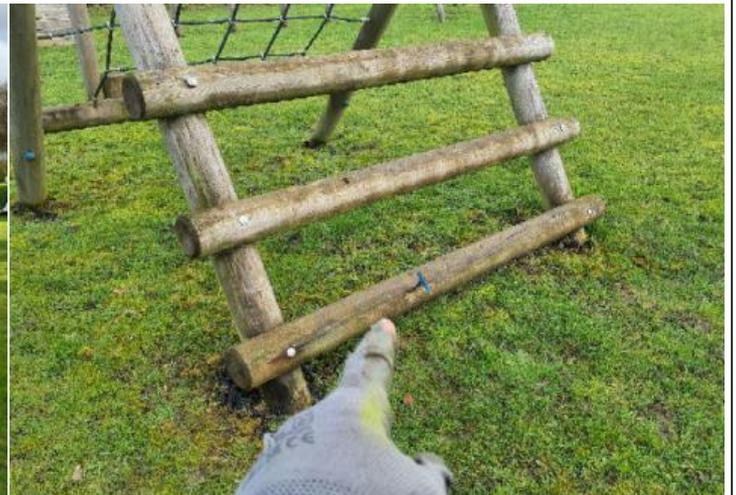
Finding: There are areas or parts of the timber on the structure that have rotted

Action: Replace all affected timbers

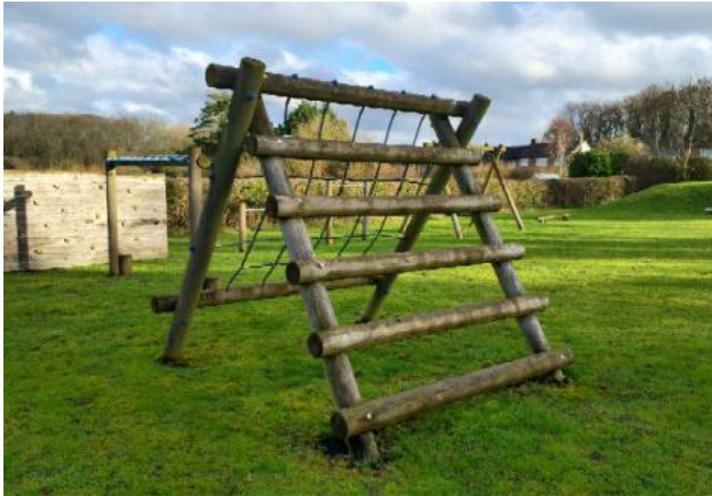
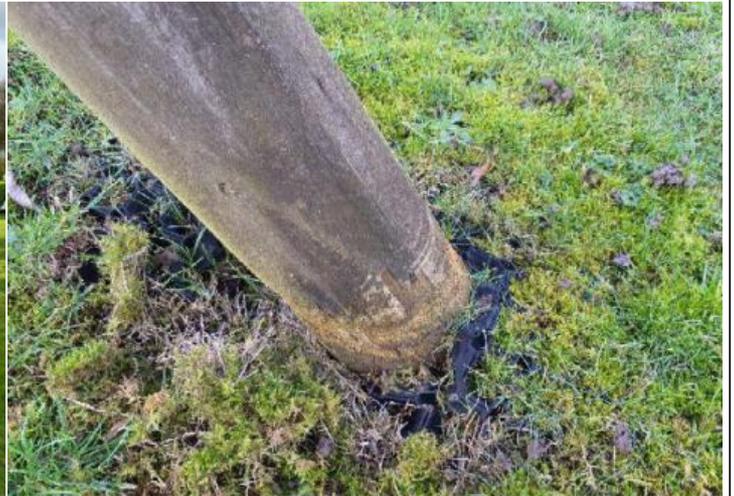
Finding: There is some strimmer / machinery damage apparent on the posts, this can penetrate the preservative applied to the timber and accelerate the rotting process

Action: Monitor for any deterioration (rot) and replace as required

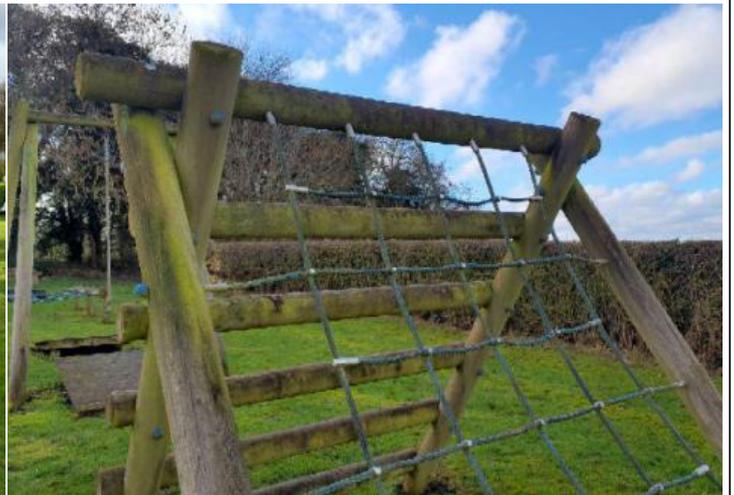
Finding: There is algae or moss on the surface of the equipment

Action: Clean and treat appropriately

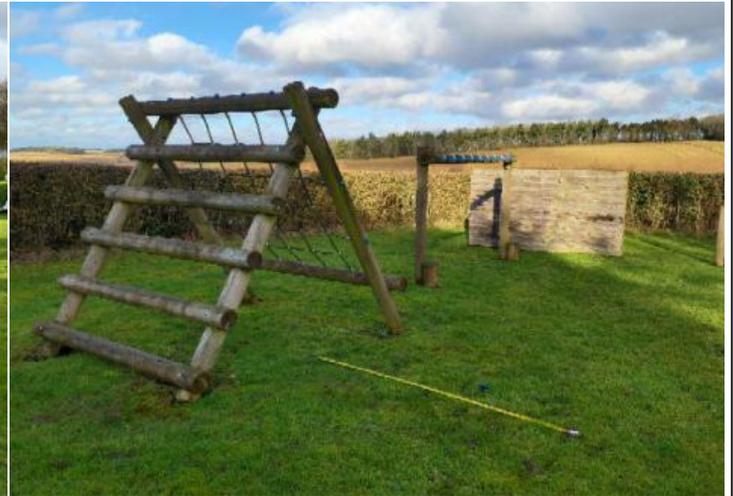
Finding: The surfacing dimensions are short and do not meet with the requirements of the current applicable standard

Action: Monitor - No action given the risk assessment

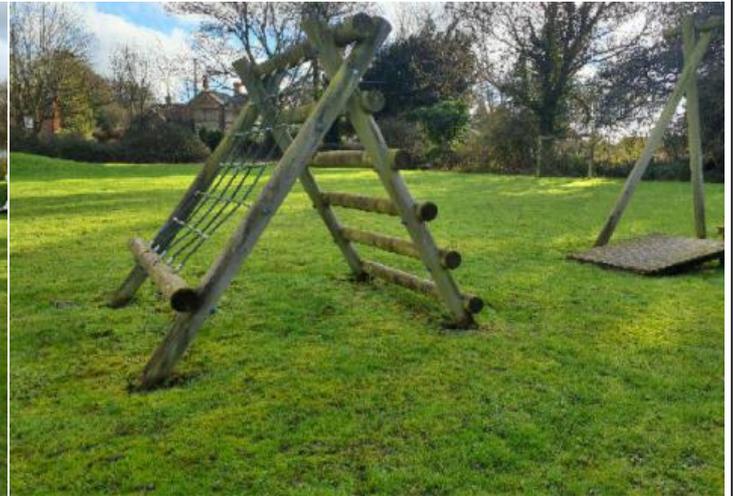
Finding: The grass mats are silted up and the soil is compacted; this may have an effect on the impact absorbing properties of the surface. Consideration should be given to HIC testing the surface to verify impact attenuating properties (<https://playinspections.co.uk/inspection-services/safety-surface-testing/>)

Action: Contact our office for a quotation for this service

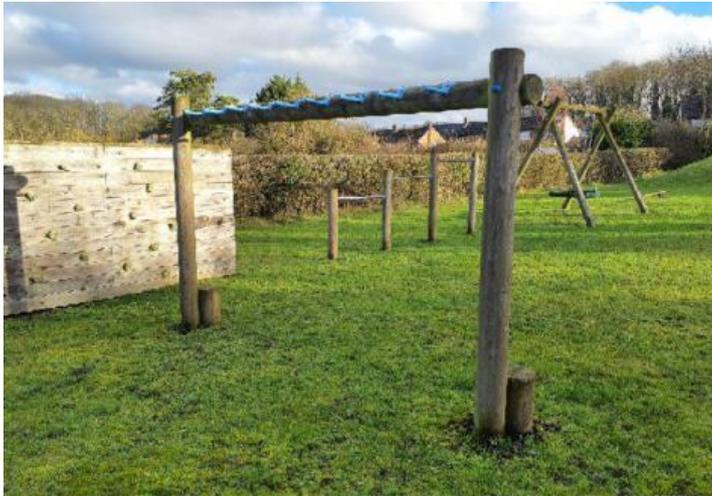
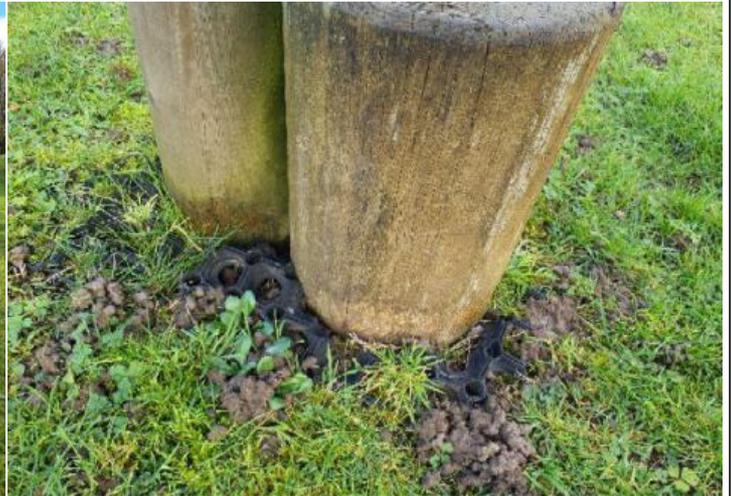
Finding: There is some strimmer / machinery damage apparent on the posts, this can penetrate the preservative applied to the timber and accelerate the rotting process

Action: Monitor for any deterioration (rot) and replace as required

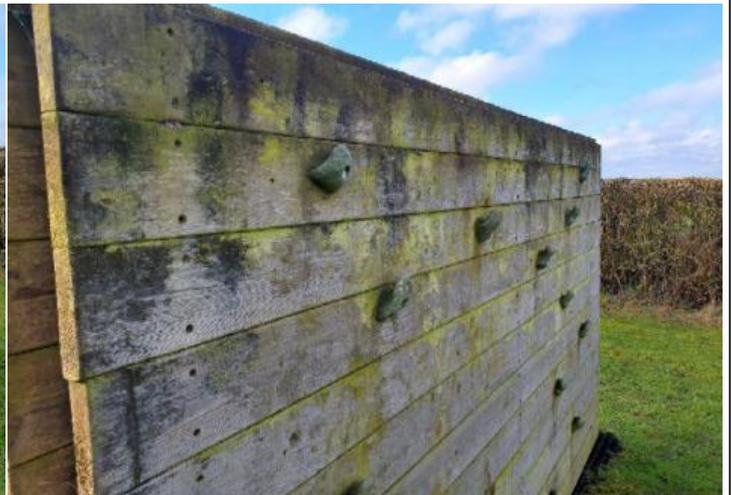
Finding: There is algae or moss on the surface of the equipment

Action: Clean and treat appropriately

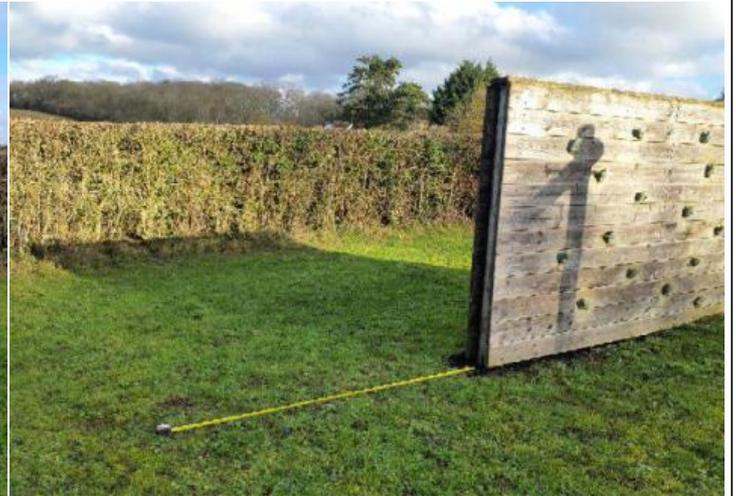
Finding: The surfacing dimensions are short and do not meet with the requirements of the current applicable standard

Action: Monitor - No action given the risk assessment

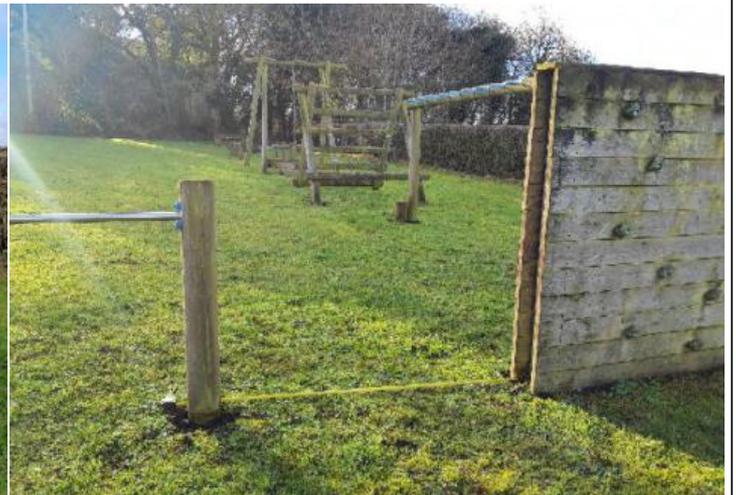
Finding: The adjacent item forms a projecting obstacle / hard object within the falling space of the equipment, in contravention of the requirements of BS EN 1176 Part 1

Action: Monitor - No action given the risk assessment

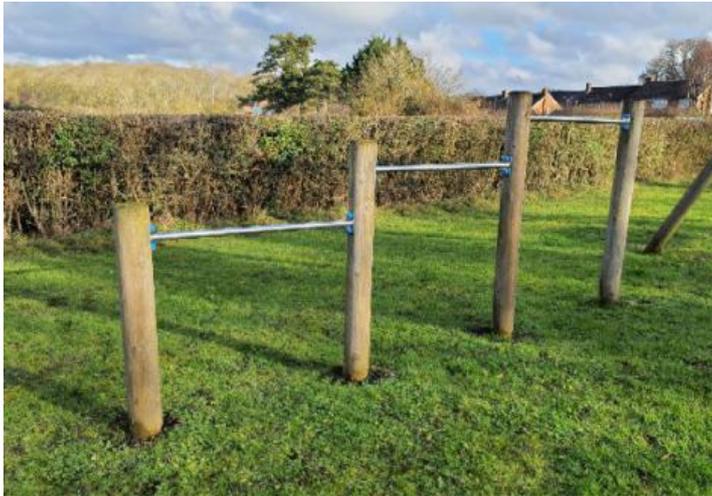
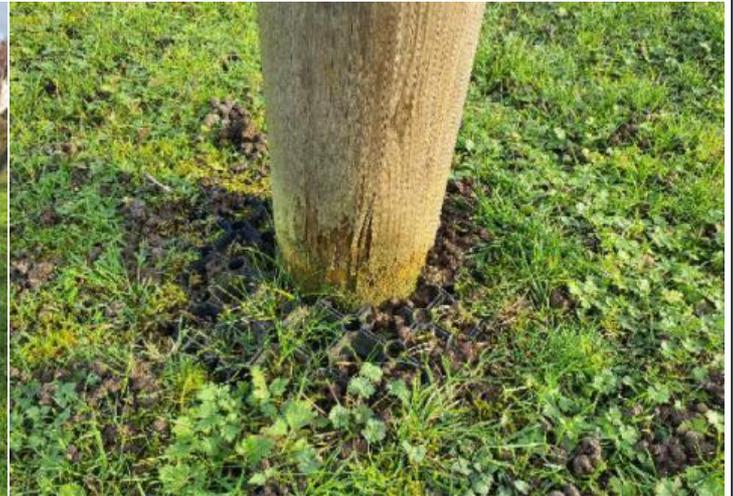
Finding: There is some strimmer / machinery damage apparent on the posts, this can penetrate the preservative applied to the timber and accelerate the rotting process

Action: Monitor for any deterioration (rot) and replace as required

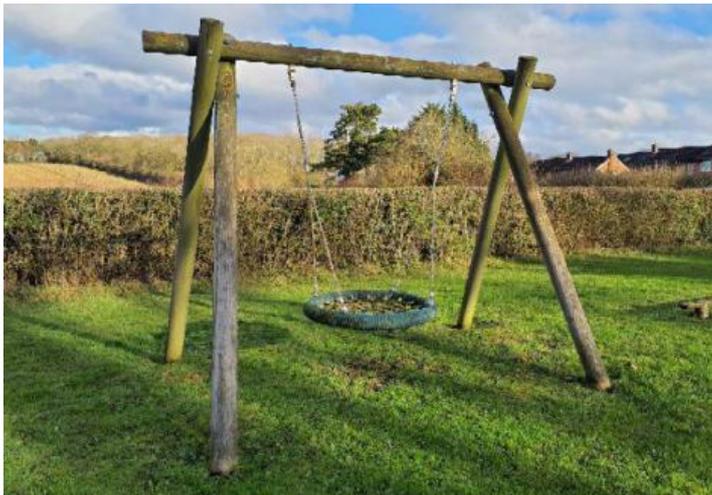
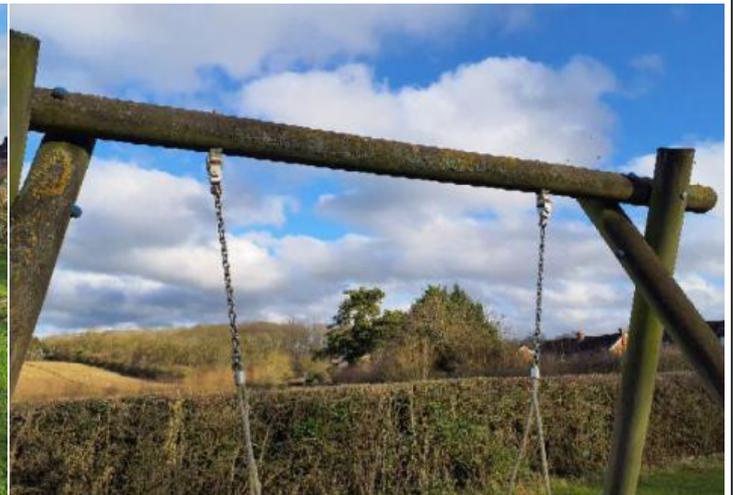
Finding: Swings of this design should have a secondary safety device fitted to prevent collapse of the seat in the event of a joint failure to meet the requirements of BS EN 1176 Part 2

Action: Consult with manufacturer and consider providing a secondary safety device where possible

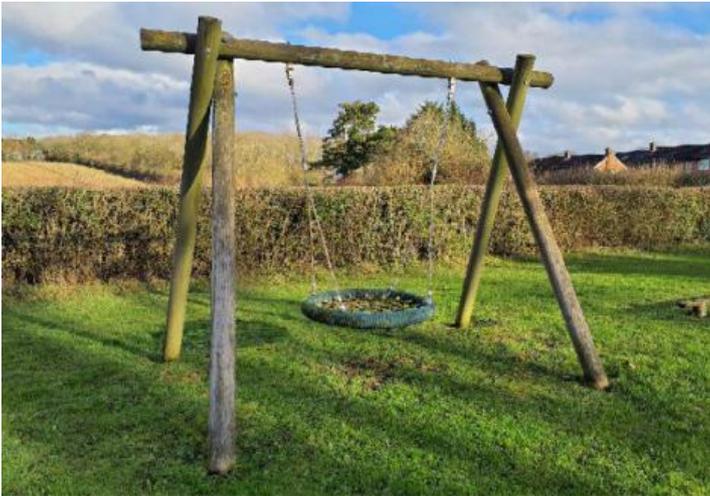
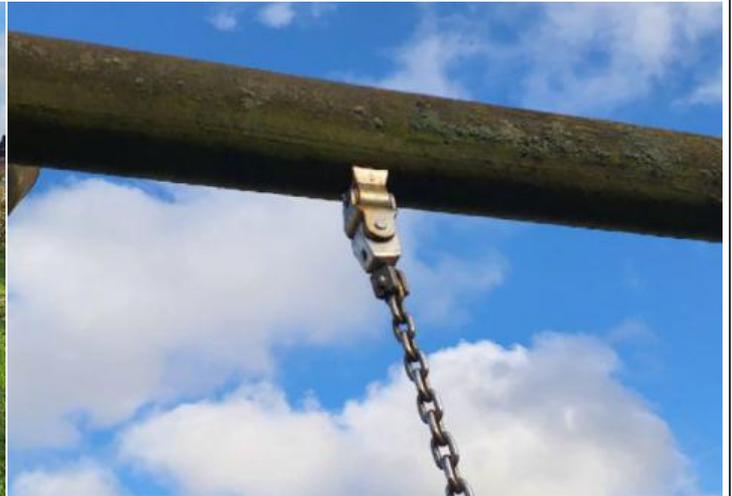
Finding: This design of swing joint has been known to fail on the weld connecting the joint to the threaded stud

Action: We would recommend that the joint be dismantled and checked on a regular basis or consulting with manufacturer on whether a Secondary Safety Device can be fitted

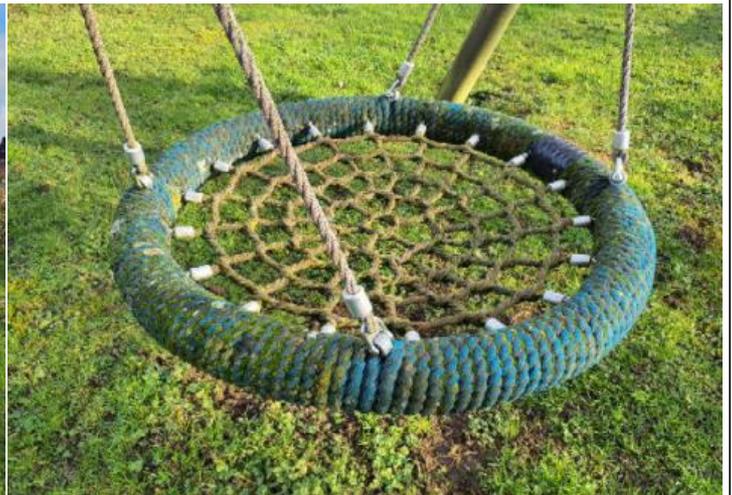
Finding: There is algae or moss on the surface of the equipment

Action: Clean and treat appropriately

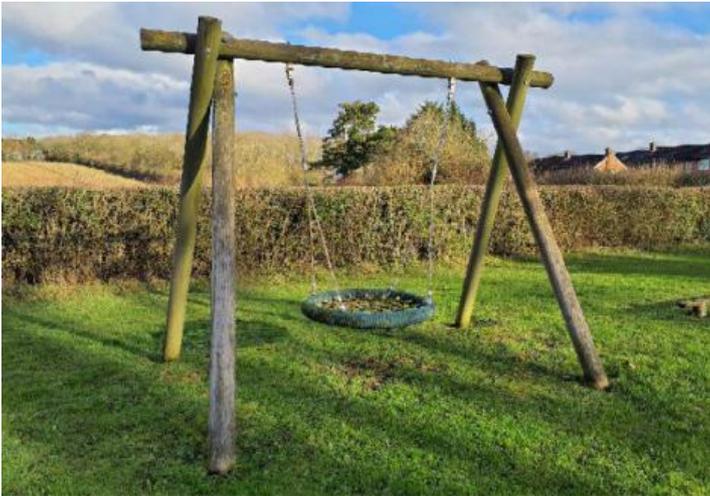
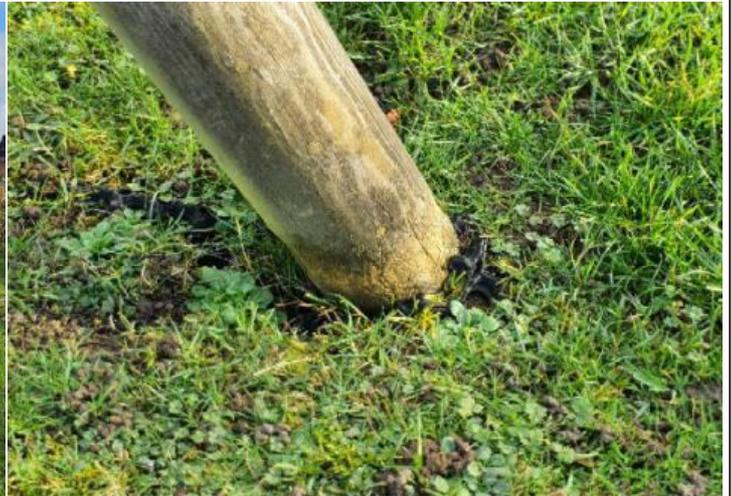
Finding: There is some strimmer / machinery damage apparent on the posts, this can penetrate the preservative applied to the timber and accelerate the rotting process

Action: Monitor for any deterioration (rot) and replace as required

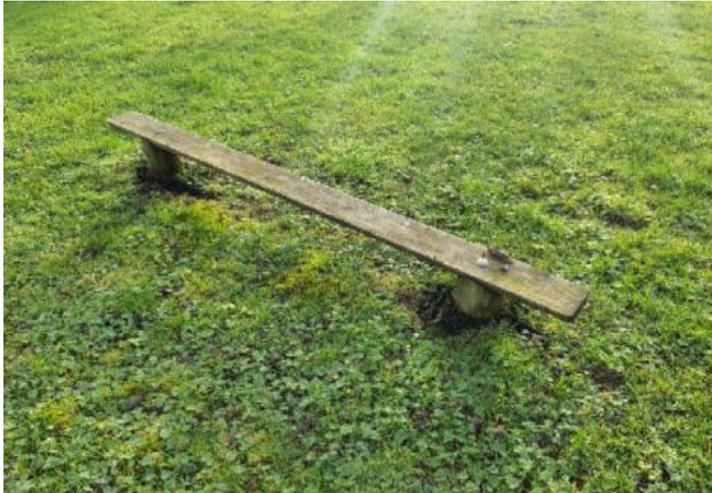
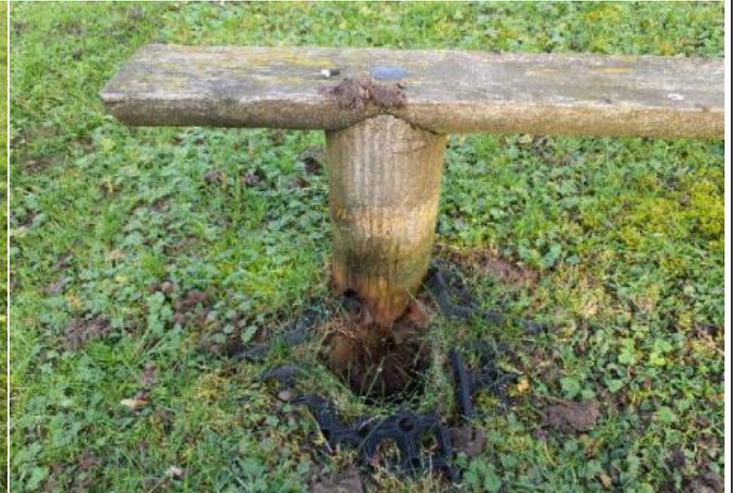
Finding: There are areas or parts of the timber on the structure that have rotted

Action: Replace all affected timbers

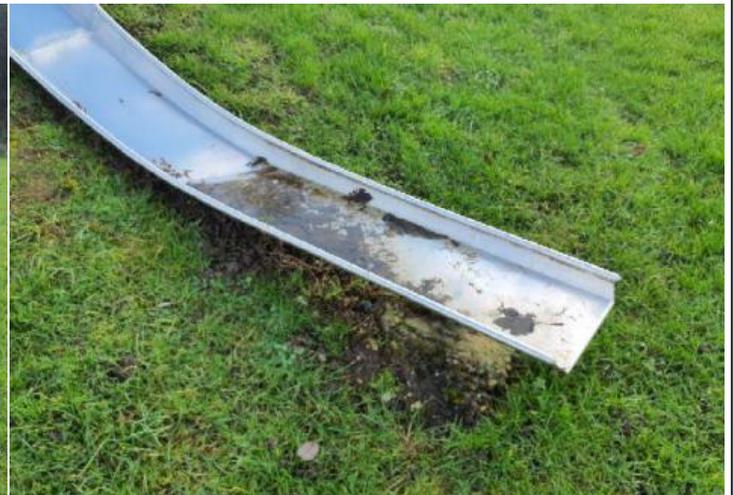
Finding: Water is pooling on the slide run out section

Action: Monitor use and adjust the design if required

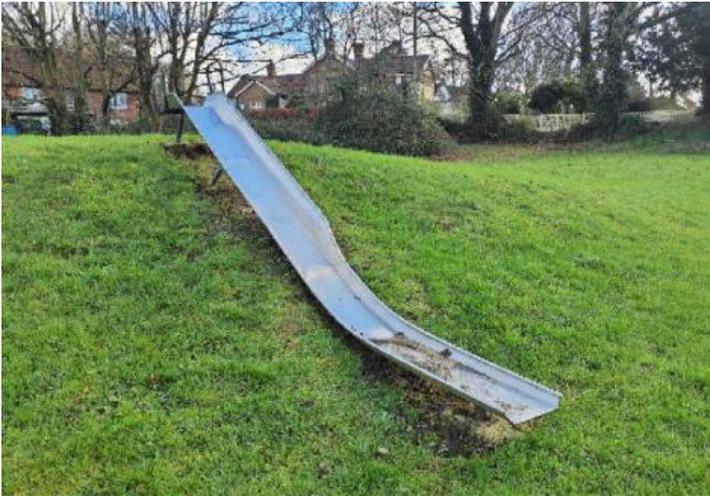
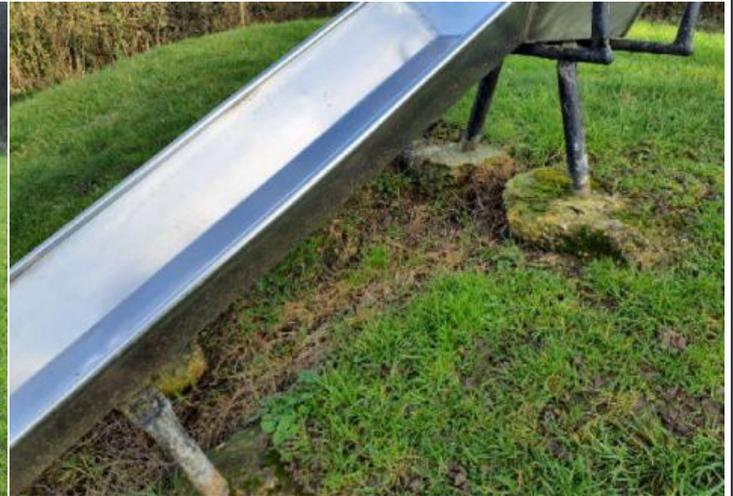
Finding: The surface has eroded in some areas and may be slippery in wet conditions
Action: Reinstate the surface

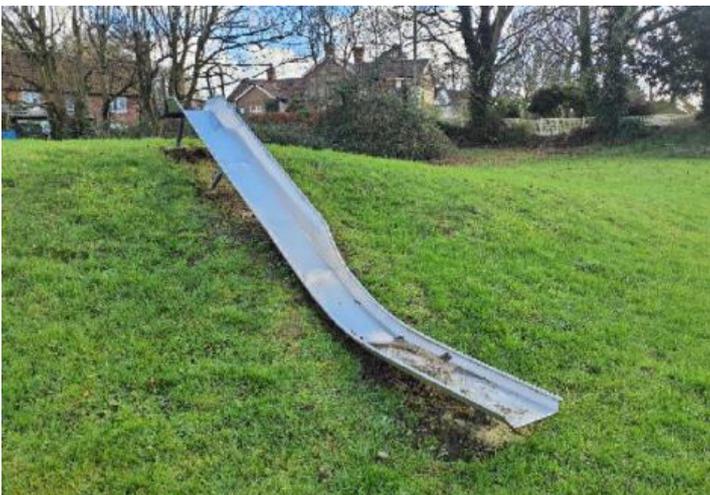
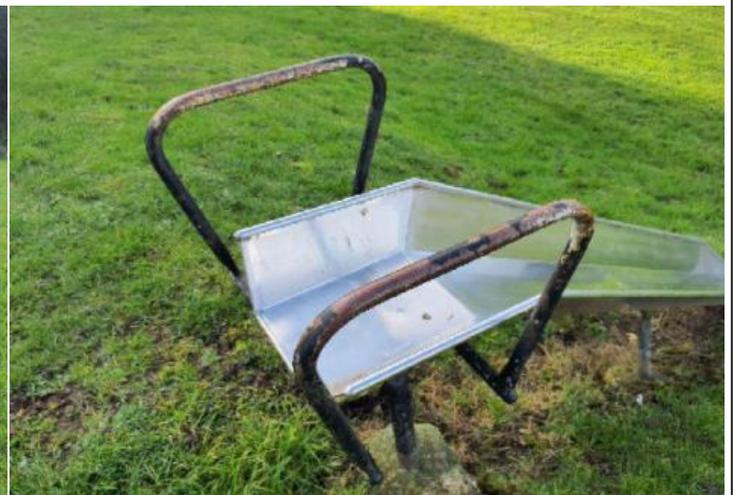
Finding: The paintwork on this item has been damaged or worn exposing the metal underneath which is rusting / corroding
Action: Treat affected areas and repaint
