the **play inspection** company

Annual Inspection

Weston Colville Parish Council

Brinkley Road Play Area

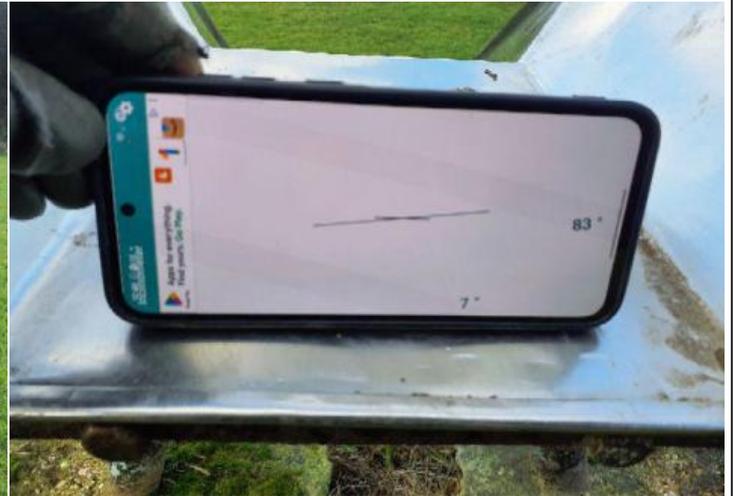
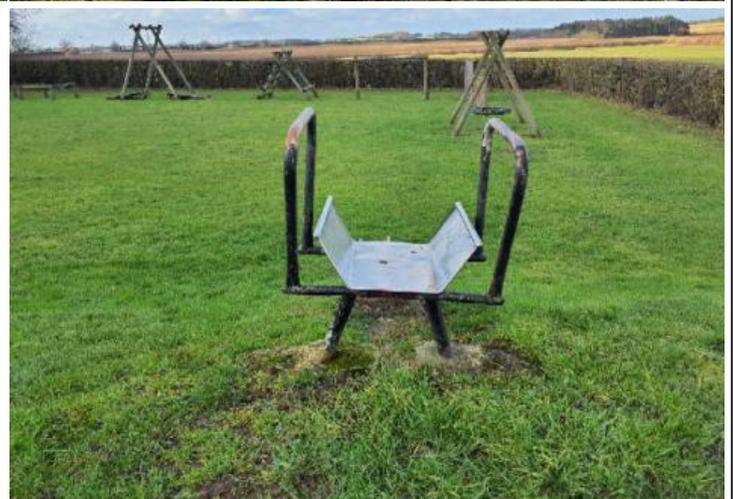
Finding: The slide starting section is leaning

Action: Monitor no remedial work required

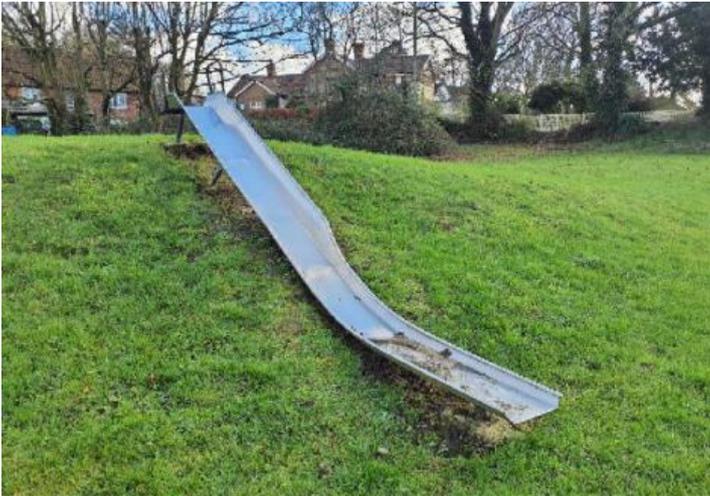
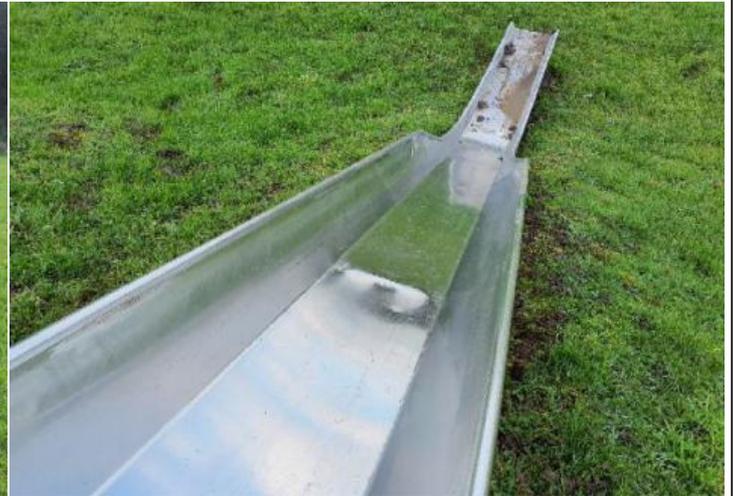
Finding: There are a number of dents in the slide surface

Action: Monitor for any further deterioration and repair as required

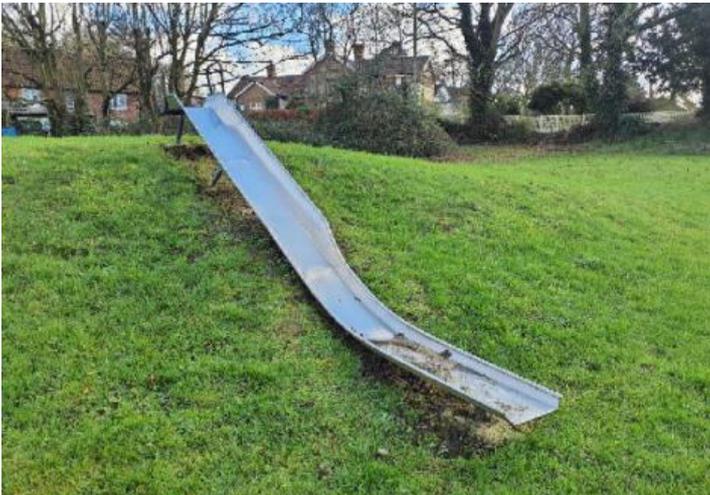
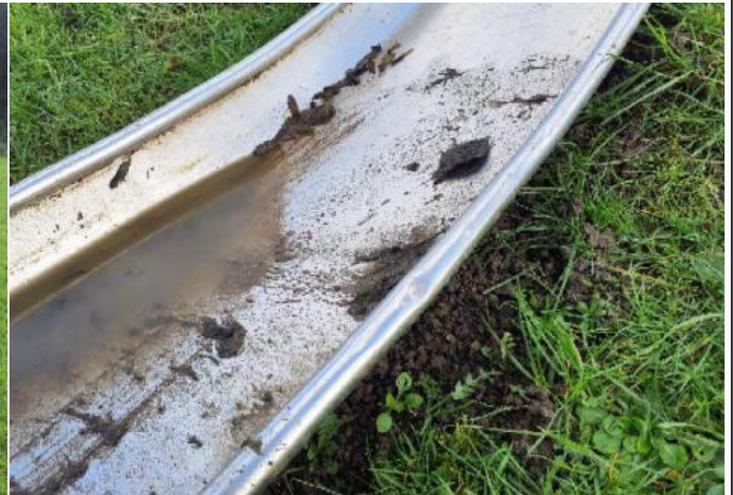
Finding: The side of the slide is damaged

Action: Monitor for any further deterioration and repair as required

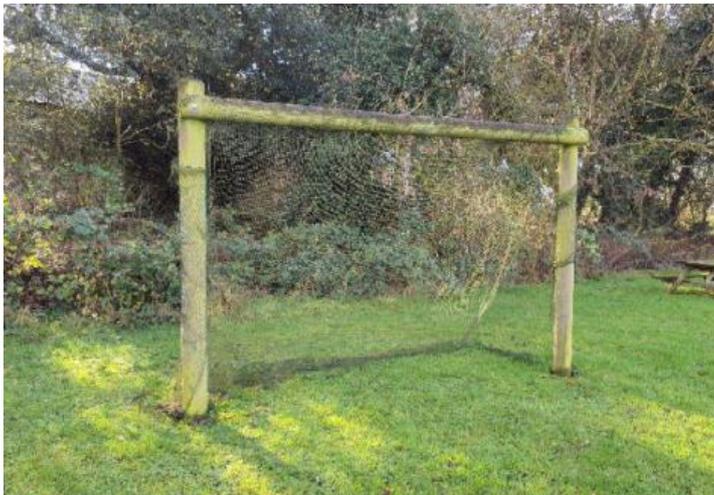
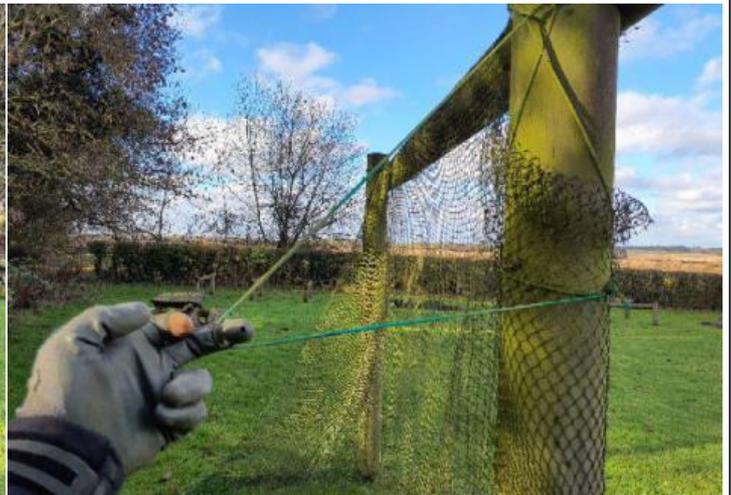
Finding: There is loose twine on the net

Action: Secure or remove

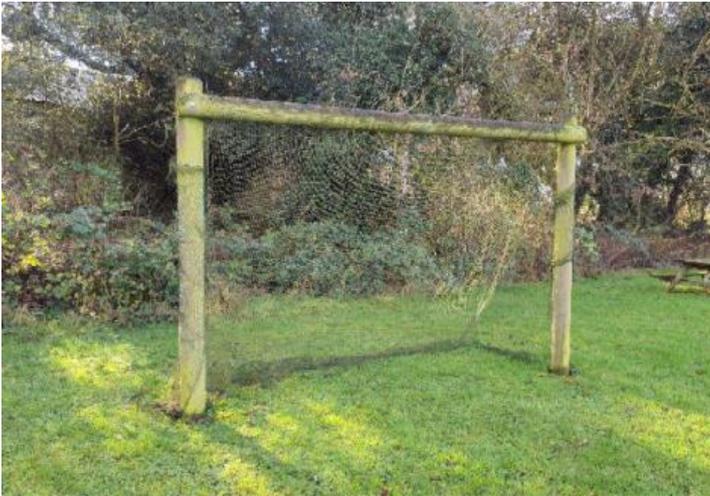
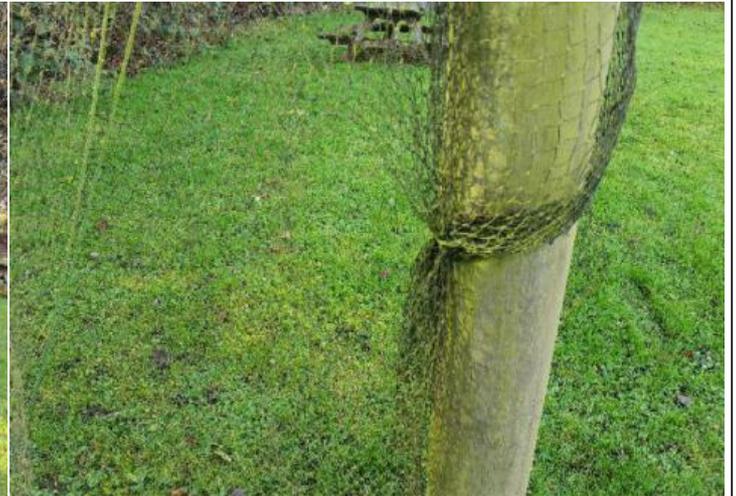
Finding: The net has been damaged

Action: Repair or replace the item
