## Annual Inspection

Weston Colville Parish Council

Brinkley Road Play Area

Brinkley Road, opp Mill Lane, Weston Colville,

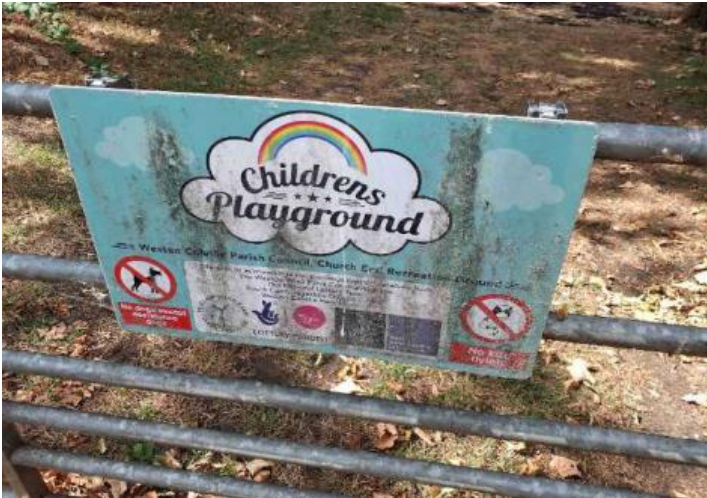
**Item:** Ancillary Items - Sign  
**Manufacturer:** Not Identified

**Finding:** It is recommended that signage, with information including the site address, contact information for maintenance issues and emergency contact details are provided for the facility

**Action:** Provide in accordance with the recommendations

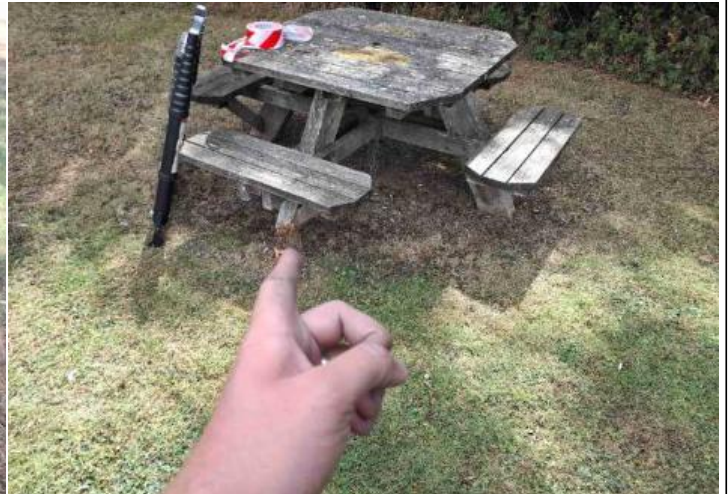
**Item:** Ancillary Items - Picnic Table  
**Manufacturer:** Not Identified

**Finding:** There are areas or parts of the timber on the structure that have rotted

**Action:** Replace all affected timbers

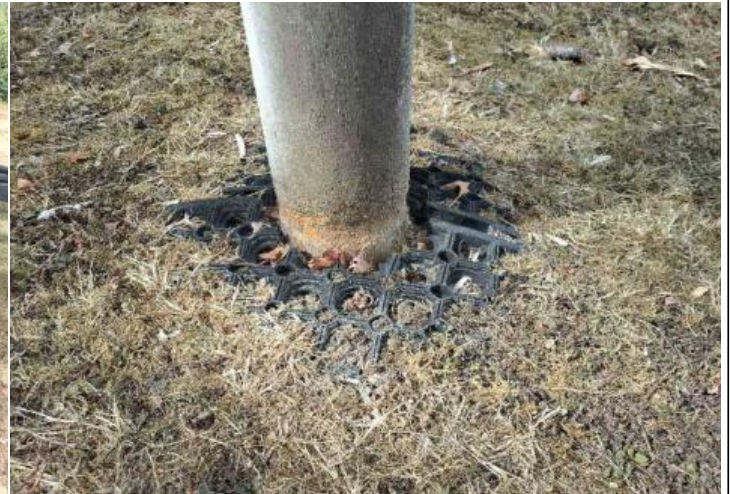
**Item:** Activity Equipment - Up and Under Bars  
**Manufacturer:** Not Identified

**Finding:** There is some strimmer / machinery damage apparent on the posts, this can penetrate the preservative applied to the timber and accelerate the rotting process

**Action:** Monitor for any deterioration (rot) and replace as required

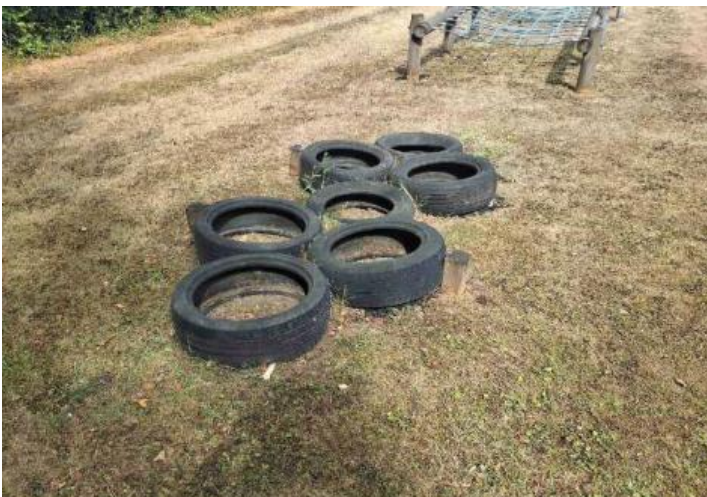
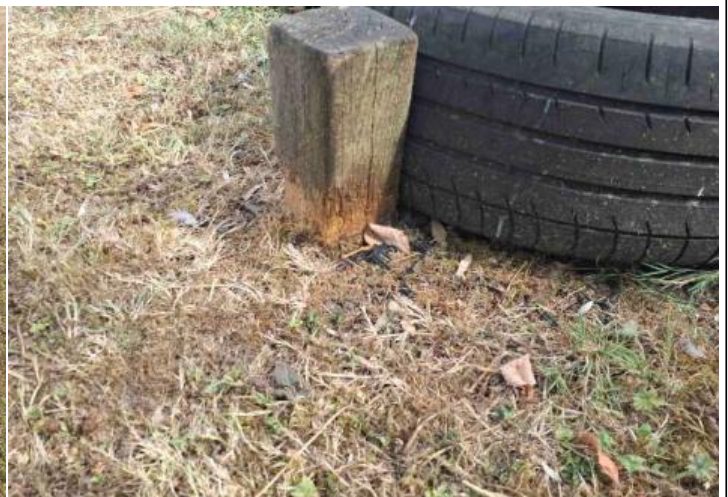
**Item:** Activity Equipment - Tyre Trail  
**Manufacturer:** Not Identified

**Finding:** There is some strimmer / machinery damage apparent on the posts, this can penetrate the preservative applied to the timber and accelerate the rotting process

**Action:** Monitor for any deterioration (rot) and replace as required

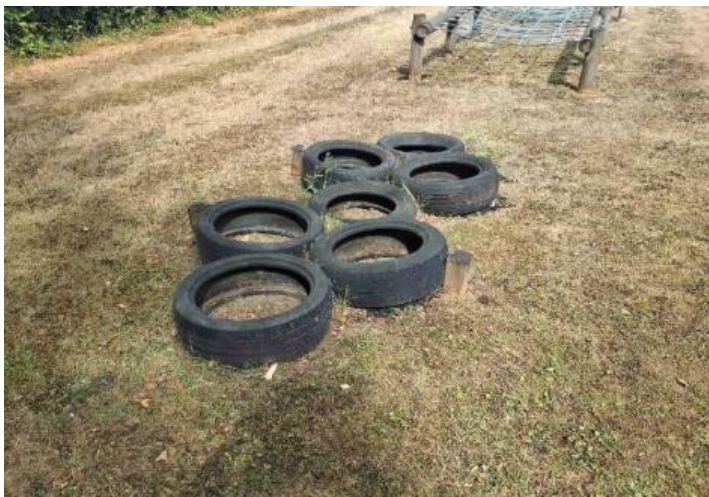
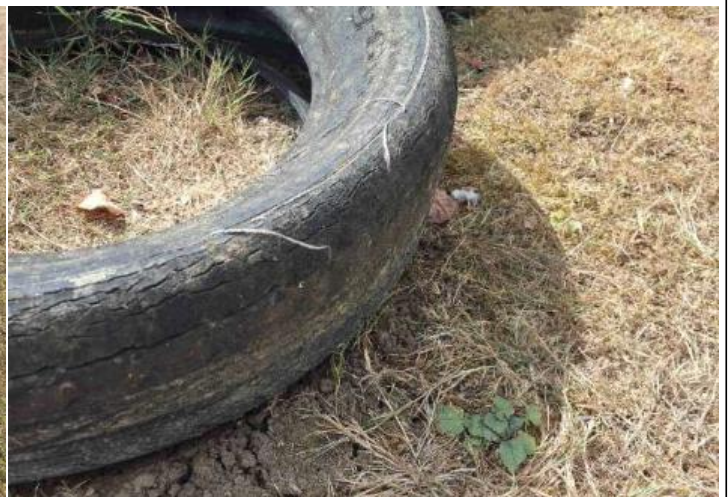
**Item:** Activity Equipment - Tyre Trail  
**Manufacturer:** Not Identified

**Finding:** The item has been damaged

**Action:** Monitor for any further deterioration and replace as required

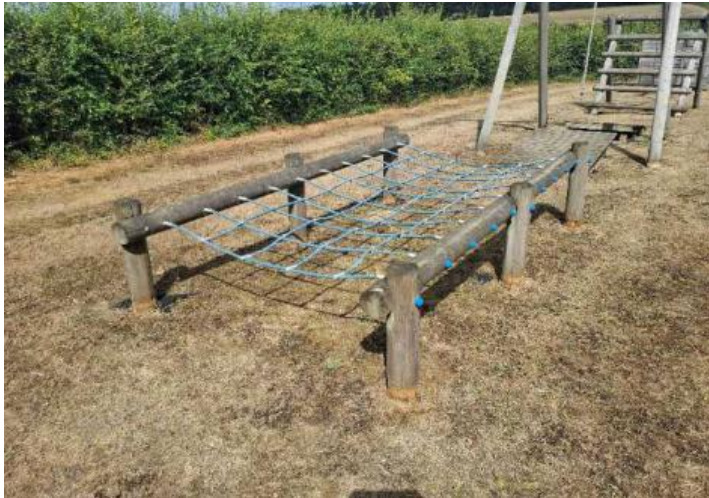
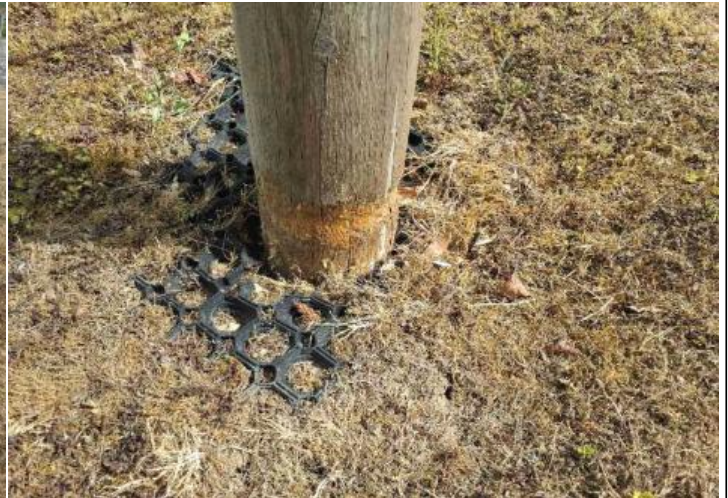
**Item:** Activity Equipment - Rope Traverse  
**Manufacturer:** Not Identified

**Finding:** There is some strimmer / machinery damage apparent on the posts, this can penetrate the preservative applied to the timber and accelerate the rotting process

**Action:** Monitor for any deterioration (rot) and replace as required

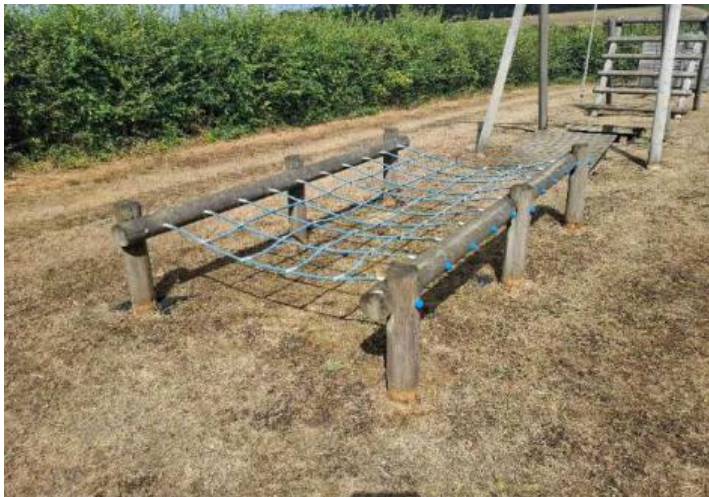
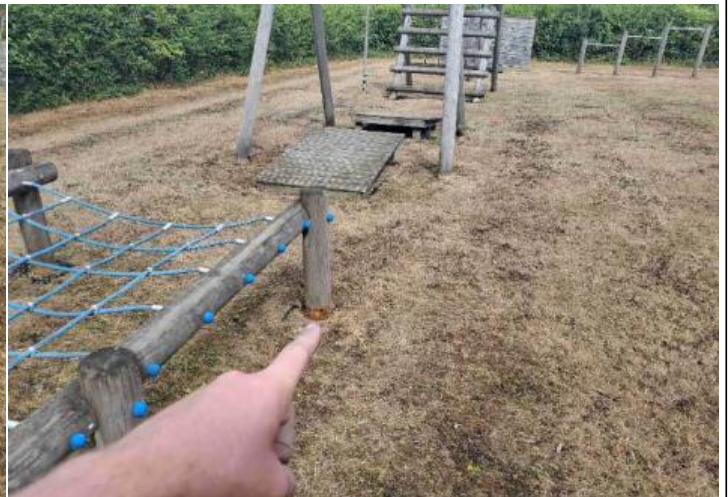
**Item:** Activity Equipment - Rope Traverse  
**Manufacturer:** Not Identified

**Finding:** There are areas or parts of the timber on the structure that have rotted

**Action:** Replace all affected timbers

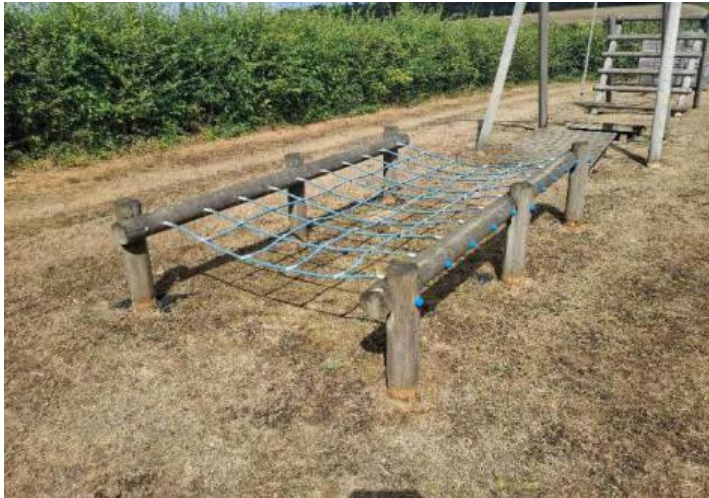
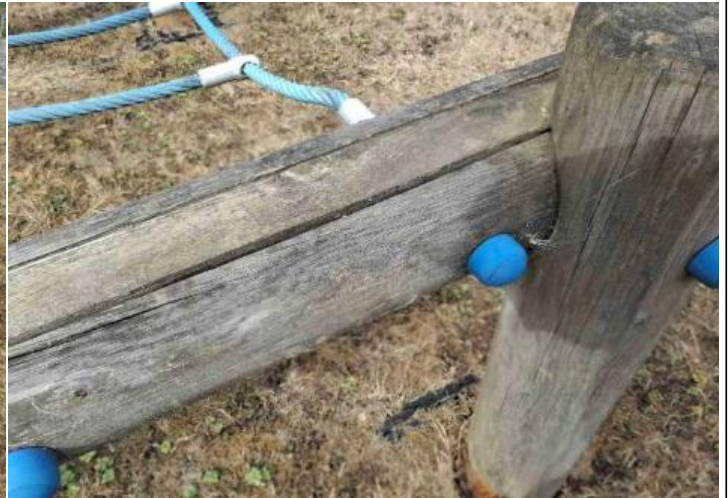
**Item:** Activity Equipment - Rope Traverse  
**Manufacturer:** Not Identified

**Finding:** The timber has a number of splits/shakes or air cracks and this may affect the stability or allow water ingress which will accelerate the rotting process. Timber splits may also create rough / splintering edges.

**Action:** Monitor, sand down any rough edges and ensure the splits do not cross through fixing points of the structure and/or cause any instability

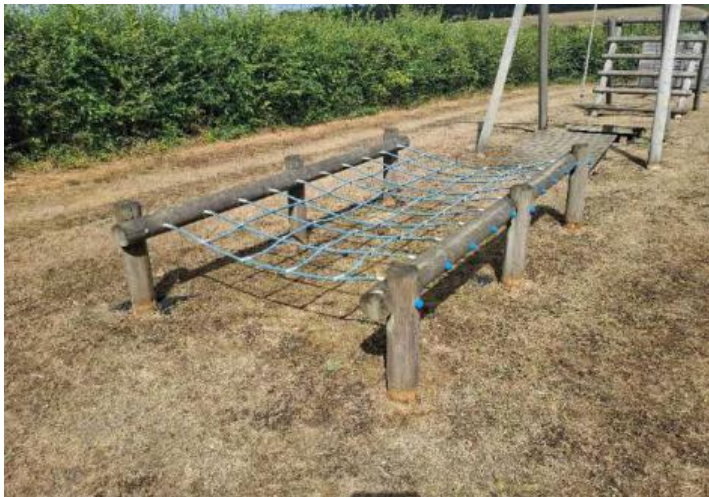
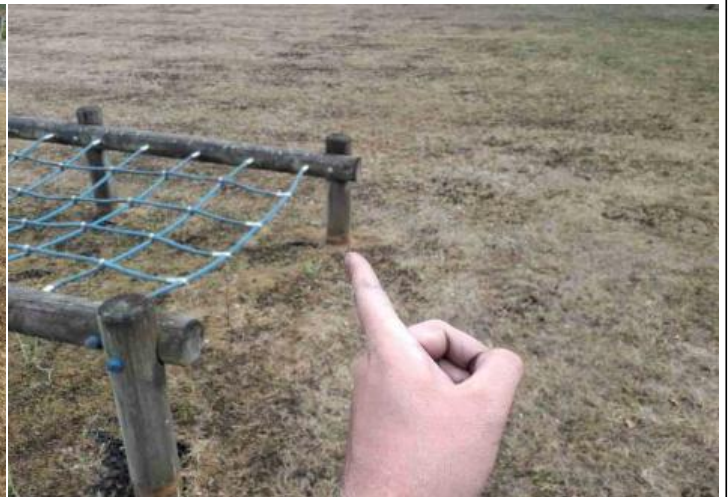
**Item:** Activity Equipment - Rope Traverse  
**Manufacturer:** Not Identified

**Finding:** There is some evidence of rot in the timber

**Action:** Monitor for any further deterioration and replace as required

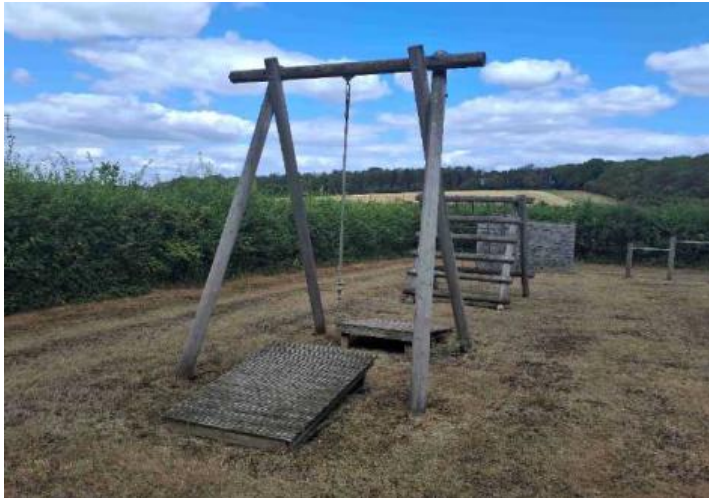
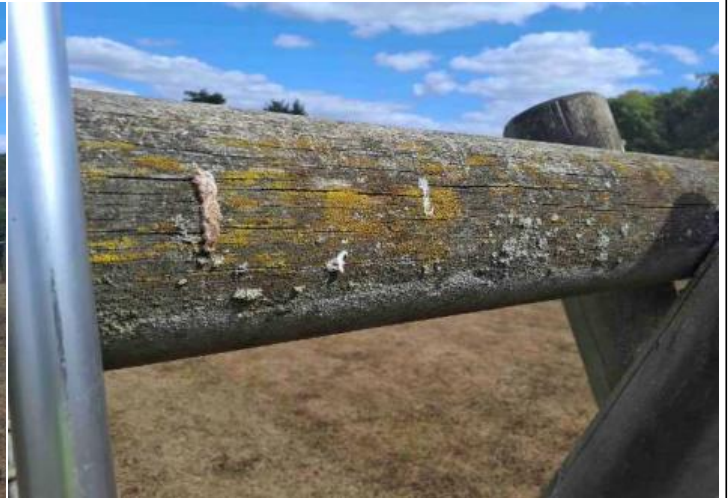
**Item:** Activity Equipment - Rope Traverse  
**Manufacturer:** Not Identified

**Finding:** There is algae or moss on the surface of the equipment which can lead to the onset of rot

**Action:** Clean and treat appropriately and monitor condition of the timber

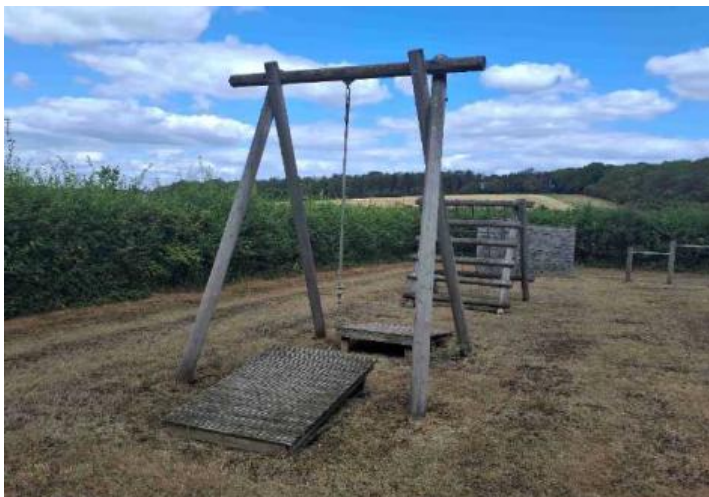
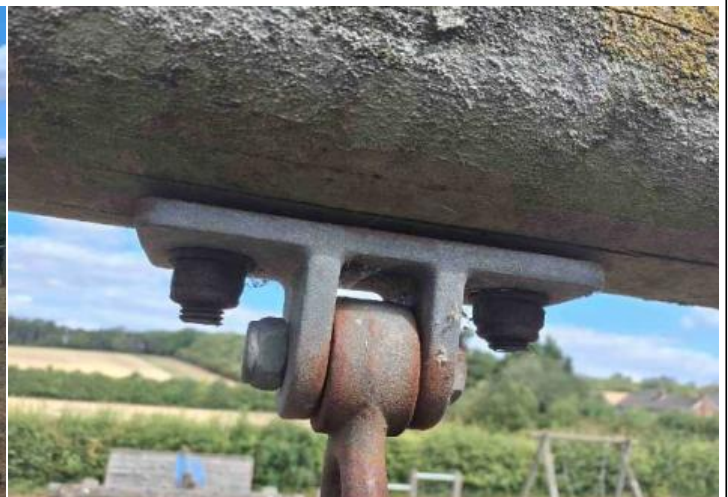
**Item:** Activity Equipment - Rope Traverse  
**Manufacturer:** Not Identified

**Finding:** A number of suspension fixing(s) have worked loose

**Action:** Secure all loose fixings

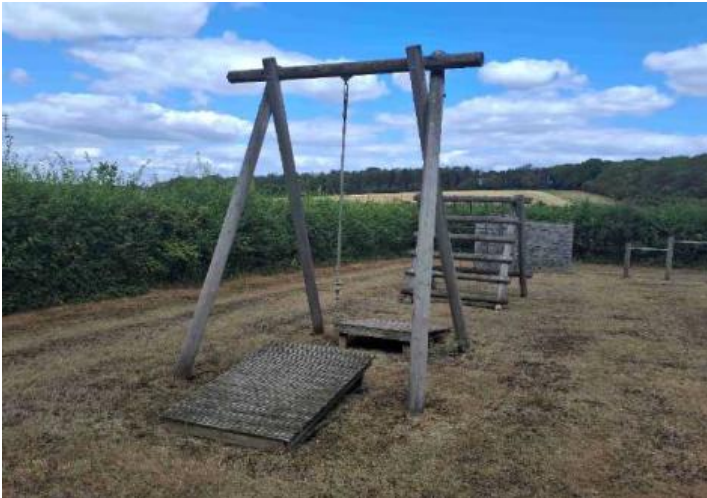
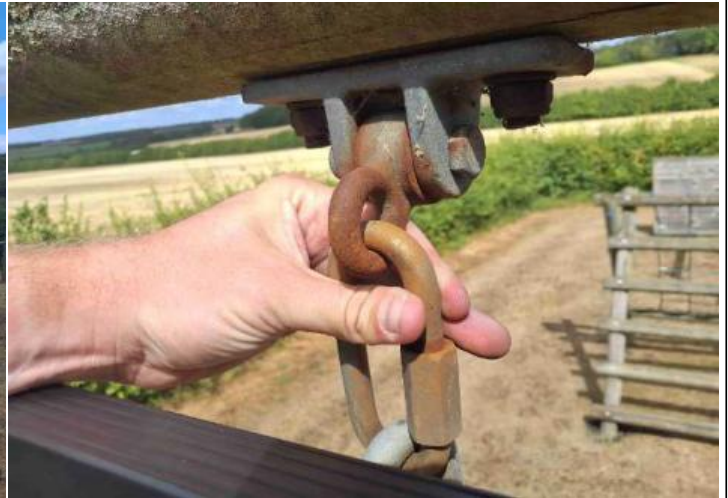
**Item:** Activity Equipment - Rope Traverse  
**Manufacturer:** Not Identified

**Finding:** The connecting lugs are showing signs of wear

**Action:** Monitor for any further deterioration and repair as required

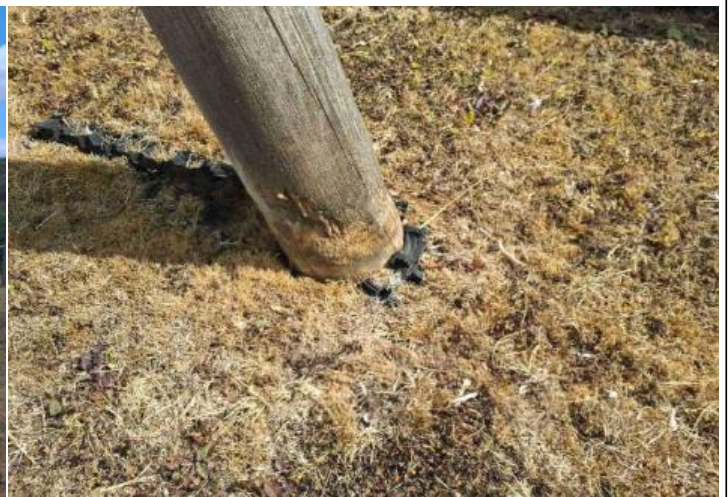
**Item:** Activity Equipment - Rope Traverse  
**Manufacturer:** Not Identified

**Finding:** There is some strimmer / machinery damage apparent on the posts, this can penetrate the preservative applied to the timber and accelerate the rotting process

**Action:** Monitor for any deterioration (rot) and replace as required

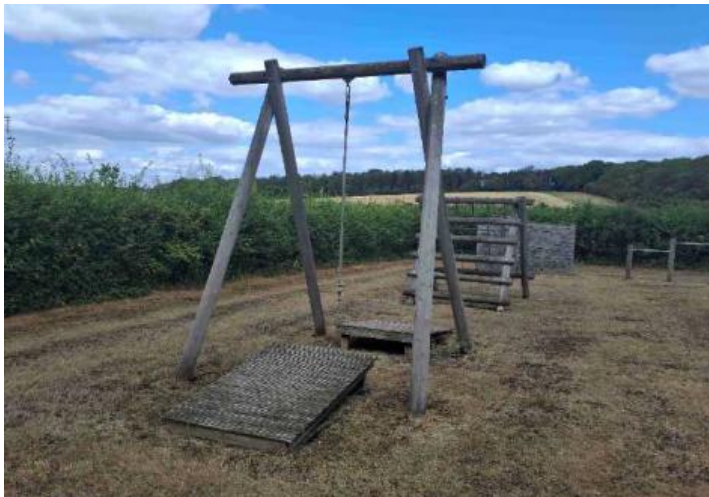
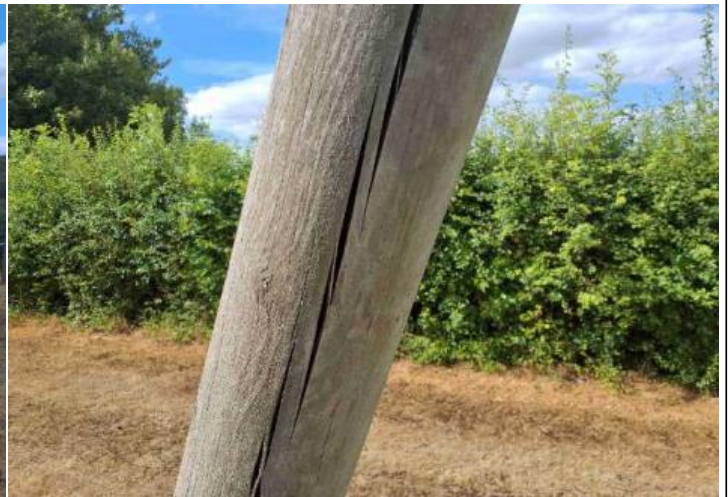
**Item:** Activity Equipment - Rope Traverse  
**Manufacturer:** Not Identified

**Finding:** The timber has a number of splits/shakes or air cracks and this may affect the stability or allow water ingress which will accelerate the rotting process. Timber splits may also create rough / splintering edges.

**Action:** Monitor, sand down any rough edges and ensure the splits do not cross through fixing points of the structure and/or cause any instability

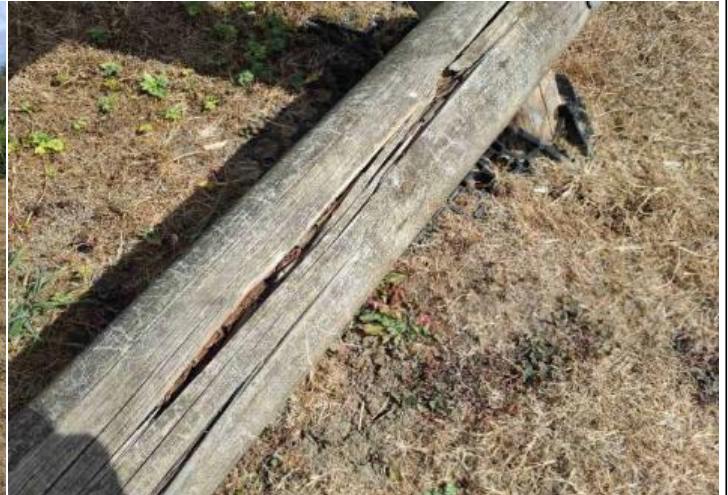
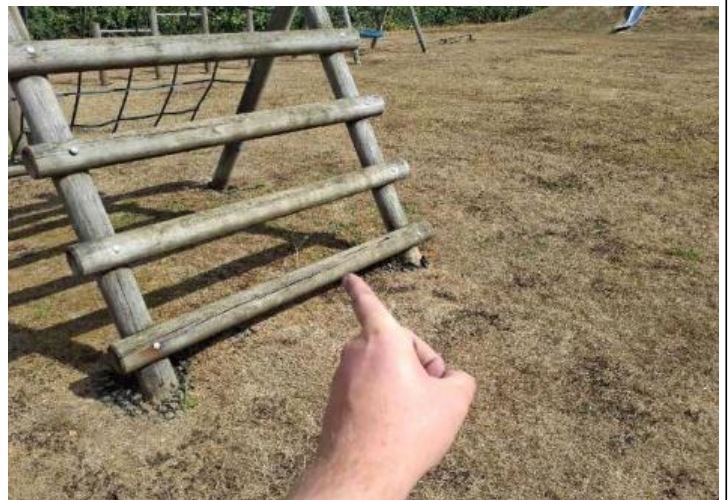
**Item:** Activity Equipment - A Frame Climber  
**Manufacturer:** Not Identified

**Finding:** There are areas or parts of the timber on the structure that have rotted

**Action:** Replace all affected timbers

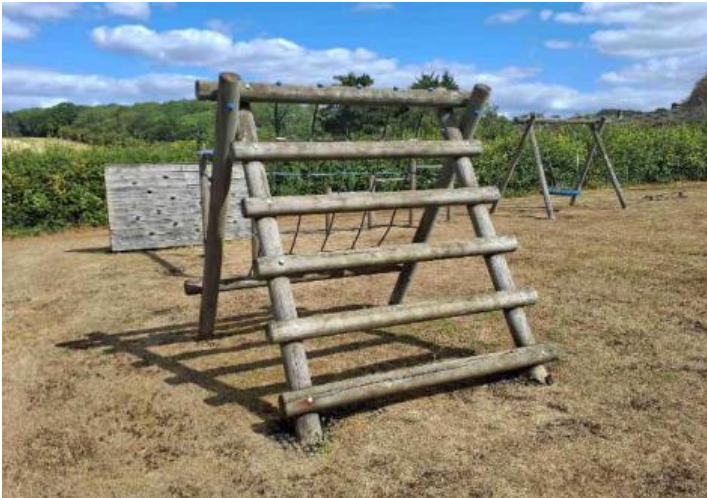
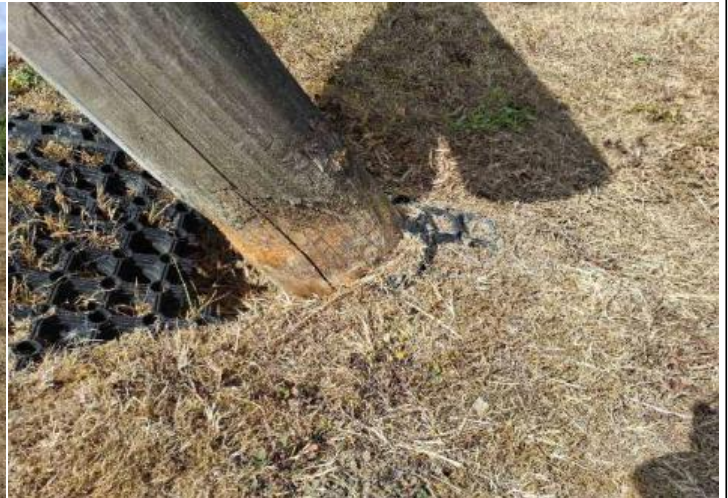
**Item:** Activity Equipment - A Frame Climber  
**Manufacturer:** Not Identified

**Finding:** There is some strimmer / machinery damage apparent on the posts, this can penetrate the preservative applied to the timber and accelerate the rotting process

**Action:** Monitor for any deterioration (rot) and replace as required

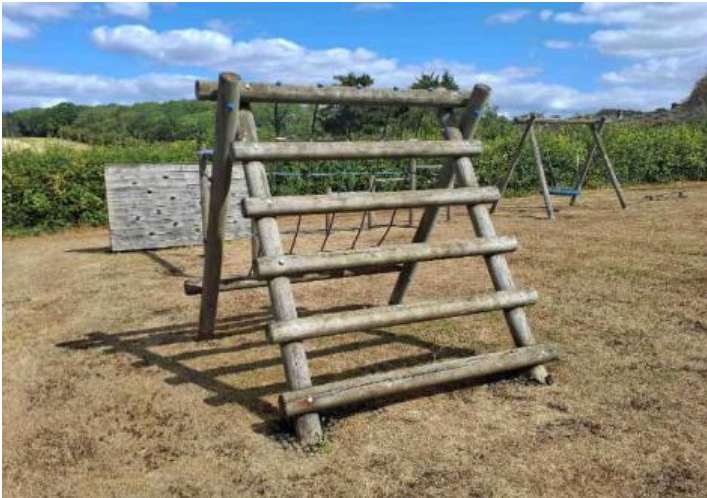
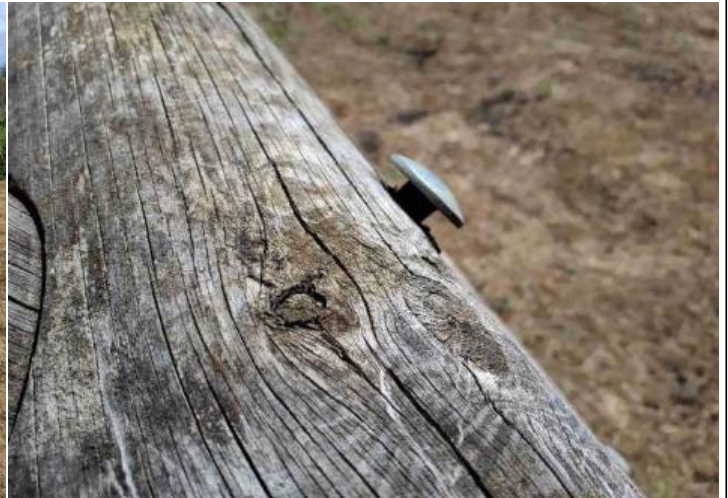
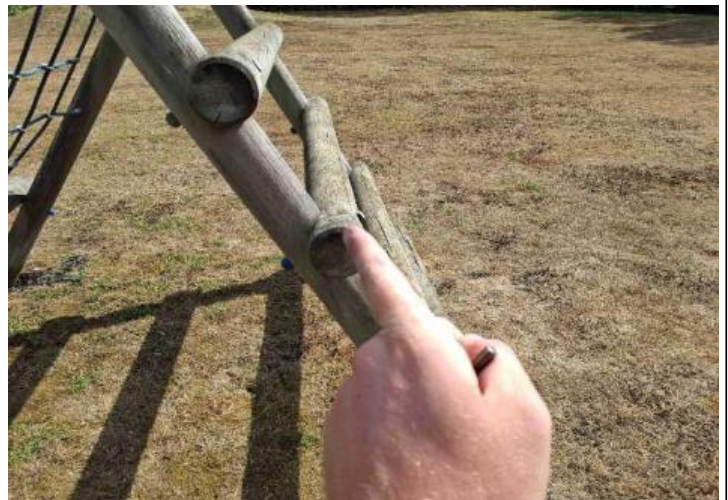
**Item:** Activity Equipment - A Frame Climber  
**Manufacturer:** Not Identified

**Finding:** A number of fixing(s) have worked loose

**Action:** Secure all loose fixings

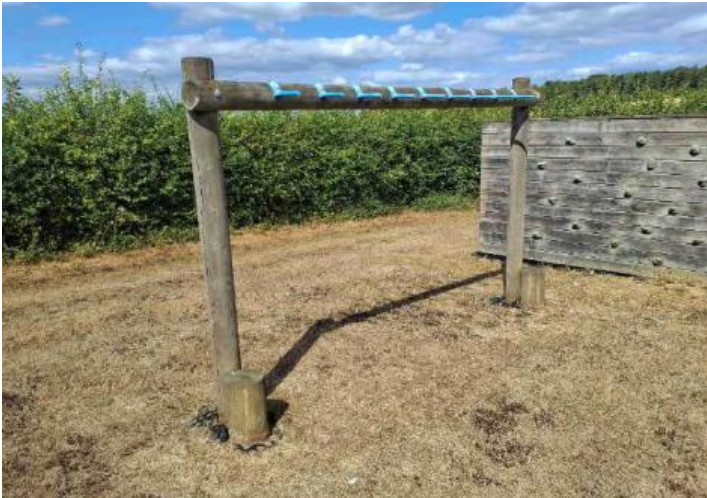
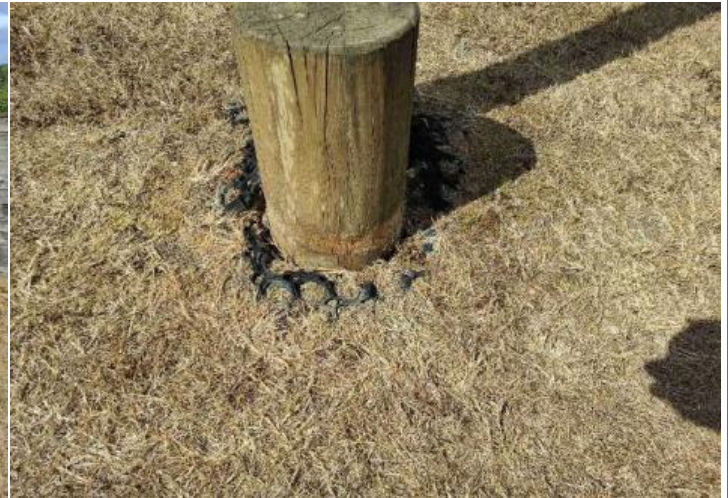
**Item:** Activity Equipment - Monkey Bars  
**Manufacturer:** Not Identified

**Finding:** There is some strimmer / machinery damage apparent on the posts, this can penetrate the preservative applied to the timber and accelerate the rotting process

**Action:** Monitor for any deterioration (rot) and replace as required

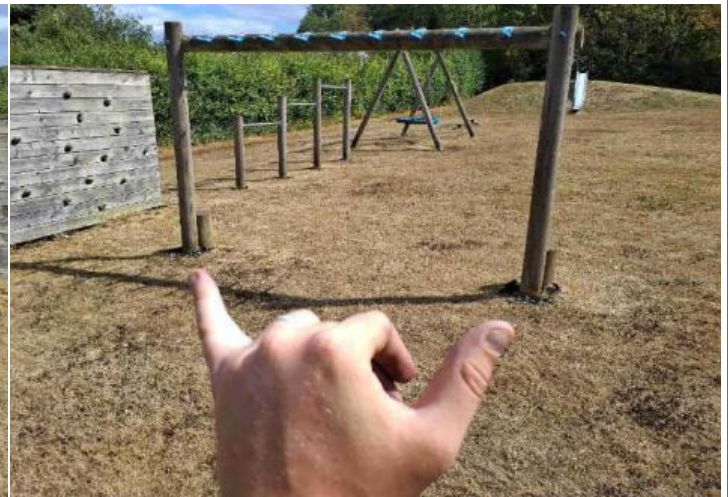
**Finding:** The item is slightly loose in its foundations

**Action:** Monitor for any further deterioration and repair as required

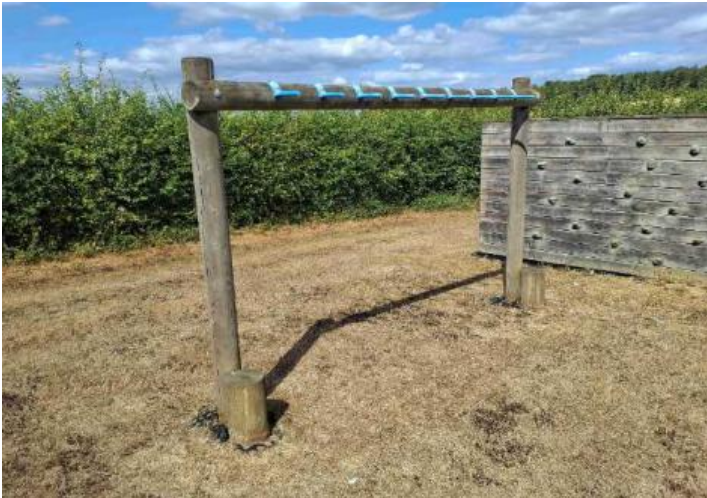
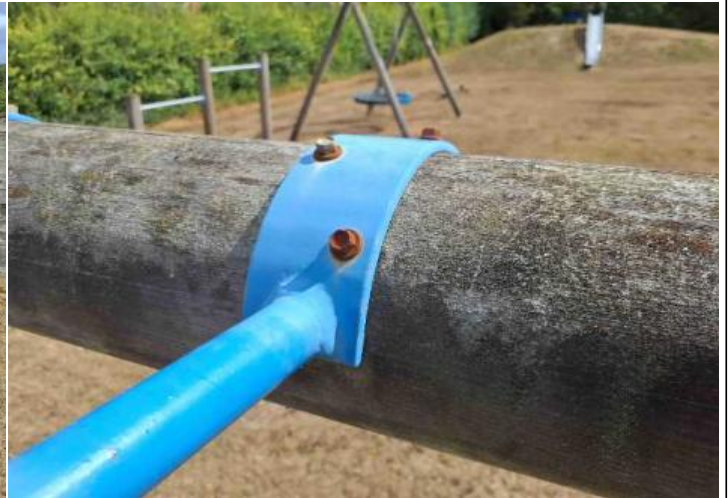
**Finding:** A number of fixing(s) have worked loose

**Action:** Secure all loose fixings

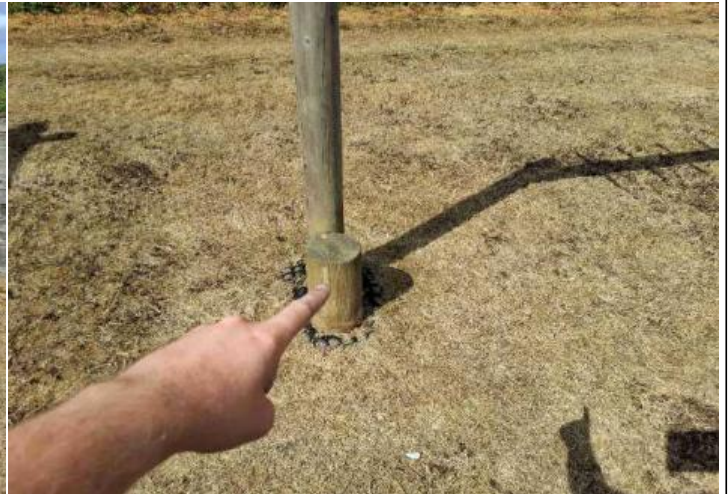
**Finding:** A number of fixing(s) have worked loose

**Action:** Secure all loose fixings

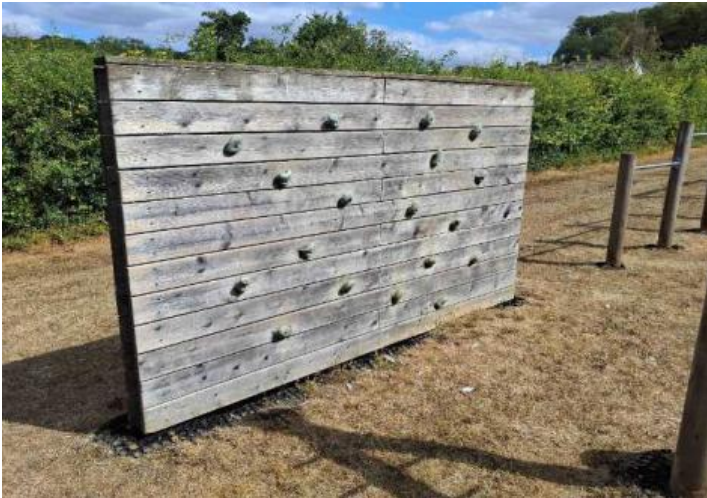
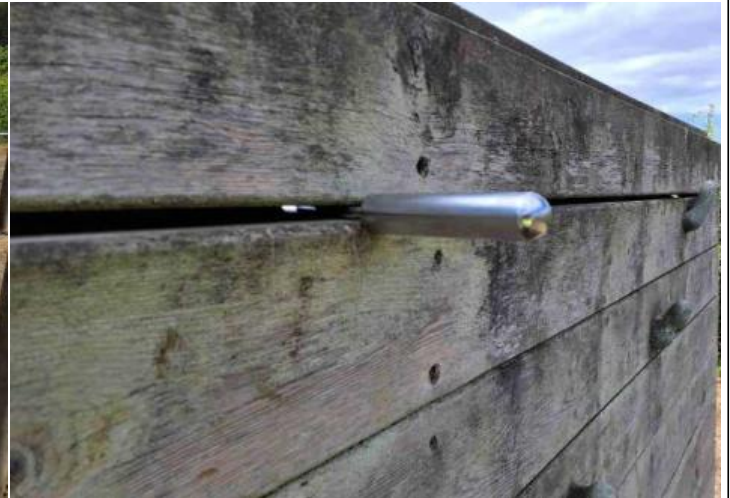
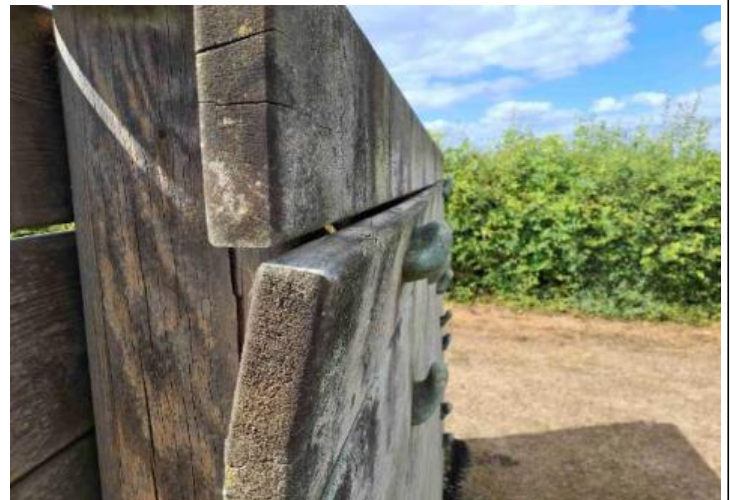
**Finding:** There is/are finger entrapment/s in the wall due to a damaged slat and the item fails to meet the requirements of BS EN 1176 Part 1 4.2.7.6 Entrapment of fingers

**Action:** Replace slat to remove entrapment

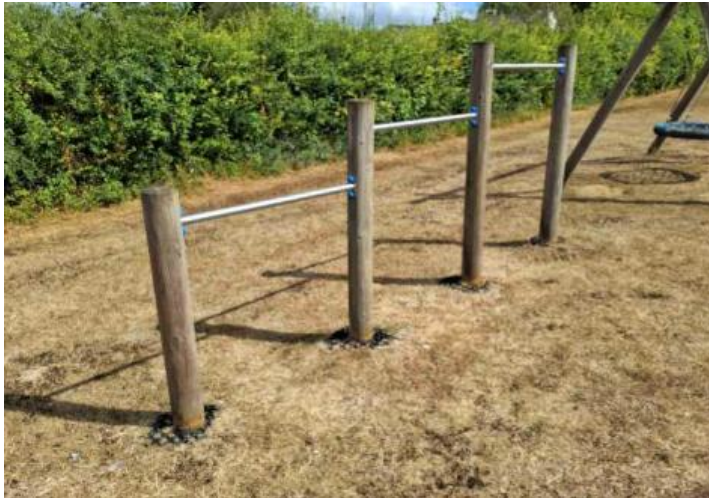
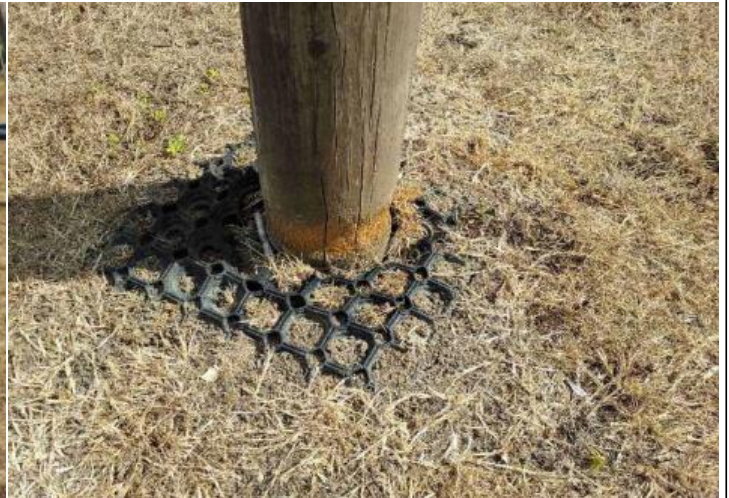
**Finding:** There is some strimmer / machinery damage apparent on the posts, this can penetrate the preservative applied to the timber and accelerate the rotting process

**Action:** Monitor for any deterioration (rot) and replace as required

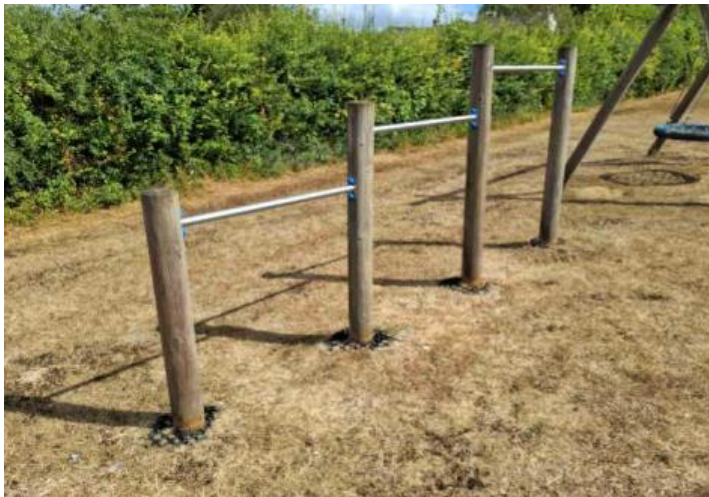
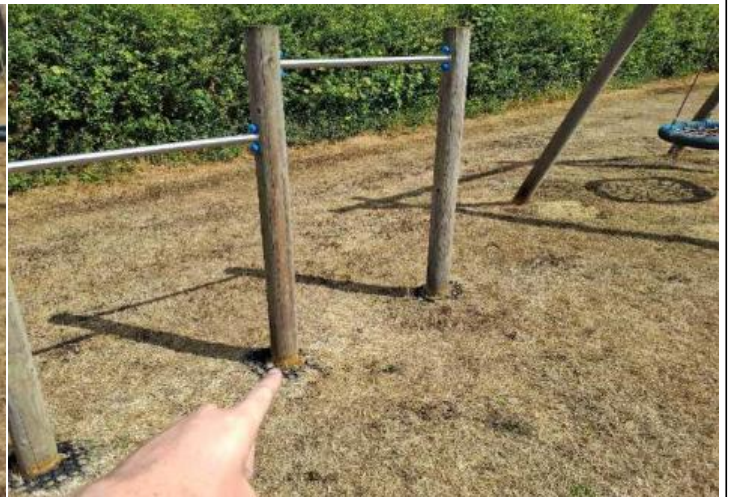
**Finding:** The item is slightly loose in its foundations

**Action:** Monitor for any further deterioration and repair as required

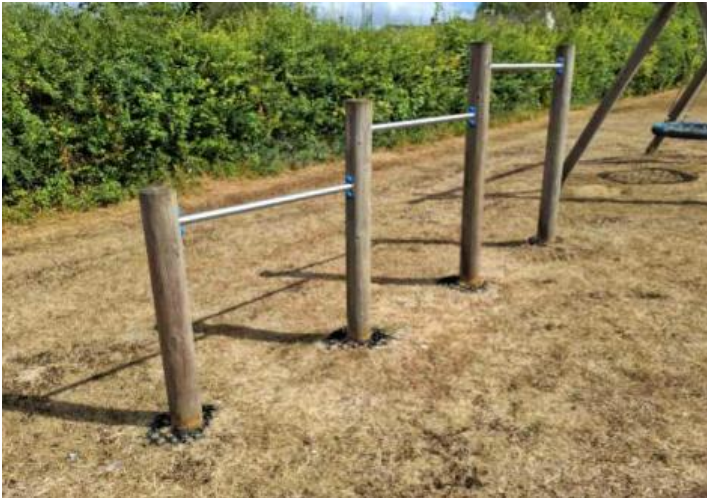
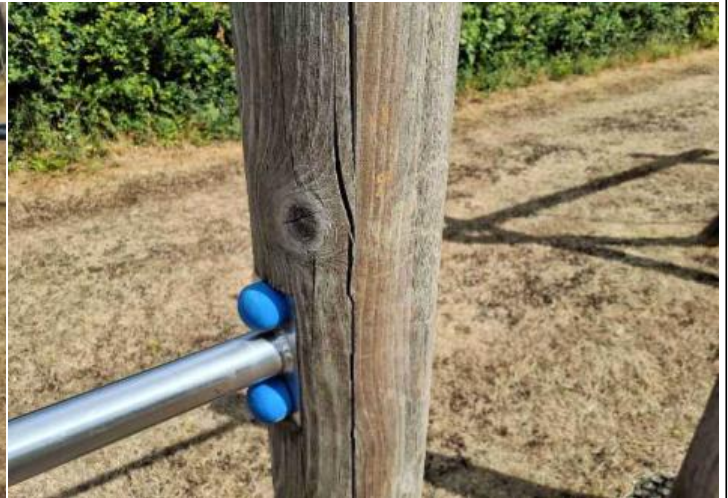
**Finding:** The timber has a number of splits/shakes or air cracks and this may affect the stability or allow water ingress which will accelerate the rotting process. Timber splits may also create rough / splintering edges.

**Action:** Monitor, sand down any rough edges and ensure the splits do not cross through fixing points of the structure and/or cause any instability

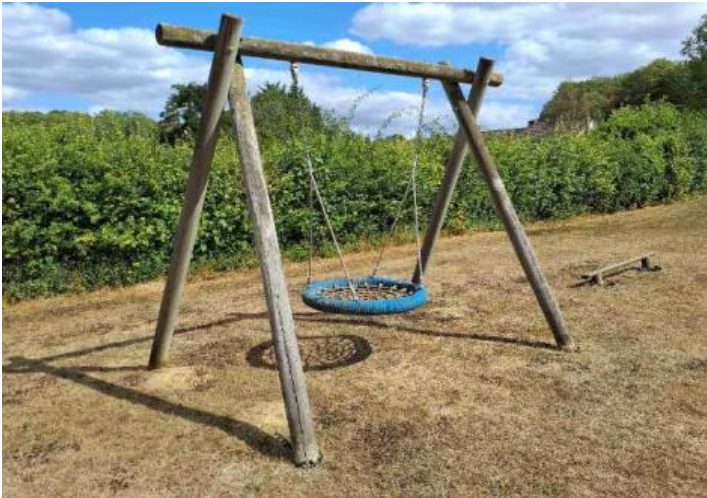
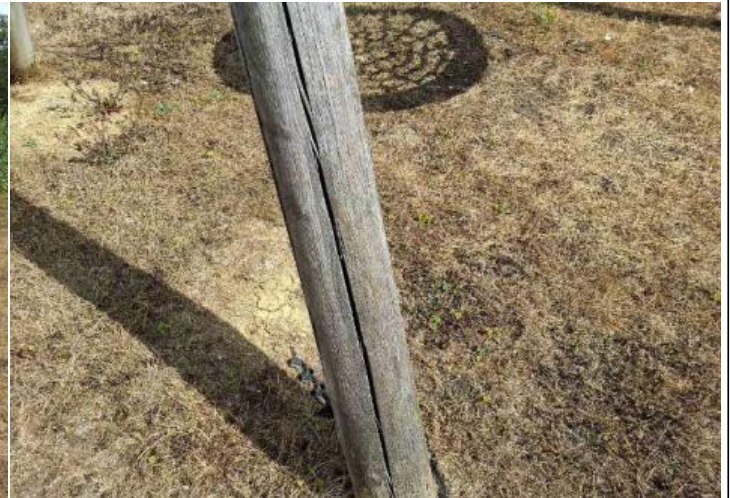
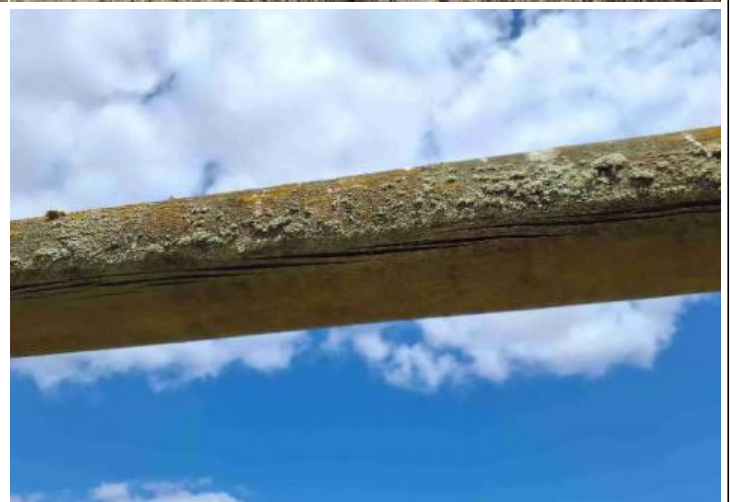
**Finding:** The timber has a number of splits/shakes or air cracks and this may affect the stability or allow water ingress which will accelerate the rotting process. Timber splits may also create rough / splintering edges.

**Action:** Monitor, sand down any rough edges and ensure the splits do not cross through fixing points of the structure and/or cause any instability

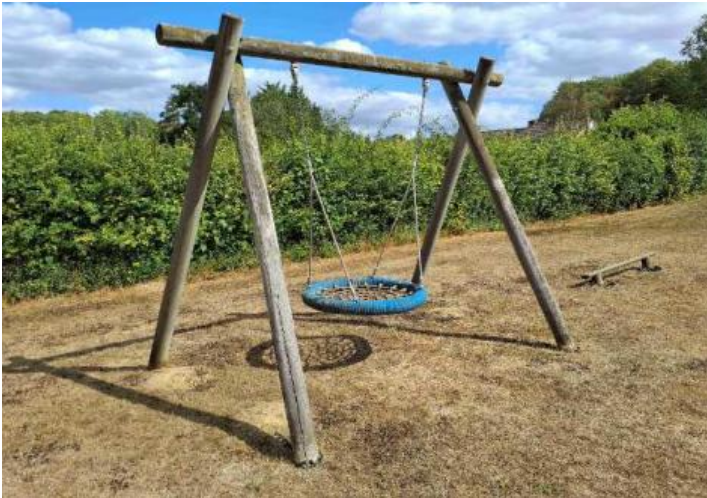
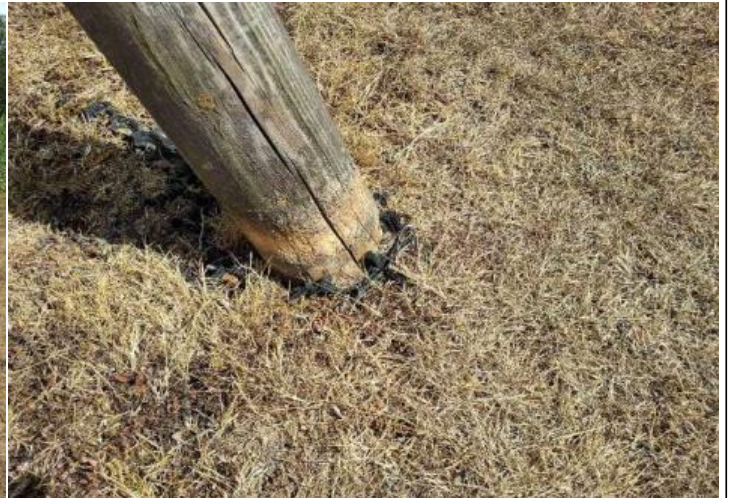
**Finding:** There is some strimmer / machinery damage apparent on the posts, this can penetrate the preservative applied to the timber and accelerate the rotting process

**Action:** Monitor for any deterioration (rot) and replace as required

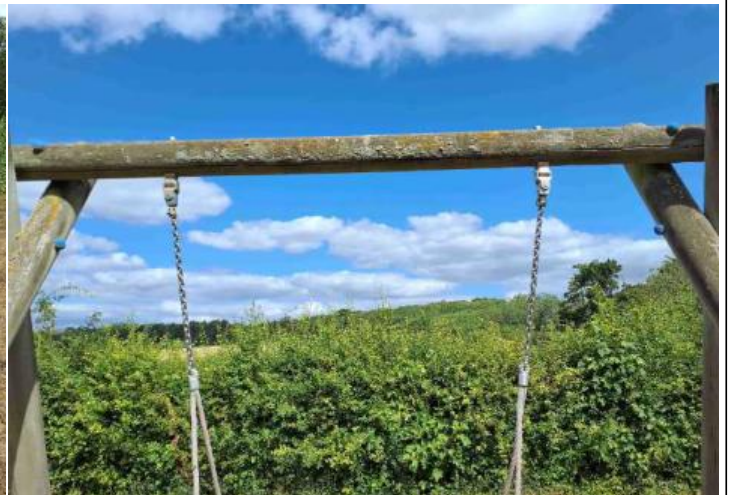
**Finding:** Swings of this design should have a secondary safety device fitted to prevent collapse of the seat in the event of a joint failure to meet the requirements of BS EN 1176 Part 2

**Action:** Consult with manufacturer and consider providing a secondary safety device where possible

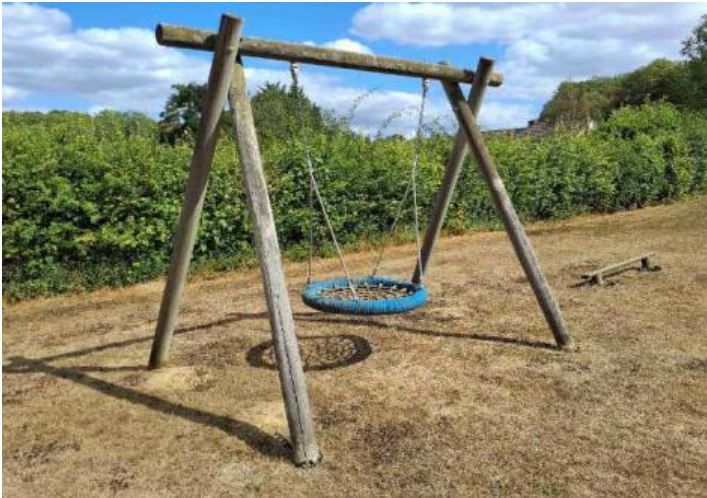
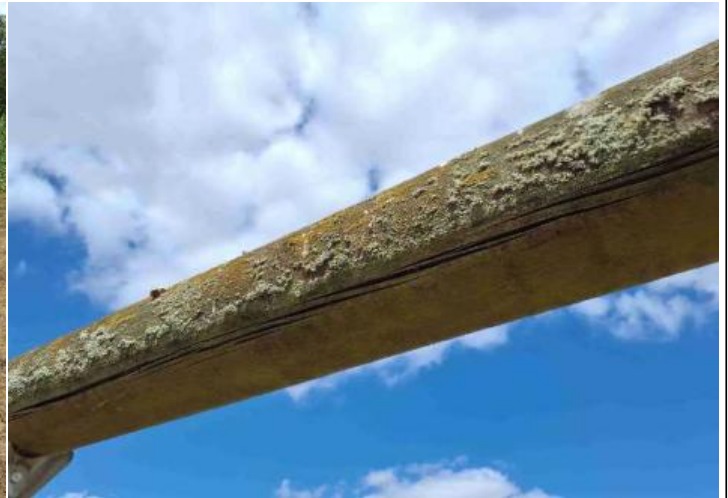
**Finding:** There is algae or moss on the surface of the equipment which can lead to the onset of rot

**Action:** Clean and treat appropriately and monitor condition of the timber

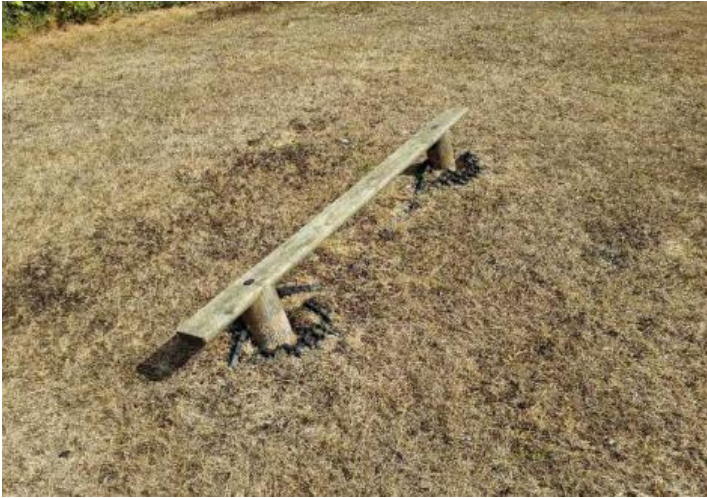
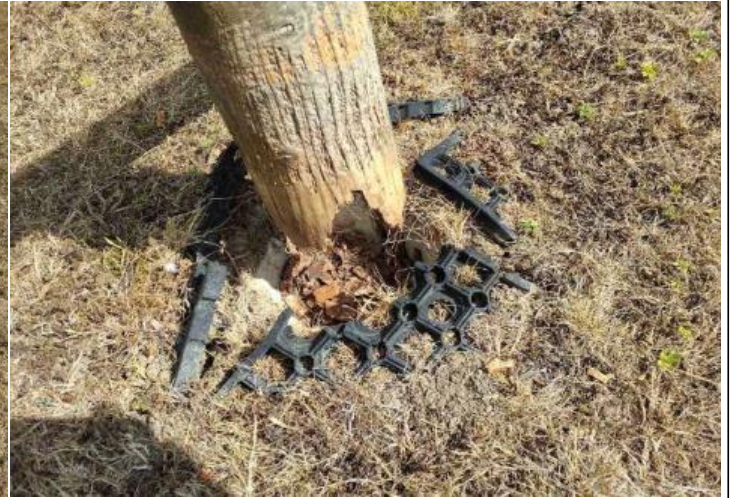
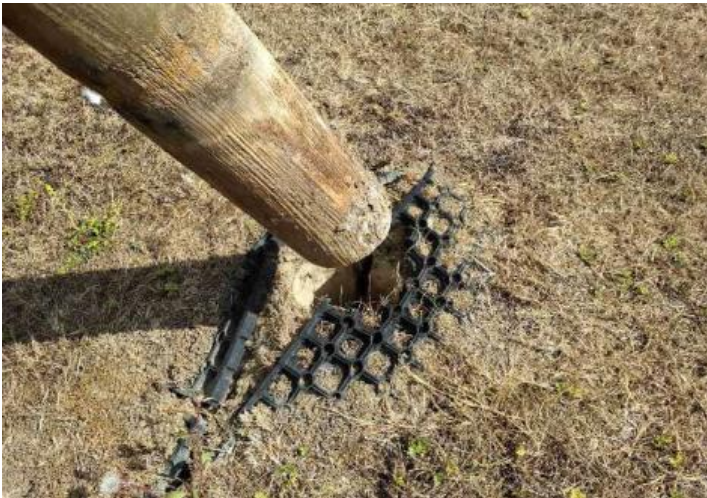
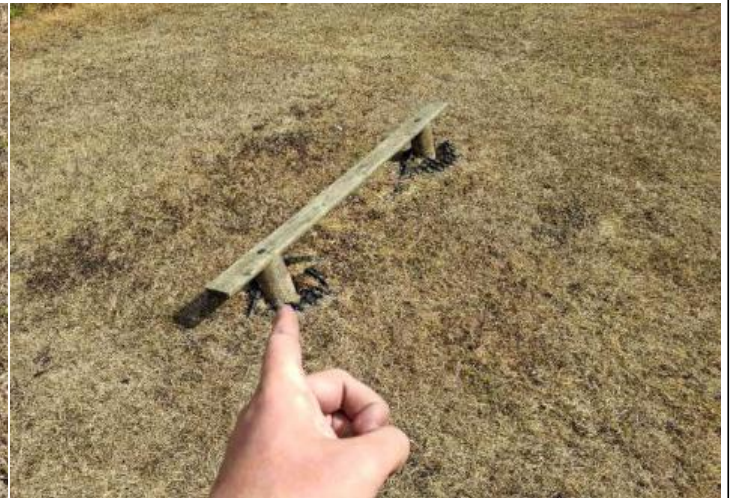
**Finding:** There are areas or parts of the timber on the structure that have rotted and one post is loose in the foundations and the item can be removed from the ground

**Action:** Replace all affected timbers and re secure item
