## Annual Inspection

Weston Colville Parish Council

Brinkley Road Play Area

Brinkley Road, opp Mill Lane, Weston Colville,

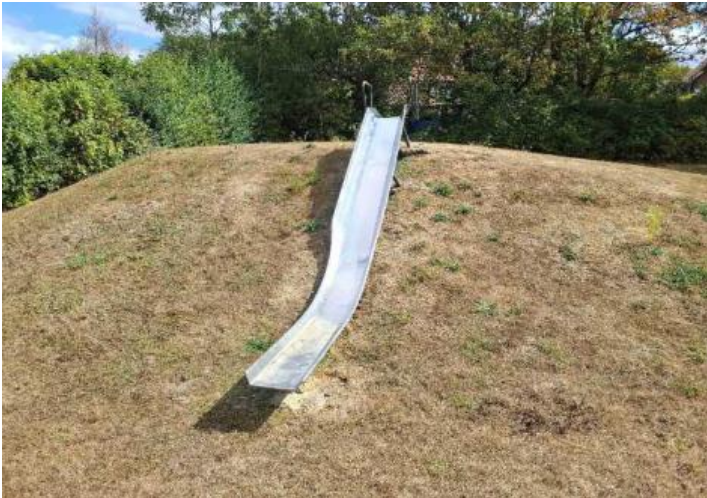
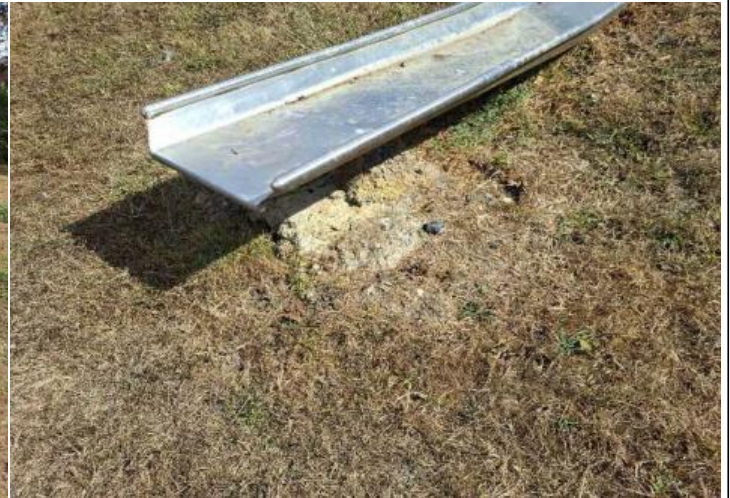
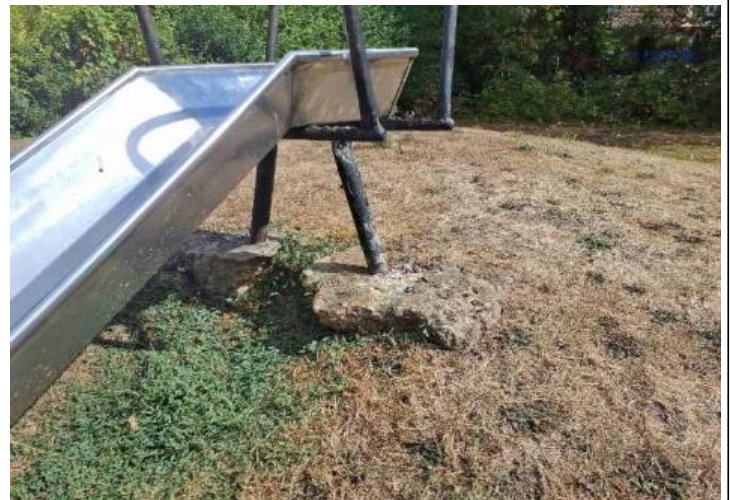
**Finding:** The surface has eroded and the foundations are exposed

**Action:** Reinstall surrounding surfaces to cover the foundations

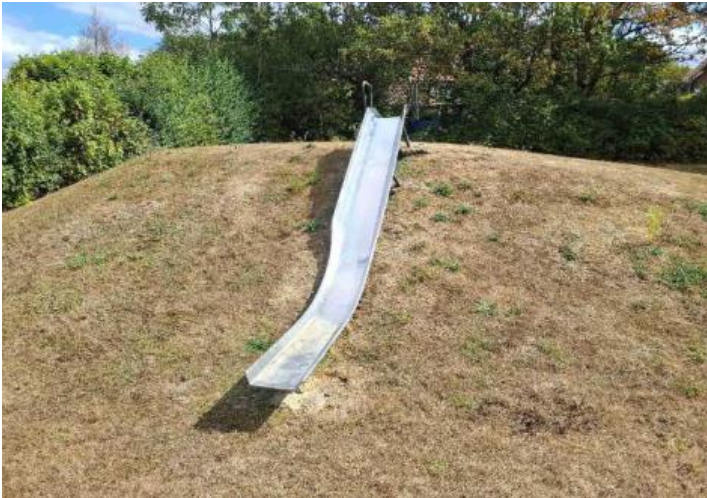
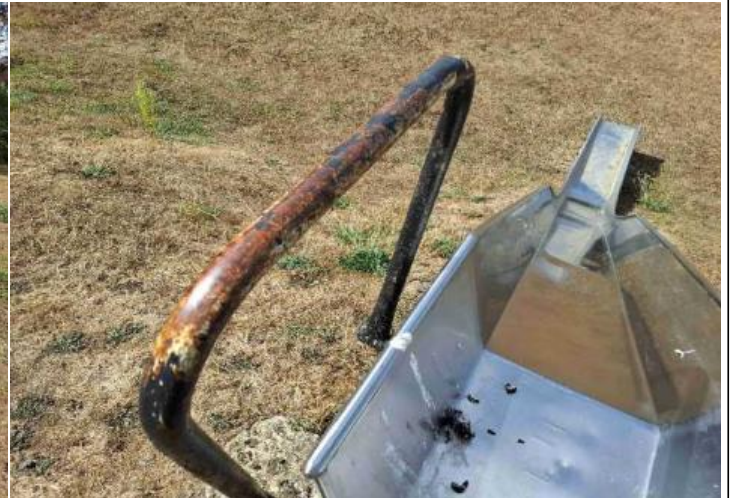
**Finding:** The paintwork on this item has been damaged or worn exposing the metal underneath which is rusting / corroding

**Action:** Treat affected areas and repaint

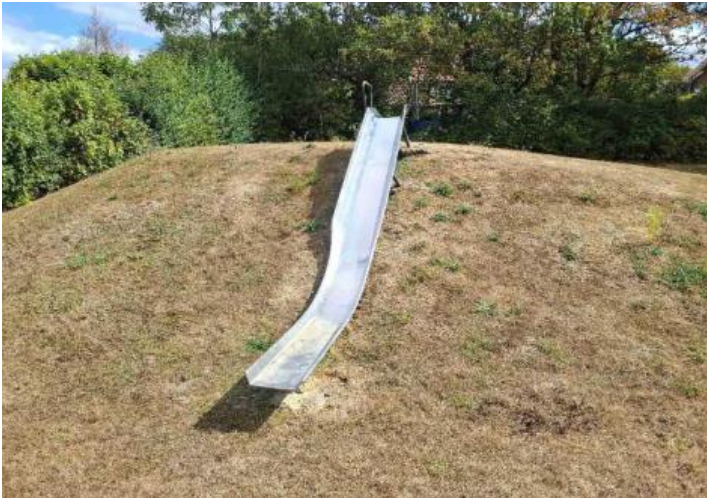
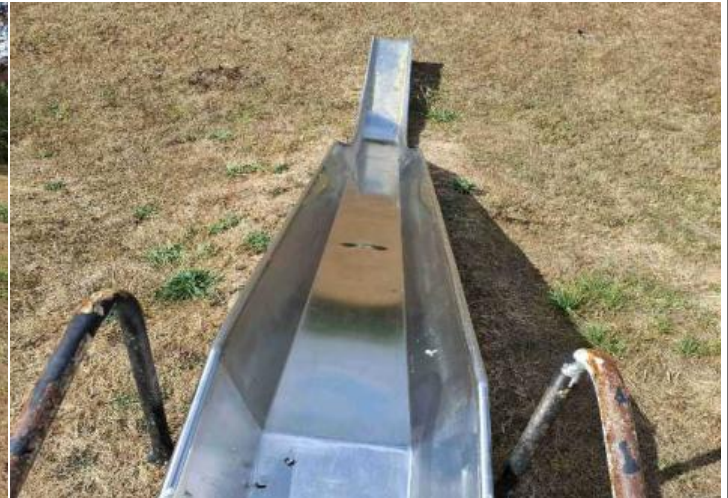
**Finding:** There are a number of dents in the slide surface

**Action:** Monitor for any further deterioration and repair as required

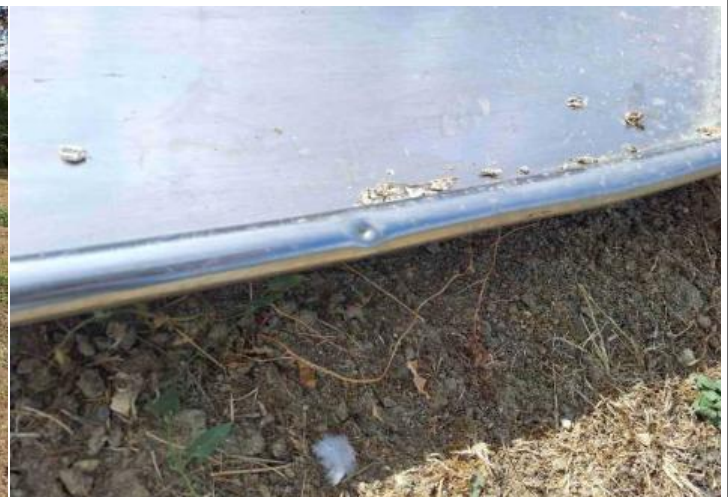
**Finding:** The side of the slide is damaged

**Action:** Monitor for any further deterioration and repair as required

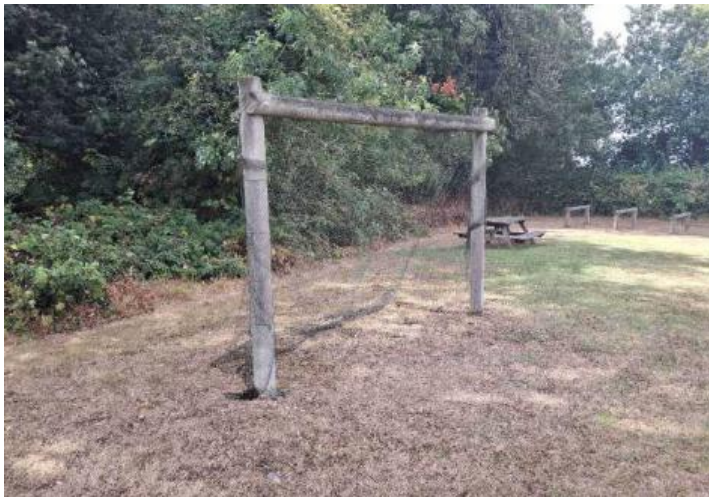
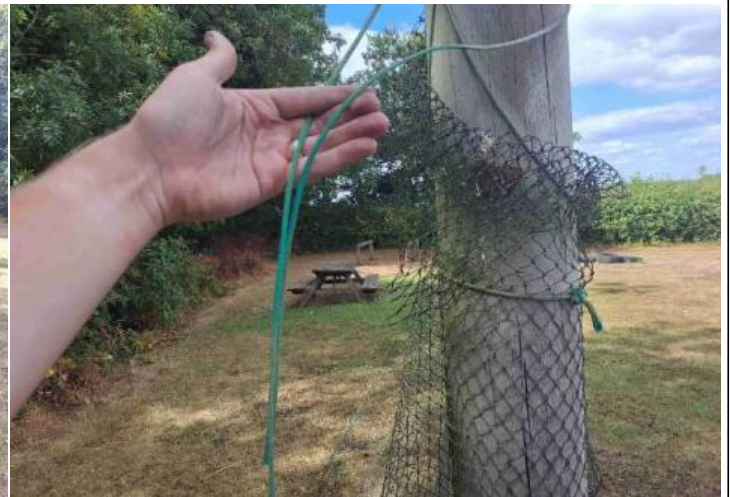
**Finding:** There is loose twine on the net

**Action:** Secure or remove

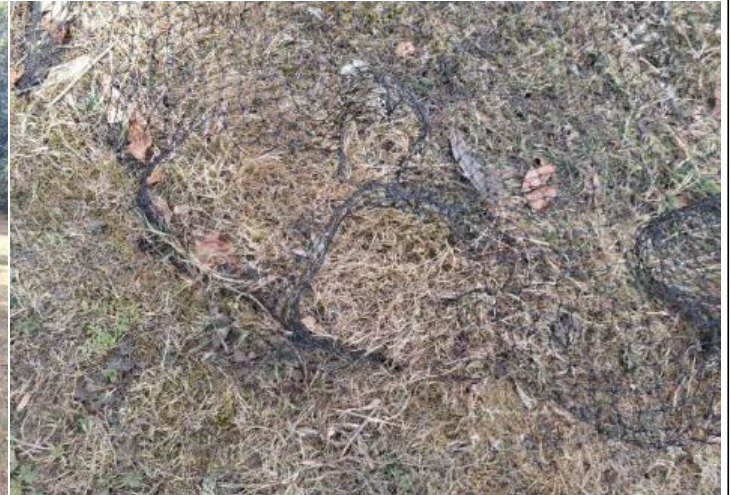
**Finding:** The net has been damaged

**Action:** Repair or replace the item
