Annual Inspection

Weston Colville Parish Council

Weston Colville Play Area

Horsehoe Lane, Cambridge, CB21 5NU

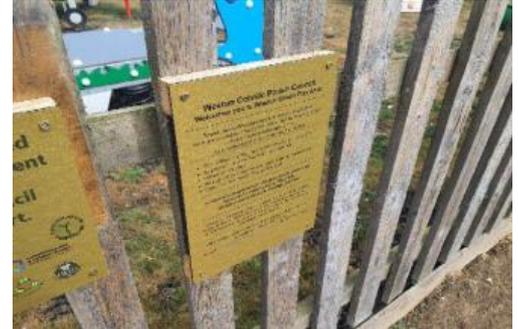
Item: Sign
Manufacturer: Not Identified
Surface Type: N/A
Item Quantity: 1
Equipment Compliance: N/A
Surface Area Compliance: N/A

This item is satisfactory - no work required -

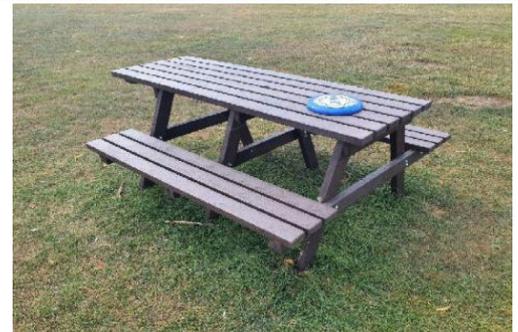
Item: Picnic Table
Manufacturer: Not Identified
Surface Type: Grass
Item Quantity: 2
Equipment Compliance: N/A
Surface Area Compliance: N/A

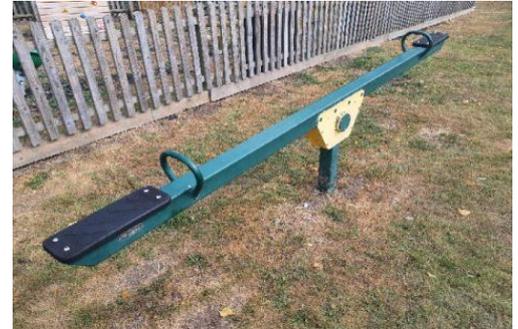
Item: See Saw
Manufacturer: Massey & Harris
Surface Type: Grass
Item Quantity: 1
Equipment Compliance: No
Surface Area Compliance: Yes

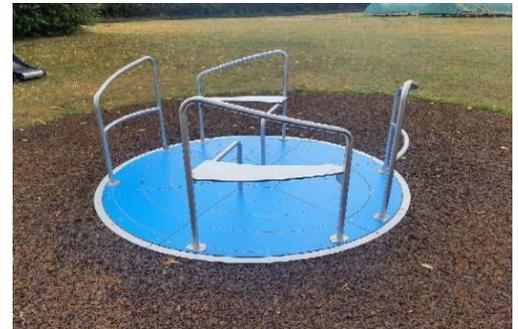
Item: Inclusive Roundabout
Manufacturer: Vinci Play
Surface Type: Bonded Rubber Mulch
Item Quantity: 1
Equipment Compliance: Yes
Surface Area Compliance: Yes

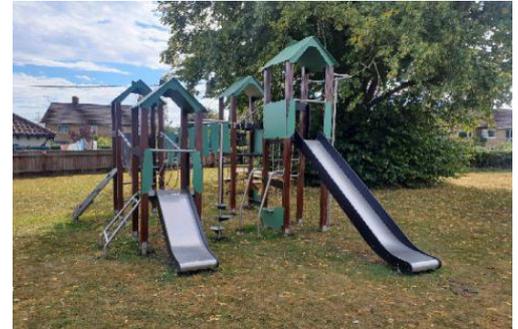
Item: Multi Play (Junior)
Manufacturer: Vinci Play
Surface Type: Grass Matrix Tiles
Item Quantity: 1
Equipment Compliance: No
Surface Area Compliance: Yes

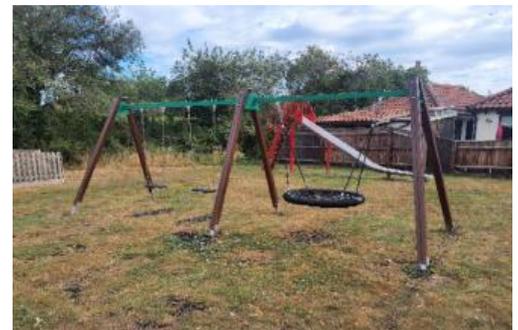
Item: 2 Bay 2 Flat 1 Basket Seat
Manufacturer: Vinci Play
Surface Type: Grass Matrix Tiles
Item Quantity: 1
Equipment Compliance: Yes
Surface Area Compliance: Yes

This item is satisfactory - no work required -

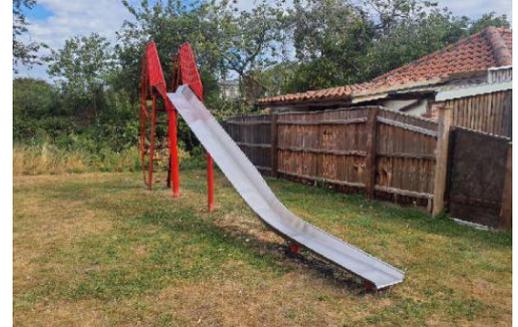
Item: Free Standing Slide
Manufacturer: Not Identified
Surface Type: Grass Matrix Tiles
Item Quantity: 1
Equipment Compliance: No
Surface Area Compliance: Yes

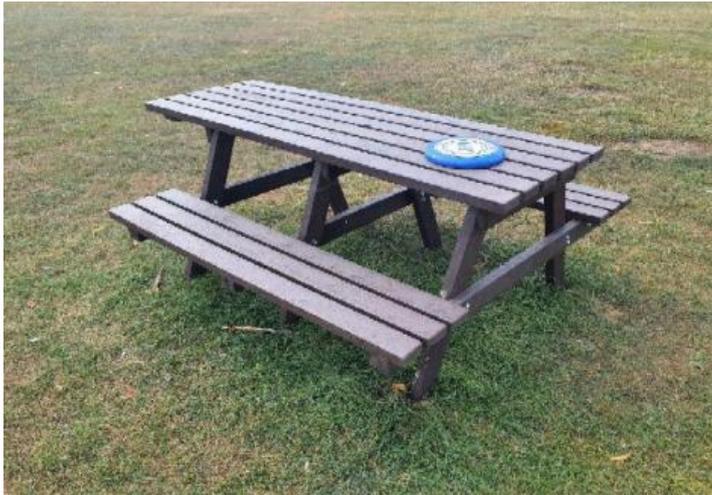
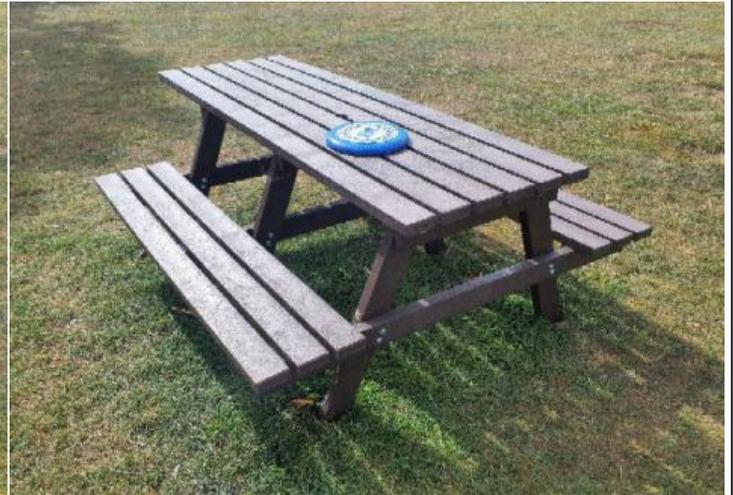
i 8 - Low Risk (Finding 1)

Item: Ancillary Items - Picnic Table
Manufacturer: Not Identified

Finding: The table/s is/are not secured to the ground and there is some potential for the item/s to be moved within falling spaces of equipment

Action: Secure to the ground

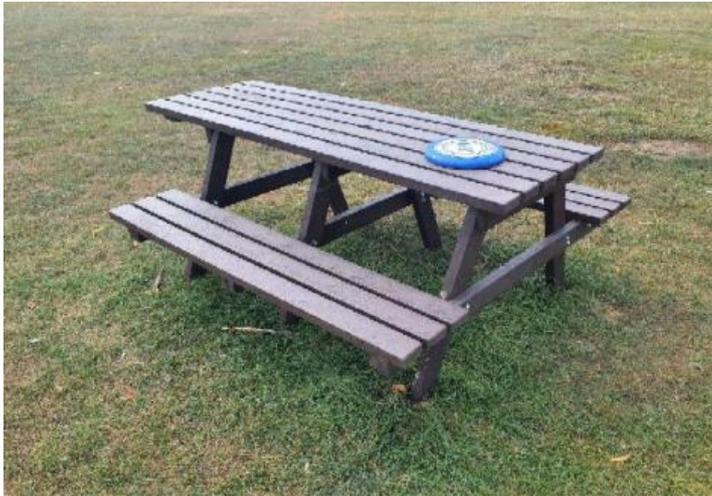
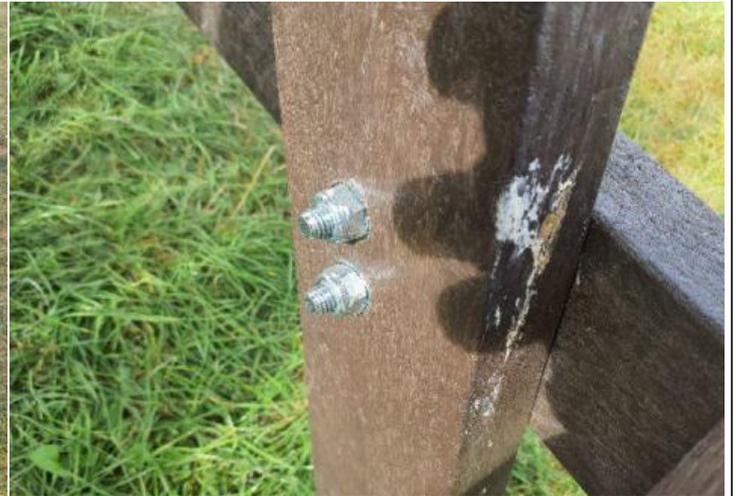
i 8 - Low Risk (Finding 2)

Item: Ancillary Items - Picnic Table
Manufacturer: Not Identified

Finding: There are projecting bolt thread(s) present

Action: Remove excess thread length and deburr or provide cap

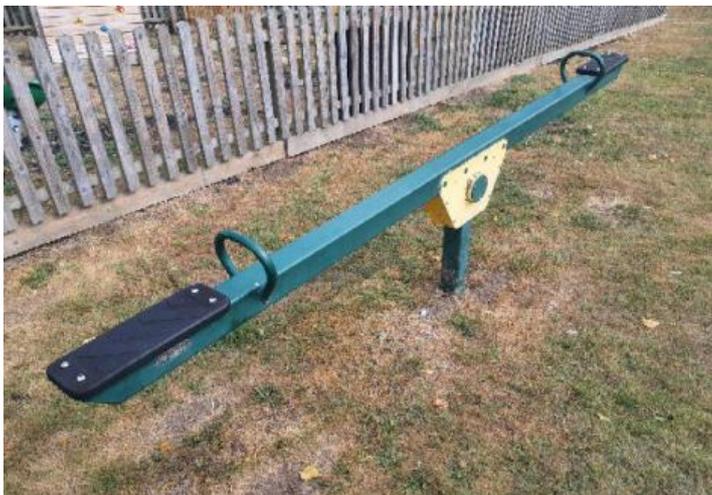
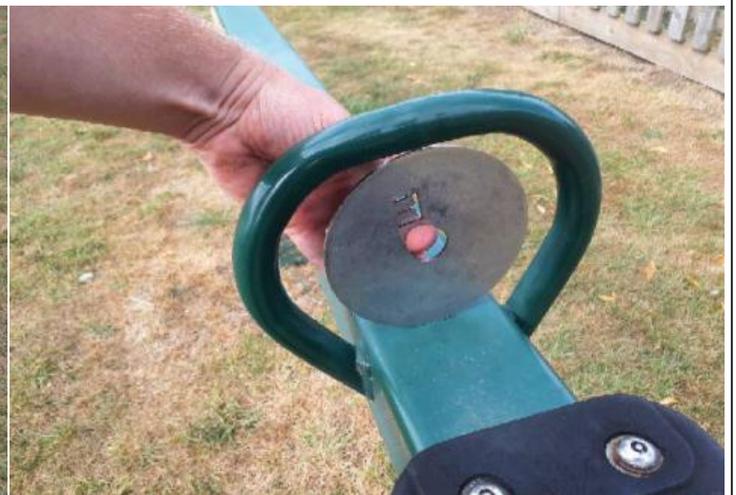
i 5 - Very Low Risk (Finding 1)

Item: Rocking Equipment - See Saw
Manufacturer: Massey & Harris

Finding: The item fails to meet the requirements of BS EN 1176 Part 1 4.2.7.2 for head and neck entrapment in the frame

Action: Monitor - No action given the risk assessment

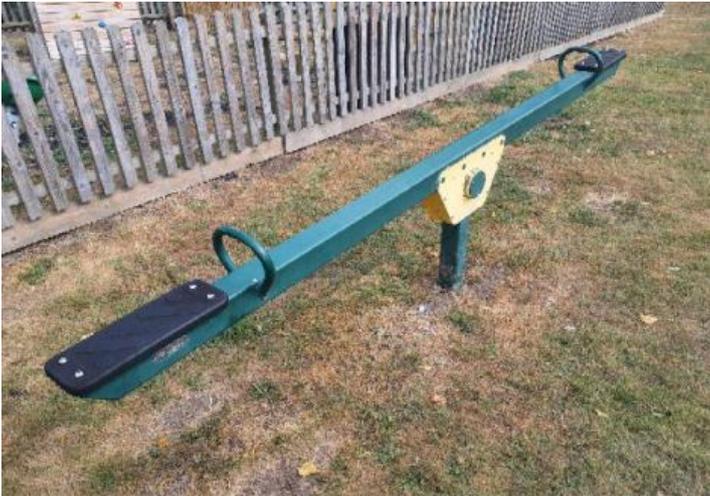
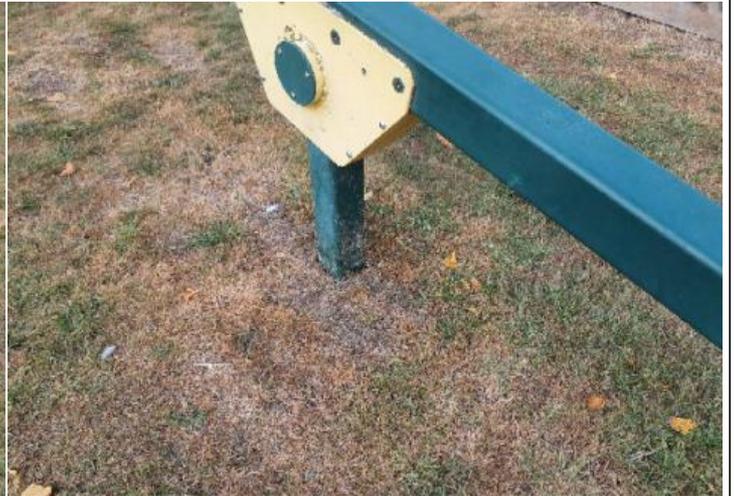
i 6 - Low Risk (Finding 2)

Item: Rocking Equipment - See Saw
Manufacturer: Massey & Harris

Finding: The item is slightly loose in its foundations

Action: Monitor for any further deterioration and repair as required

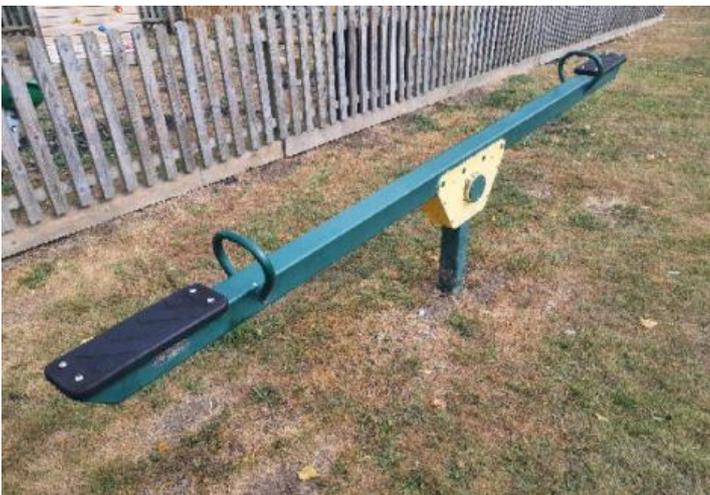
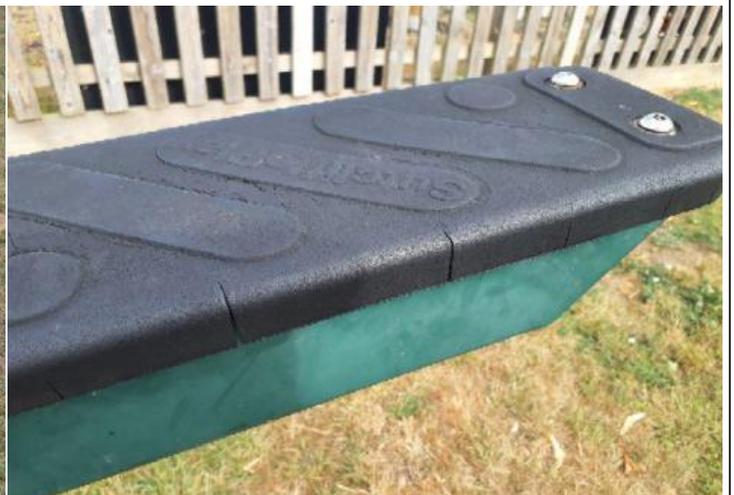
i 6 - Low Risk (Finding 3)

Item: Rocking Equipment - See Saw
Manufacturer: Massey & Harris

Finding: The seat has minor damage or wear

Action: Monitor for any further deterioration and replace as required

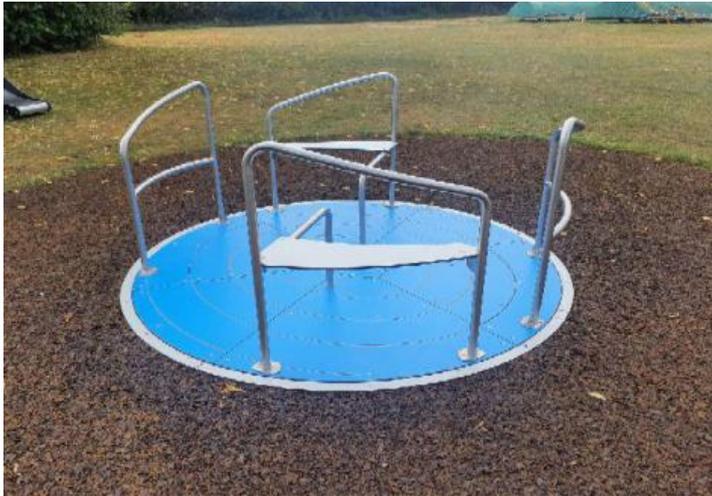
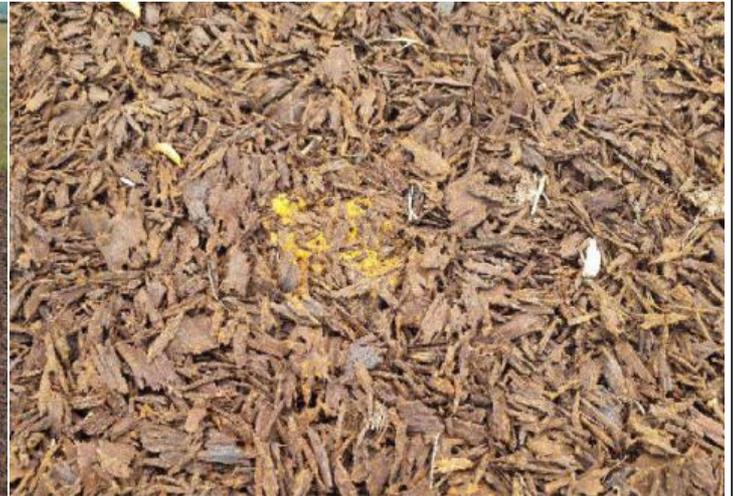
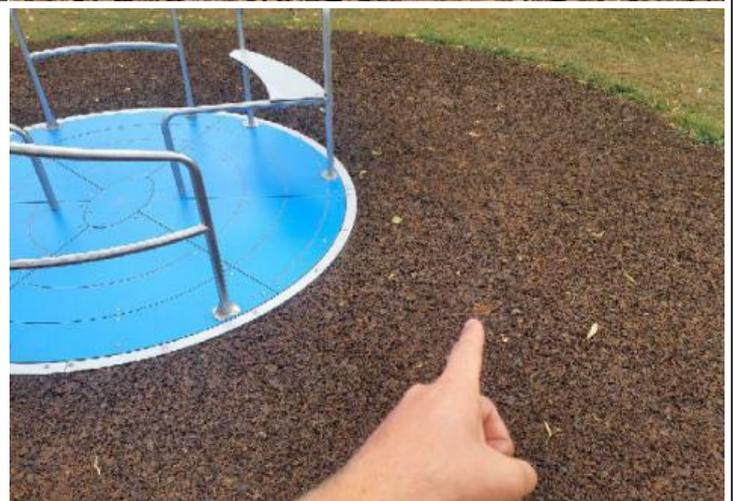
i 6 - Low Risk (Finding 1)

Item: Rotor Play - Inclusive Roundabout
Manufacturer: Vinci Play

Finding: There is dry resin on the surface

Action: Remove

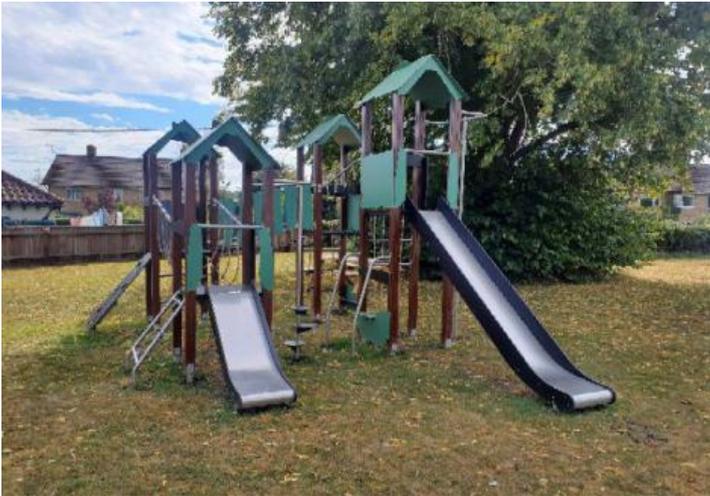
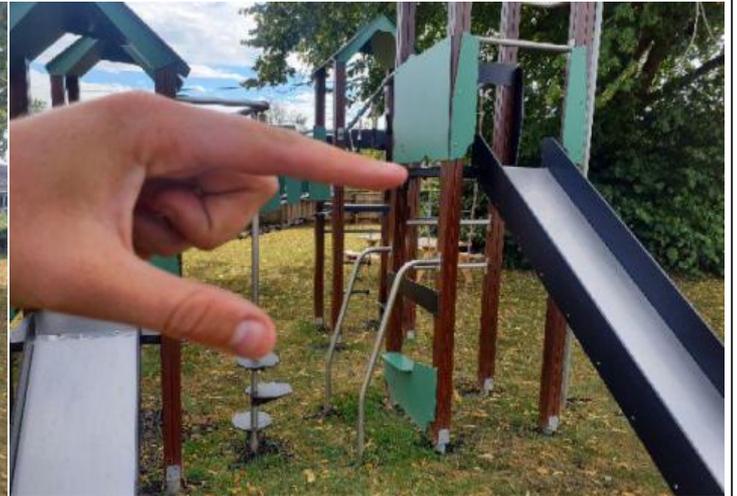
i 8 - Low Risk (Finding 1)

Item: Activity Equipment - Multi Play (Junior)
Manufacturer: Vinci Play

Finding: There are falls in excess of 600mm (1100mm) between adjacent components on the structure, in contravention of the recommendations set out in BS EN 1176 Part 1; 4.2.8.4

Action: Monitor - No action given the risk assessment

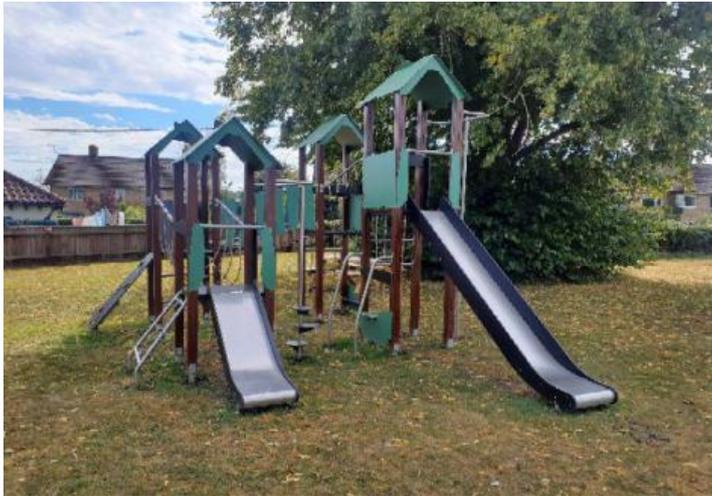
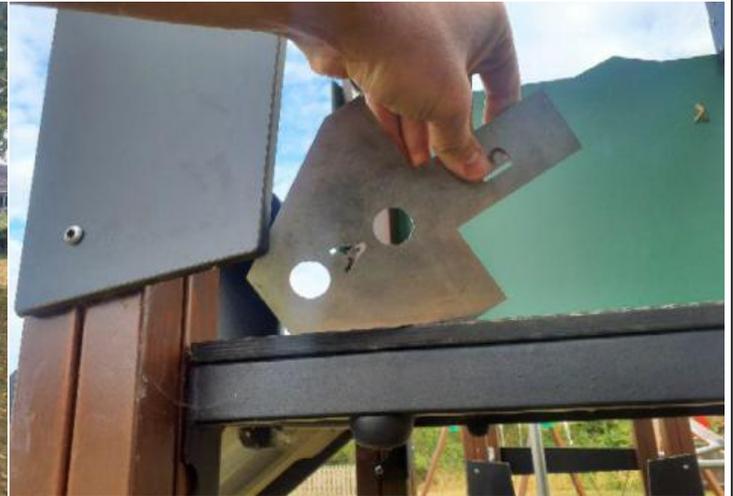
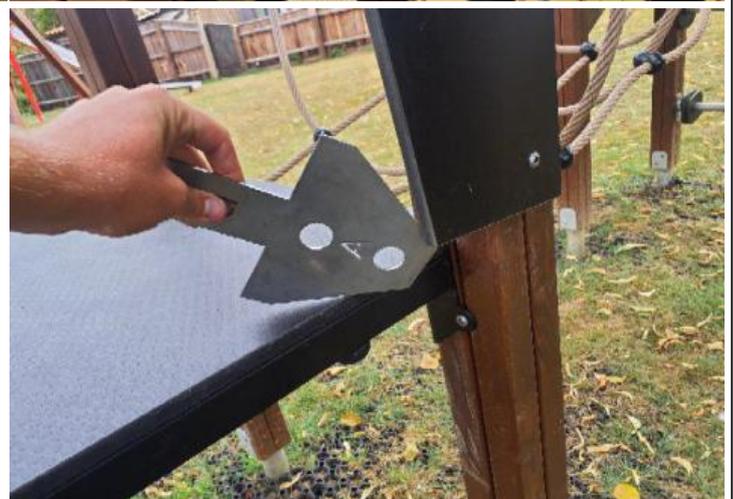
i 5 - Very Low Risk (Finding 2)

Item: Activity Equipment - Multi Play (Junior)
Manufacturer: Vinci Play

Finding: The item fails to meet the requirements of BS EN 1176 Part 1 4.2.7.2 head and neck entrapment in the barriers and/or steps

Action: Monitor - No action given the risk assessment

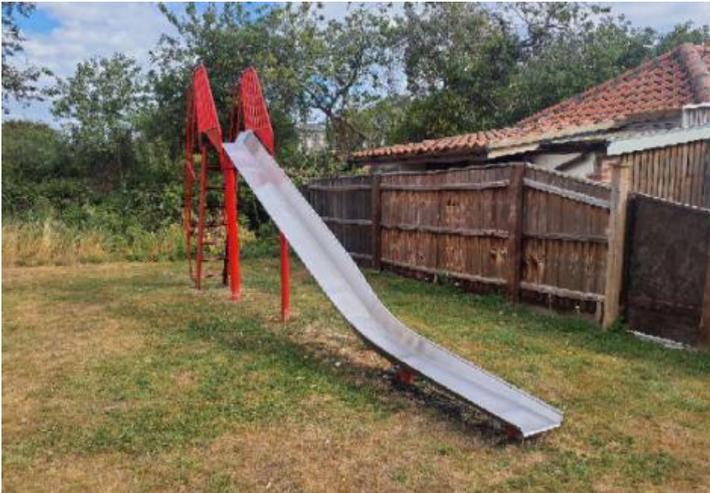
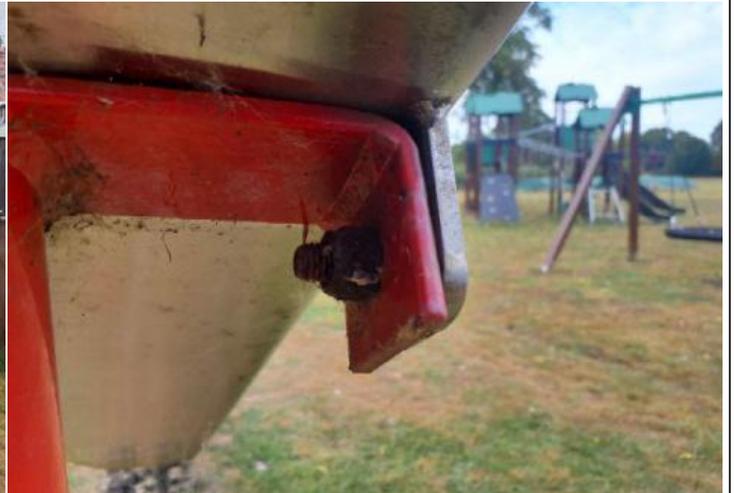
i 8 - Low Risk (Finding 1)

Item: Other - Free Standing Slide
Manufacturer: Not Identified

Finding: There are projecting bolt thread(s) present

Action: Remove excess thread length and deburr or provide cap

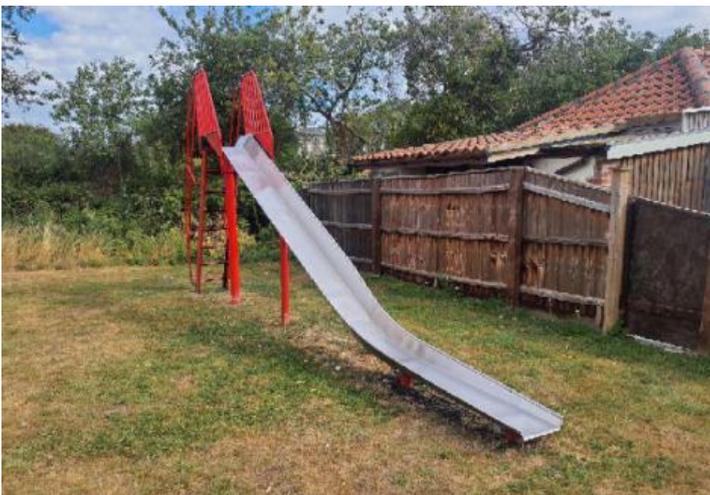
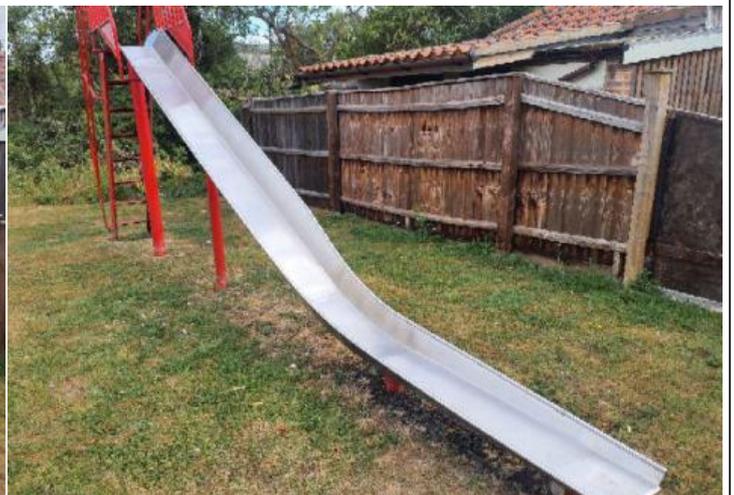
i 6 - Low Risk (Finding 2)

Item: Other - Free Standing Slide
Manufacturer: Not Identified

Finding: The slide is predominately south facing and will catch the majority of the sun's heat during the day. Slide surfaces can become very warm during periods of sustained sunny weather

Action: Monitor - No action given the risk assessment

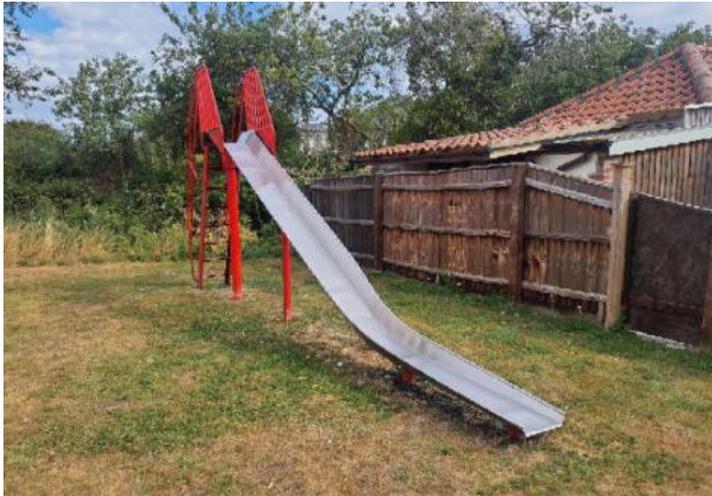
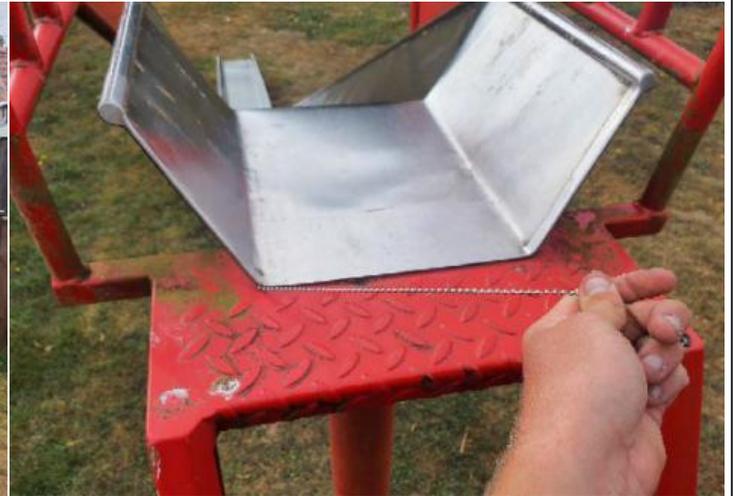
i 5 - Very Low Risk (Finding 3)

Item: Other - Free Standing Slide
Manufacturer: Not Identified

Finding: There is / are toggle entrapment/s present in contravention of the recommendations set out in BS EN 1176 Part 1

Action: Monitor - No action given the risk assessment
