the **play inspection** company

Annual Inspection

Weston Colville Parish Council

Brinkley Road Play Area

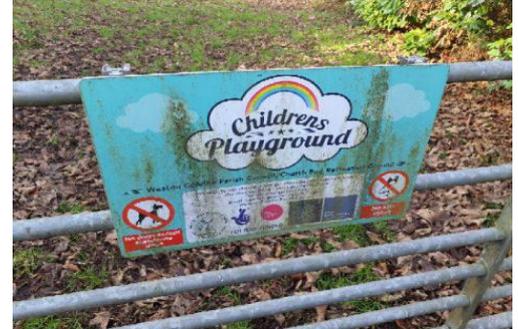
Item: Sign
Manufacturer: Not Identified
Surface Type: N/A
Item Quantity: 1
Equipment Compliance: N/A
Surface Area Compliance: N/A

There is algae or moss on the surface of the equipment - Clean and treat appropriately

BS EN 1176 Part 7 recommends that signage shall include emergency contact details and contact details of owner / operator for reporting maintenance issues - Provide additional information

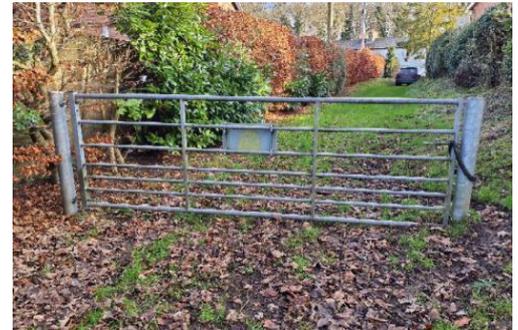
Item: Gate - Maintenance
Manufacturer: Not Identified
Surface Type: Grass
Item Quantity: 1
Equipment Compliance: N/A
Surface Area Compliance: N/A

The maintenance gate was correctly padlocked at the time of inspection, however this means that the inspector was unable to fully assess the gate - Ensure that there are 12mm gaps throughout the full range of motion on gate/s and between leaves where relevant

There is / are post or end caps missing / damaged on the item - Replace missing / damaged post or end caps

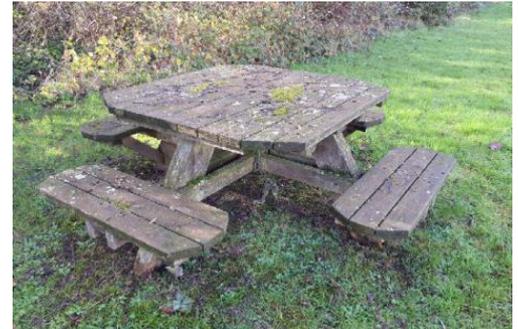
Item: Picnic Table
Manufacturer: Not Identified
Surface Type: Grass
Item Quantity: 1
Equipment Compliance: N/A
Surface Area Compliance: N/A

There are areas or parts of the timber on the structure that
have rotted - Replace all affected timbers

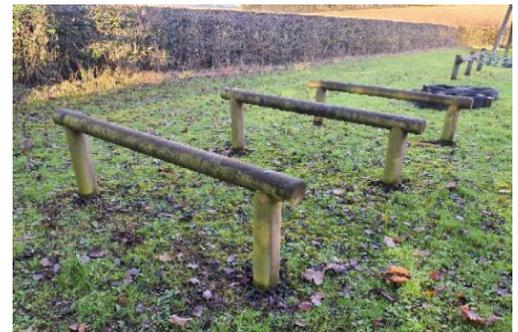
Item: Up and Under Bars
Manufacturer: Not Identified
Surface Type: Grass
Item Quantity: 1
Equipment Compliance: N/A
Surface Area Compliance: N/A

There is some strimmer / machinery damage apparent on the posts, this can penetrate the preservative applied to the timber and accelerate the rotting process - Monitor for any deterioration (rot) and replace as required

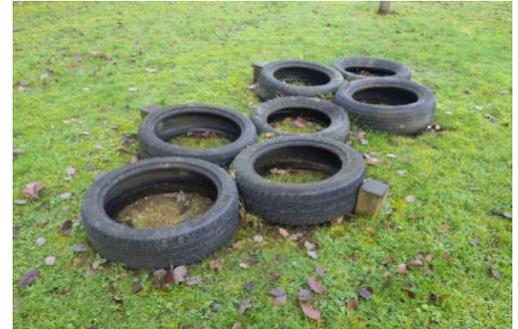
Item: Tyre Trail
Manufacturer: Not Identified
Surface Type: Grass Matrix Tiles
Item Quantity: 1
Equipment Compliance: Yes
Surface Area Compliance: Yes

There is some strimmer / machinery damage apparent on the posts, this can penetrate the preservative applied to the timber and accelerate the rotting process - Monitor for any deterioration (rot) and replace as required

The item has been damaged - Monitor for any further deterioration and replace as required

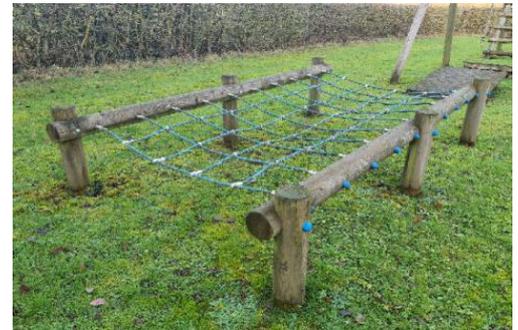
Item: Rope Traverse
Manufacturer: Not Identified
Surface Type: Grass Matrix Tiles
Item Quantity: 1
Equipment Compliance: Yes
Surface Area Compliance: Yes

There is some strimmer / machinery damage apparent on the posts, this can penetrate the preservative applied to the timber and accelerate the rotting process - Monitor for any deterioration (rot) and replace as required

There are areas or parts of the timber on the structure that have rotted - Replace all affected timbers

There is some evidence of rot in the timber - Monitor for any further deterioration and replace as required

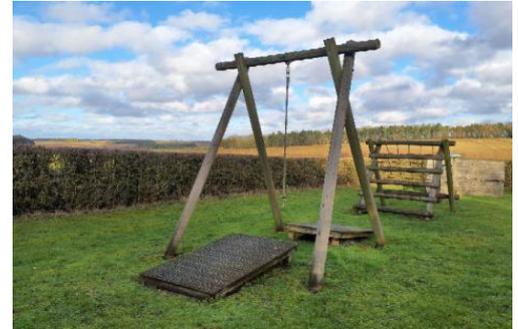
Item: Rope Traverse
Manufacturer: Not Identified
Surface Type: Grass Matrix Tiles
Item Quantity: 1
Equipment Compliance: No
Surface Area Compliance: Yes

NOTE - The fixings or components for this item were in excess of 2.5m above the standing surface and could not be fully accessed by the inspector. We have completed a visual inspection of the fixings from ground level but a maintenance inspection should be undertaken to assess the condition, security and wear of the components at intervals in accordance with the manufacturers recommendations. - Inspect in accordance with the manufacturers recommendations

There is some strimmer / machinery damage apparent on the posts, this can penetrate the preservative applied to the timber and accelerate the rotting process - Monitor for any deterioration (rot) and replace as required

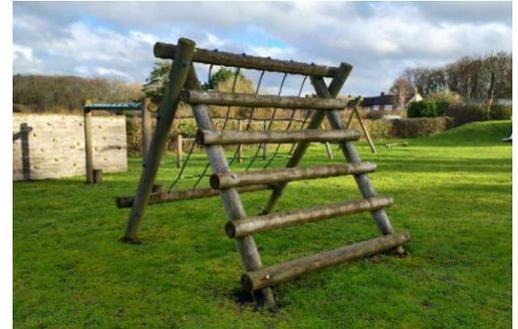
Item: A Frame Climber
Manufacturer: Not Identified
Surface Type: Grass Matrix Tiles
Item Quantity: 1
Equipment Compliance: Yes
Surface Area Compliance: No

There are areas or parts of the timber on the structure that have rotted - Replace all affected timbers

There is some strimmer / machinery damage apparent on the posts, this can penetrate the preservative applied to the timber and accelerate the rotting process - Monitor for any deterioration (rot) and replace as required

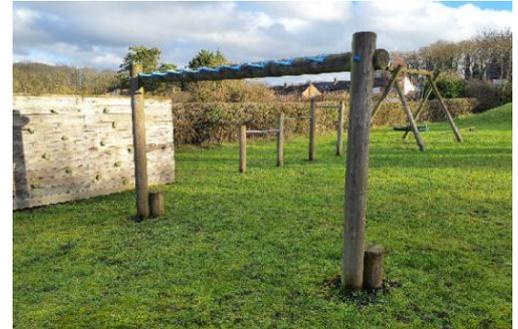
Item: Monkey Bars
Manufacturer: Not Identified
Surface Type: Grass Matrix Tiles
Item Quantity: 1
Equipment Compliance: Yes
Surface Area Compliance: Yes

There is some strimmer / machinery damage apparent on the posts, this can penetrate the preservative applied to the timber and accelerate the rotting process - Monitor for any deterioration (rot) and replace as required

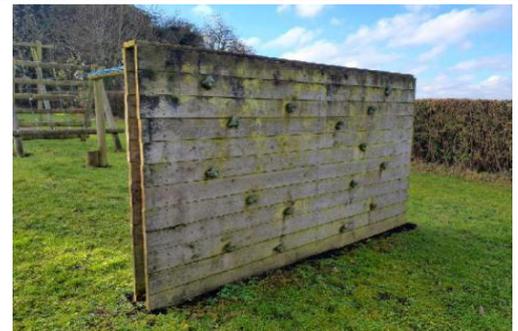
Item: Climbing Wall
Manufacturer: Not Identified
Surface Type: Grass Matrix Tiles
Item Quantity: 1
Equipment Compliance: No
Surface Area Compliance: No

There is algae or moss on the surface of the equipment - Clean and treat appropriately

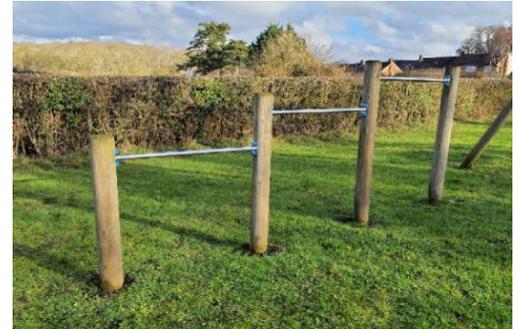
Item: Somersault Bars
Manufacturer: Not Identified
Surface Type: Grass Matrix Tiles
Item Quantity: 1
Equipment Compliance: Yes
Surface Area Compliance: Yes

There is some strimmer / machinery damage apparent on the posts, this can penetrate the preservative applied to the timber and accelerate the rotting process - Monitor for any deterioration (rot) and replace as required

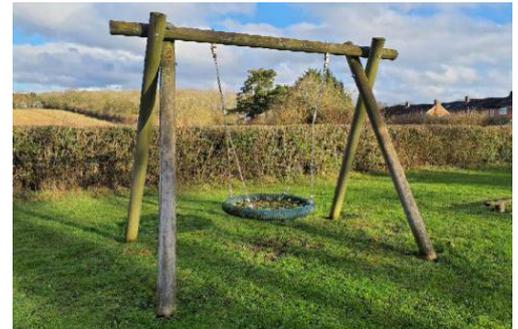
Item: Basket Swing - Type 1
Manufacturer: Not Identified
Surface Type: Grass Matrix Tiles
Item Quantity: 1
Equipment Compliance: No
Surface Area Compliance: Yes

Swings of this design should have a secondary safety device fitted to prevent collapse of the seat in the event of a joint failure to meet the requirements of BS EN 1176 Part 2 - Consult with manufacturer and consider providing a secondary safety device where possible

This design of swing joint has been known to fail on the weld connecting the joint to the threaded stud - We would recommend that the joint be dismantled and checked on a regular basis or consulting with manufacturer on whether a Secondary Safety Device can be fitted

There is some strimmer / machinery damage apparent on the posts, this can penetrate the preservative applied to the timber and accelerate the rotting process - Monitor for any deterioration (rot) and replace as required

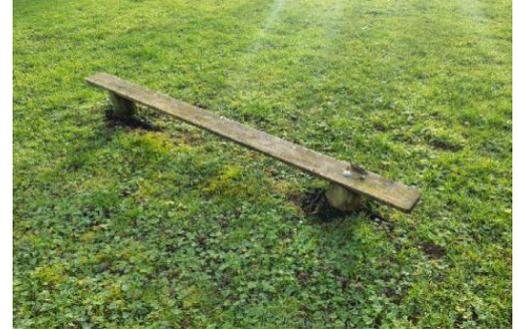
Item: Balance Beam
Manufacturer: Not Identified
Surface Type: Grass Matrix Tiles
Item Quantity: 1
Equipment Compliance: Yes
Surface Area Compliance: Yes

There are areas or parts of the timber on the structure that have rotted - Replace all affected timbers

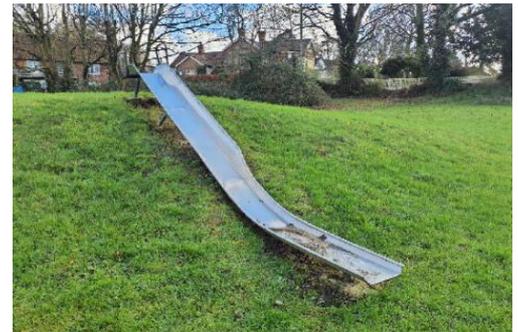
Item: Embankment Slide
Manufacturer: Not Identified
Surface Type: Grass
Item Quantity: 1
Equipment Compliance: Yes
Surface Area Compliance: Yes

The surface has eroded in some areas and may be slippery in wet conditions - Reinstate the surface

The paintwork on this item has been damaged or worn exposing the metal underneath which is rusting / corroding - Treat affected areas and repaint

There are a number of dents in the slide surface - Monitor for any further deterioration and repair as required

The side of the slide is damaged - Monitor for any further deterioration and repair as required

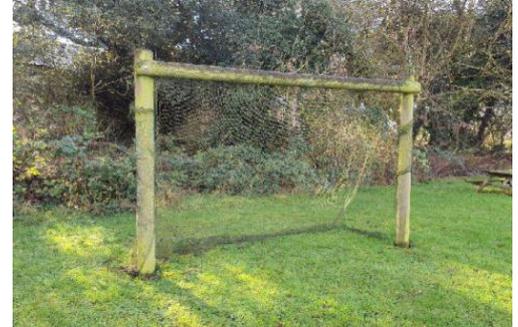
Item: Football Goal
Manufacturer: Not Identified
Surface Type: Grass
Item Quantity: 1
Equipment Compliance: N/A
Surface Area Compliance: N/A

NB: We have undertaken a maintenance inspection only of the football goal(s); full load testing falls outside the scope of our inspection. - Implement load testing as required

The net has been damaged - Repair or replace the item

There is loose twine on the net - Secure or remove

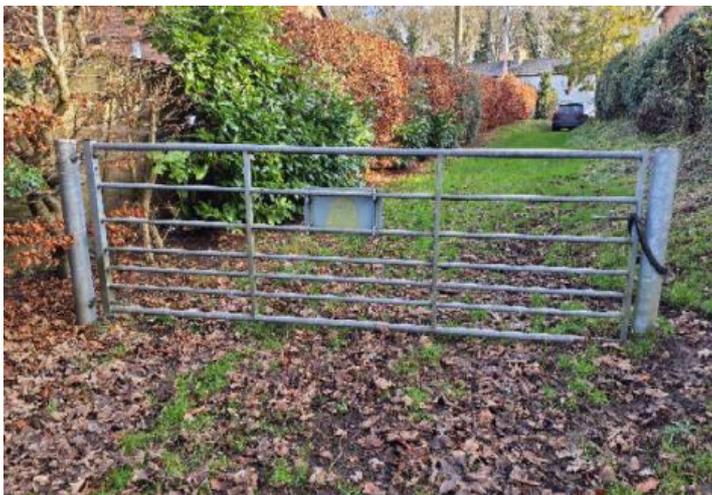
Item: Gates - Gate - Maintenance
Manufacturer: Not Identified

Finding: The gate is not secured to the hinges and can be lifted off
Action: Secure the gate

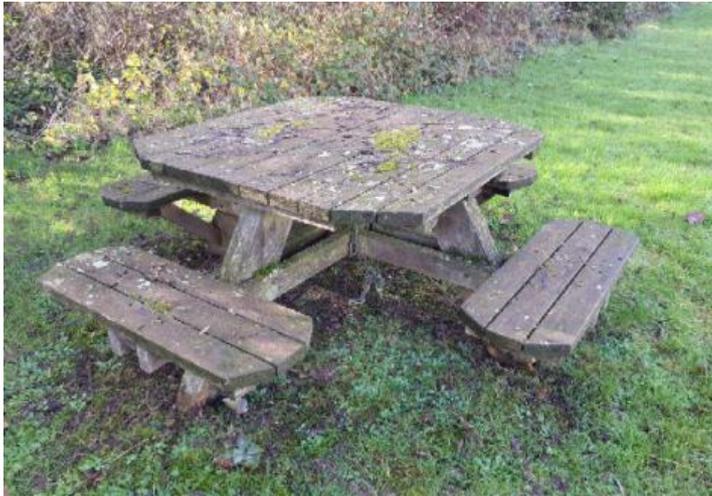
Item: Ancillary Items - Picnic Table
Manufacturer: Not Identified

Finding: There is algae or moss on the surface of the equipment

Action: Clean and treat appropriately

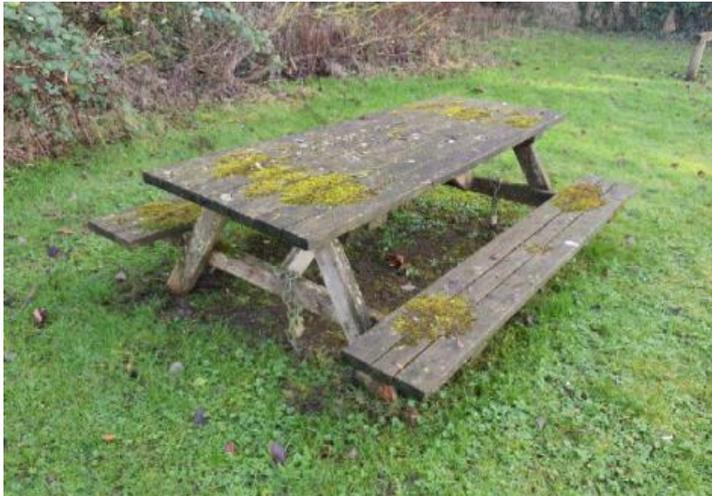
Item: Ancillary Items - Picnic Table
Manufacturer: Not Identified

Finding: There is algae or moss on the surface of the equipment

Action: Clean and treat appropriately

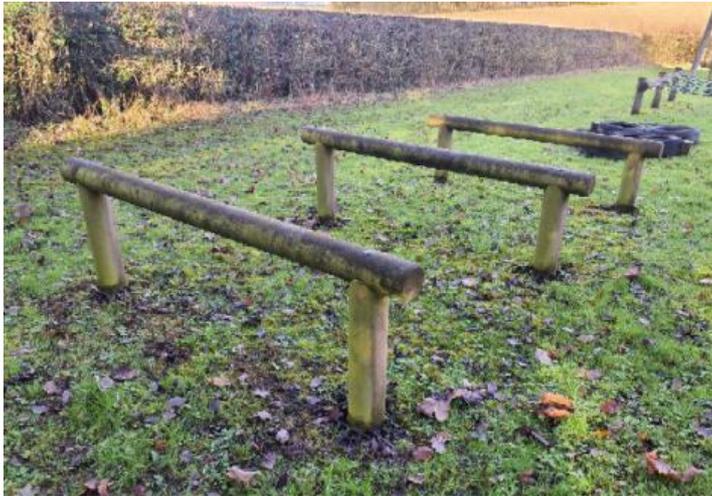
Item: Activity Equipment - Up and Under Bars
Manufacturer: Not Identified

Finding: There are gaps opening between the grass mat tiles

Action: Provide additional ties or secure / reinstate surface tiles

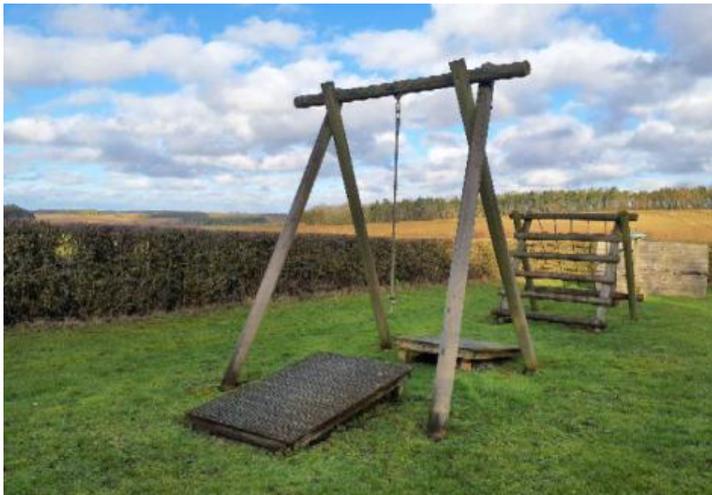
Item: Activity Equipment - Rope Traverse
Manufacturer: Not Identified

Finding: There is algae or moss on the surface of the equipment

Action: Clean and treat appropriately

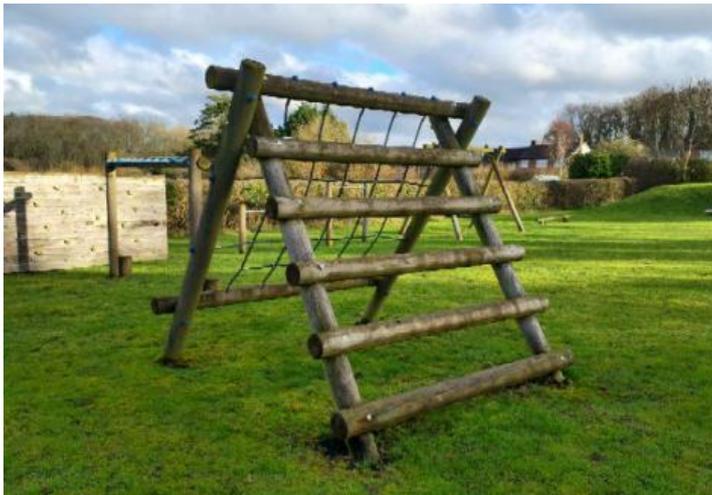
Item: Activity Equipment - A Frame Climber
Manufacturer: Not Identified

Finding: There is algae or moss on the surface of the equipment

Action: Clean and treat appropriately

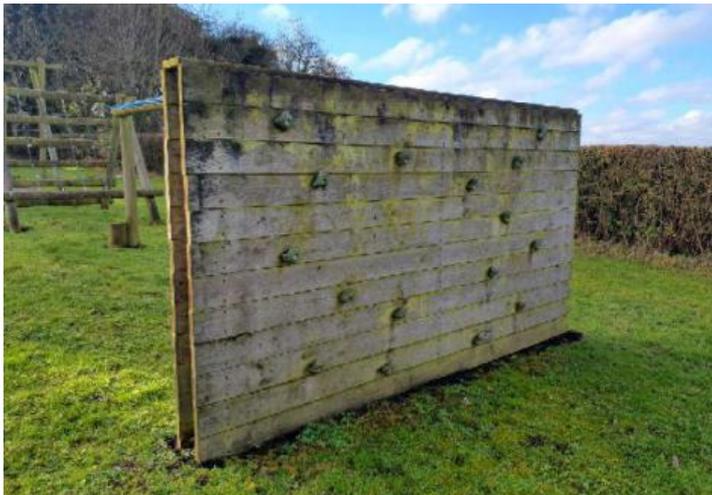
Item: Activity Equipment - Climbing Wall
Manufacturer: Not Identified

Finding: There is algae or moss on the surface of the equipment

Action: Clean and treat appropriately

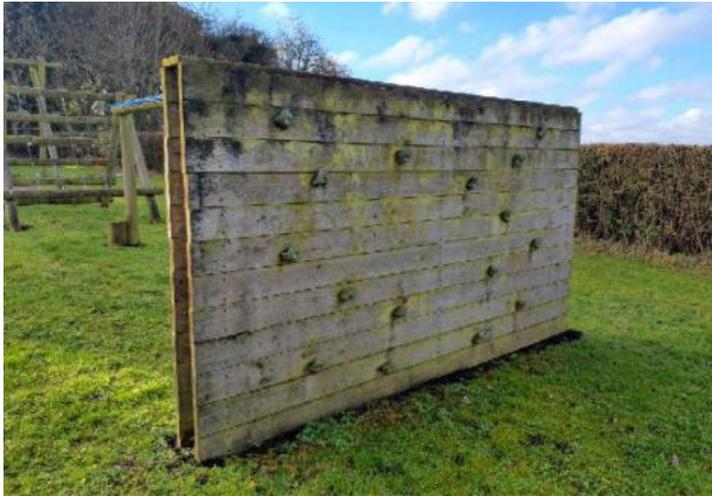
Item: Activity Equipment - Climbing Wall
Manufacturer: Not Identified

Finding: The surfacing dimensions are short and do not meet with the requirements of the current applicable standard

Action: Monitor - No action given the risk assessment

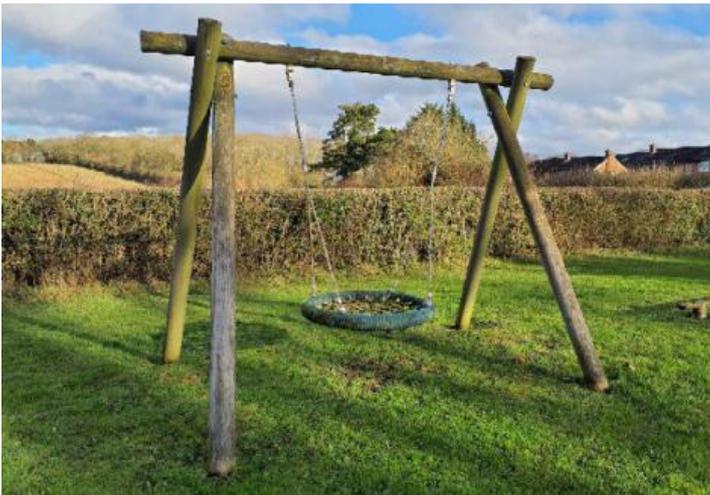
Item: Swings - Basket Swing - Type 1
Manufacturer: Not Identified

Finding: There is algae or moss on the surface of the equipment

Action: Clean and treat appropriately

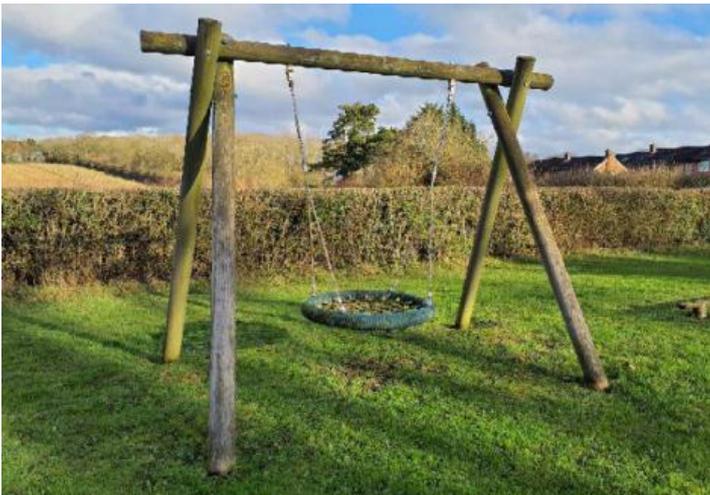
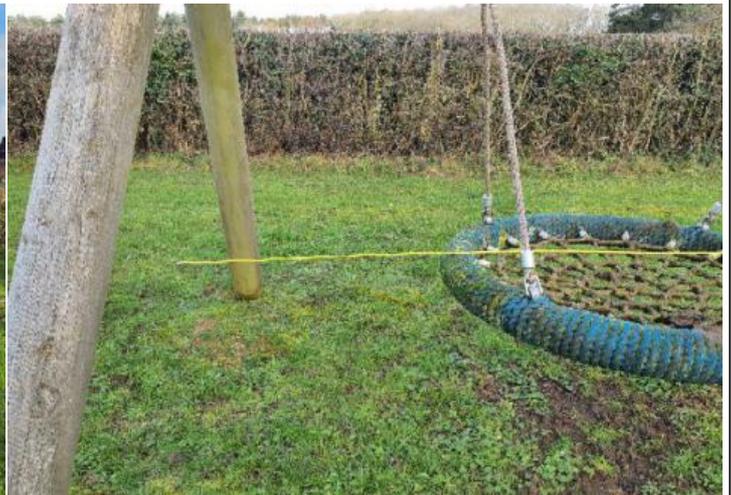
Item: Swings - Basket Swing - Type 1
Manufacturer: Not Identified

Finding: The seat/s is / are too close to the frame as defined in BS EN 1176 Part 2

Action: Monitor - No action given the risk assessment

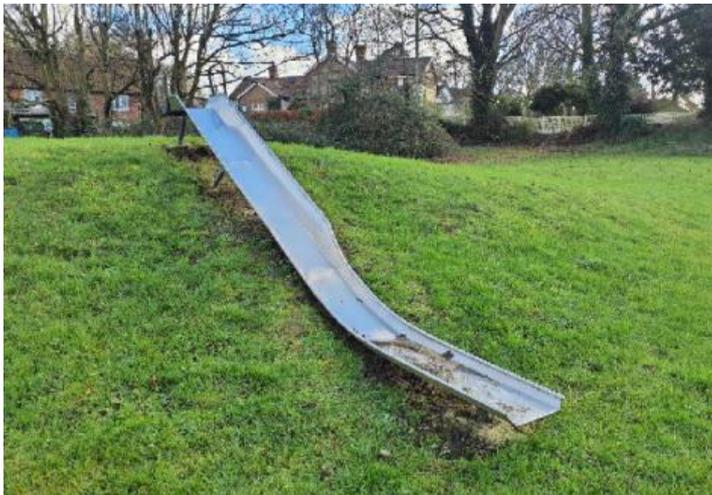
Item: Other - Embankment Slide
Manufacturer: Not Identified

Finding: Water is pooling on the slide run out section

Action: Monitor use and adjust the design if required

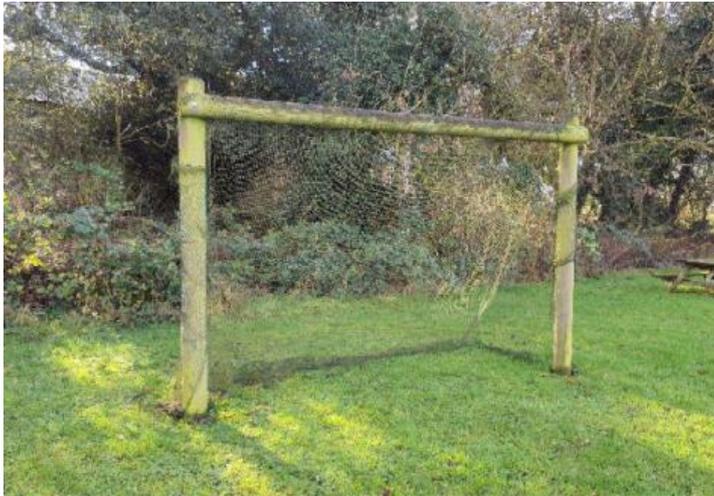
Item: Multi Use Games Area - Football Goal
Manufacturer: Not Identified

Finding: NB: We have undertaken a maintenance inspection only of the football goal(s); full load testing falls outside the scope of our inspection.

Action: Implement load testing as required
