## Annual Inspection

Weston Colville Parish Council

Brinkley Road Play Area

Brinkley Road, opp Mill Lane, Weston Colville,

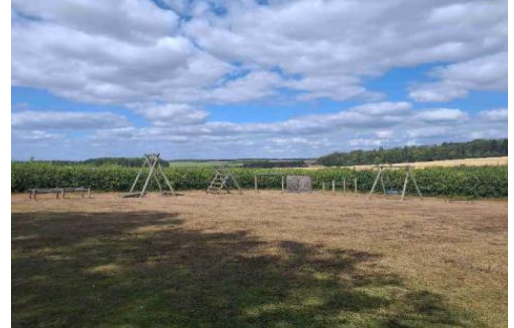
NOTE - The client was made aware of any findings with a risk score of 15 and above at the time of the inspection, due to the urgency of action required. - Ensure appropriate action is, or has already been taken.

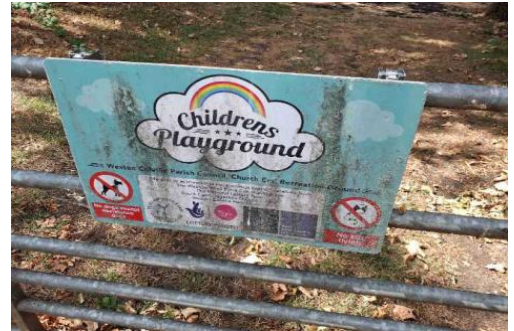
It is recommended that signage, with information including the site address, contact information for maintenance issues and emergency contact details are provided for the facility - Provide in accordance with the recommendations

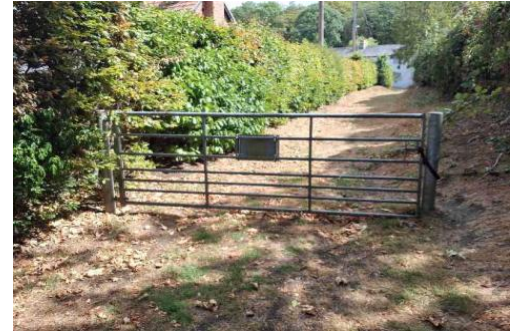
The maintenance gate was correctly padlocked at the time of inspection, however this means that the inspector was unable to fully assess the gate - Ensure that there are 12mm gaps throughout the full range of motion on gate/s and between leaves where relevant

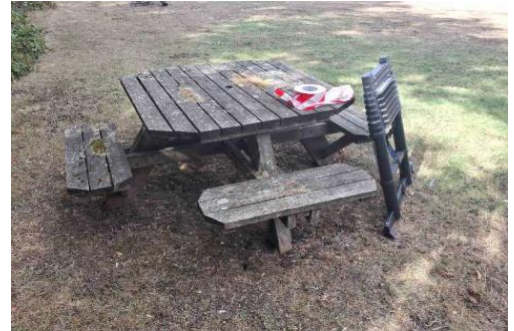
There is algae or moss on the surface of the bench - Clean and treat appropriately

There are areas or parts of the timber on the structure that have rotted - Replace all affected timbers

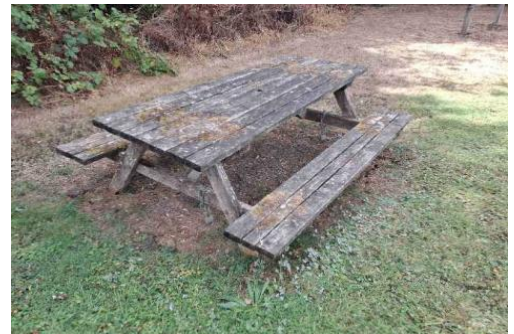
There is algae or moss on the surface of the bench - Clean and treat appropriately

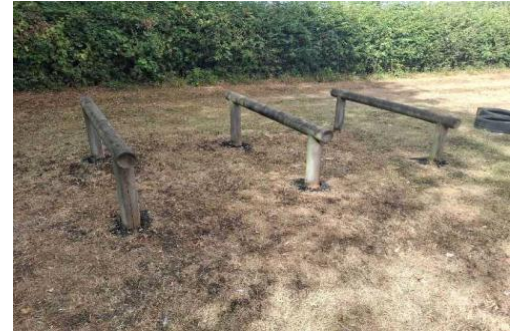
There is some strimmer / machinery damage apparent on the posts, this can penetrate the preservative applied to the timber and accelerate the rotting process - Monitor for any deterioration (rot) and replace as required

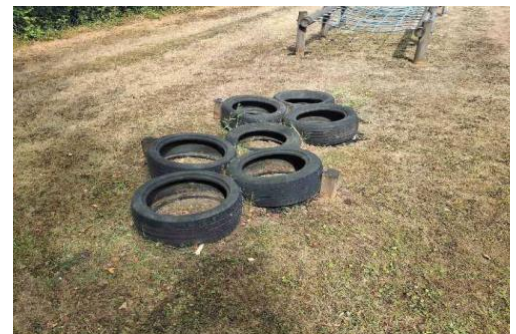
There is some strimmer / machinery damage apparent on the posts, this can penetrate the preservative applied to the timber and accelerate the rotting process - Monitor for any deterioration (rot) and replace as required

The item has been damaged - Monitor for any further deterioration and replace as required

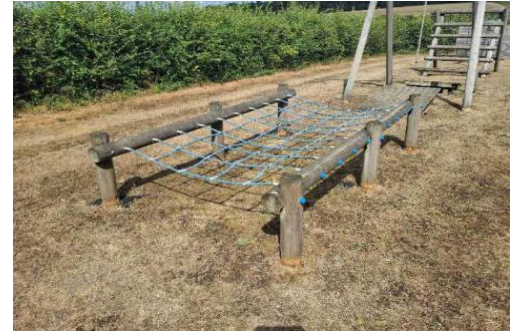
There is some strimmer / machinery damage apparent on the posts, this can penetrate the preservative applied to the timber and accelerate the rotting process - Monitor for any deterioration (rot) and replace as required

There are areas or parts of the timber on the structure that have rotted - Replace all affected timbers

The timber has a number of splits/shakes or air cracks and this may affect the stability or allow water ingress which will accelerate the rotting process. Timber splits may also create rough / splintering edges. - Monitor, sand down any rough edges and ensure the splits do not cross through fixing points of the structure and/or cause any instability

There is some evidence of rot in the timber - Monitor for any further deterioration and replace as required

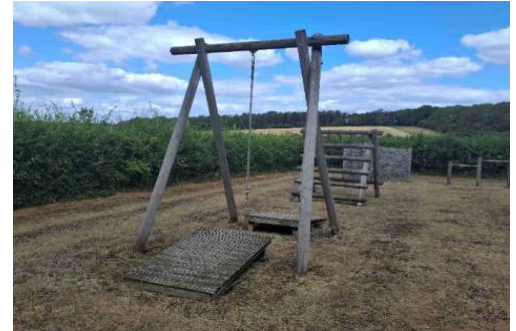
There is algae or moss on the surface of the equipment which can lead to the onset of rot - Clean and treat appropriately and monitor condition of the timber

The connecting lugs are showing signs of wear - Monitor for any further deterioration and repair as required

A number of suspension fixing(s) have worked loose - Secure all loose fixings

There is some strimmer / machinery damage apparent on the posts, this can penetrate the preservative applied to the timber and accelerate the rotting process - Monitor for any deterioration (rot) and replace as required

The timber has a number of splits/shakes or air cracks and this may affect the stability or allow water ingress which will accelerate the rotting process. Timber splits may also create rough / splintering edges. - Monitor, sand down any rough edges and ensure the splits do not cross through fixing points of the structure and/or cause any instability

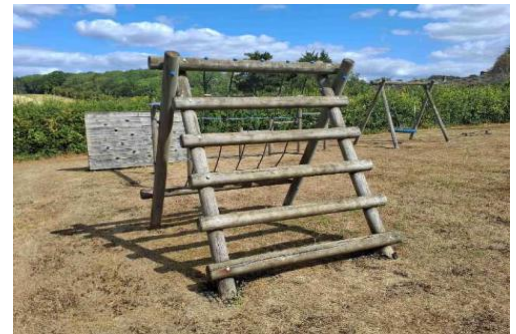
There are areas or parts of the timber on the structure that have rotted - Replace all affected timbers

A number of fixing(s) have worked loose - Secure all loose fixings

There is some strimmer / machinery damage apparent on the posts, this can penetrate the preservative applied to the timber and accelerate the rotting process - Monitor for any deterioration (rot) and replace as required

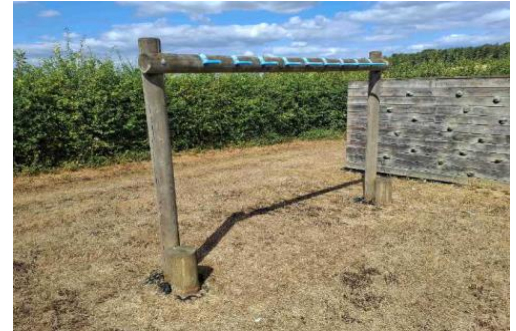
There is some strimmer / machinery damage apparent on the posts, this can penetrate the preservative applied to the timber and accelerate the rotting process - Monitor for any deterioration (rot) and replace as required

The item is slightly loose in its foundations - Monitor for any further deterioration and repair as required

A number of fixing(s) have worked loose - Secure all loose fixings

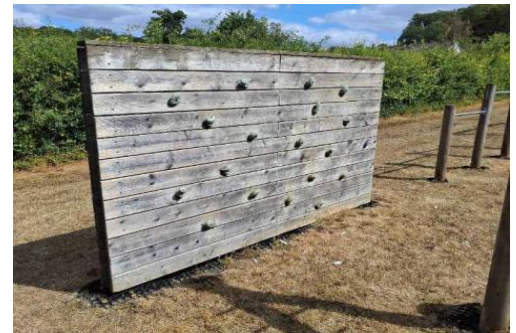
The adjacent item forms a projecting obstacle / hard object within the falling space of the equipment, in contravention of the requirements of BS EN 1176 Part 1 - Monitor - No action given the risk assessment

There is/are finger entrapment/s in the wall due to a damaged slat and the item fails to meet the requirements of BS EN 1176 Part 1 4.2.7.6 Entrapment of fingers - Replace slat to remove entrapment

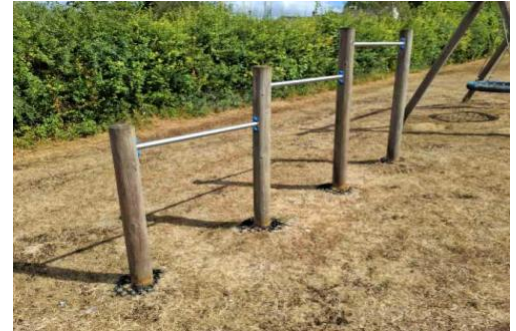
There is some strimmer / machinery damage apparent on the posts, this can penetrate the preservative applied to the timber and accelerate the rotting process - Monitor for any deterioration (rot) and replace as required

The timber has a number of splits/shakes or air cracks and this may affect the stability or allow water ingress which will accelerate the rotting process. Timber splits may also create rough / splintering edges. - Monitor, sand down any rough edges and ensure the splits do not cross through fixing points of the structure and/or cause any instability

The item is slightly loose in its foundations - Monitor for any further deterioration and repair as required

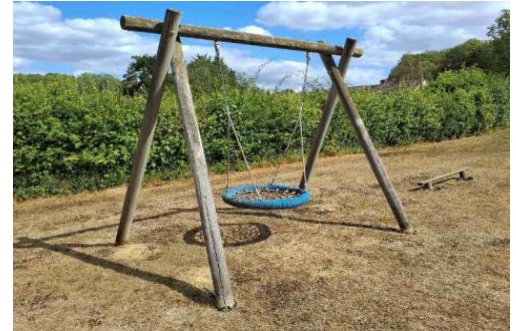
The timber has a number of splits/shakes or air cracks and this may affect the stability or allow water ingress which will accelerate the rotting process. Timber splits may also create rough / splintering edges. - Monitor, sand down any rough edges and ensure the splits do not cross through fixing points of the structure and/or cause any instability

There is some strimmer / machinery damage apparent on the posts, this can penetrate the preservative applied to the timber and accelerate the rotting process - Monitor for any deterioration (rot) and replace as required

Swings of this design should have a secondary safety device fitted to prevent collapse of the seat in the event of a joint failure to meet the requirements of BS EN 1176 Part 2 - Consult with manufacturer and consider providing a secondary safety device where possible

There is algae or moss on the surface of the equipment which can lead to the onset of rot - Clean and treat appropriately and monitor condition of the timber

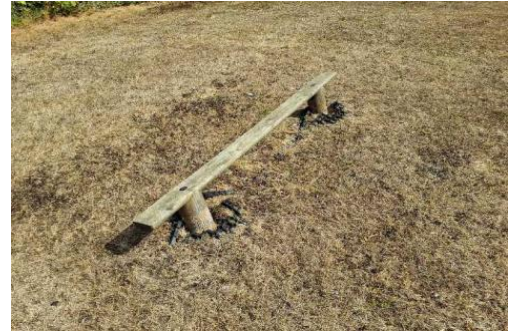
There are areas or parts of the timber on the structure that have rotted and one post is loose in the foundations and the item can be removed from the ground - Replace all affected timbers and re secure item

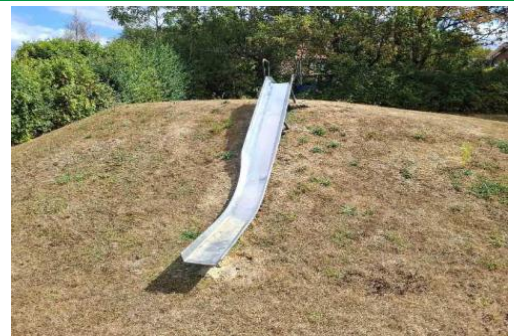
The surface has eroded and the foundations are exposed - Reinstate surrounding surfaces to cover the foundations

The paintwork on this item has been damaged or worn exposing the metal underneath which is rusting / corroding - Treat affected areas and repaint

The start section is leaning in its foundations - Monitor for any further deterioration and repair or replace as required

There are a number of dents in the slide surface - Monitor for any further deterioration and repair as required

The side of the slide is damaged - Monitor for any further deterioration and repair as required

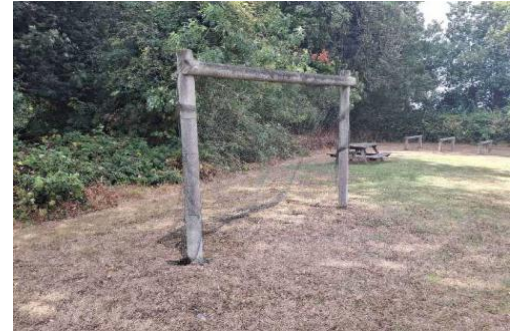
NB: We have undertaken a maintenance inspection only of the football goal(s); full load testing falls outside the scope of our inspection. - Implement load testing as required

The net has been damaged - Repair or replace the item

There is loose twine on the net - Secure or remove

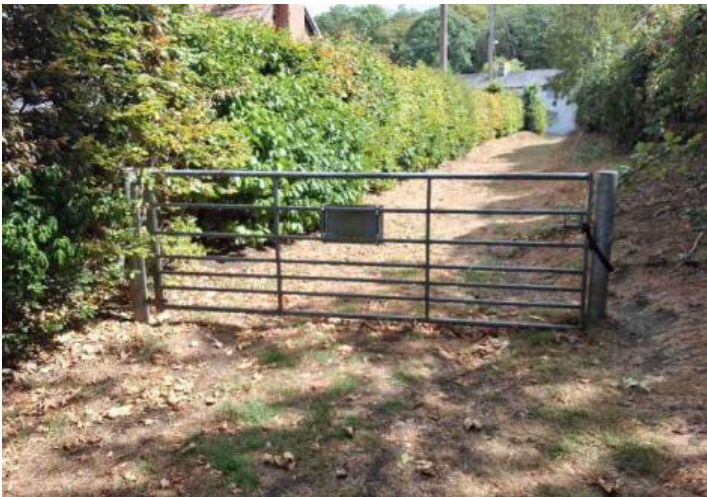
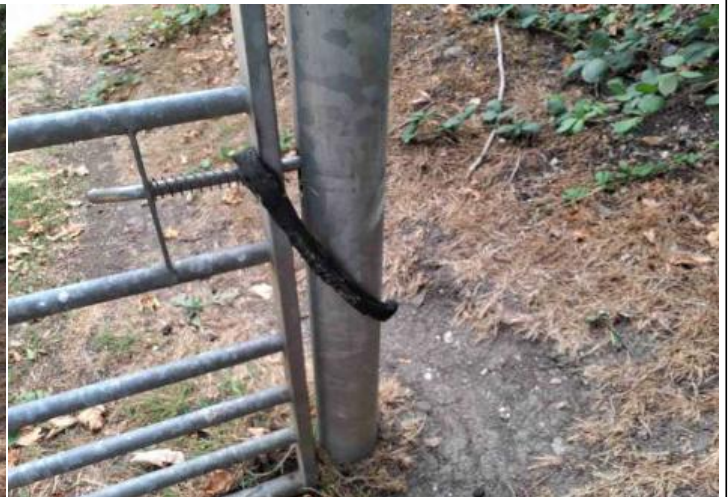
**Finding:** The maintenance gate was correctly padlocked at the time of inspection, however this means that the inspector was unable to fully assess the gate

**Action:** Ensure that there are 12mm gaps throughout the full range of motion on gate/s and between leaves where relevant

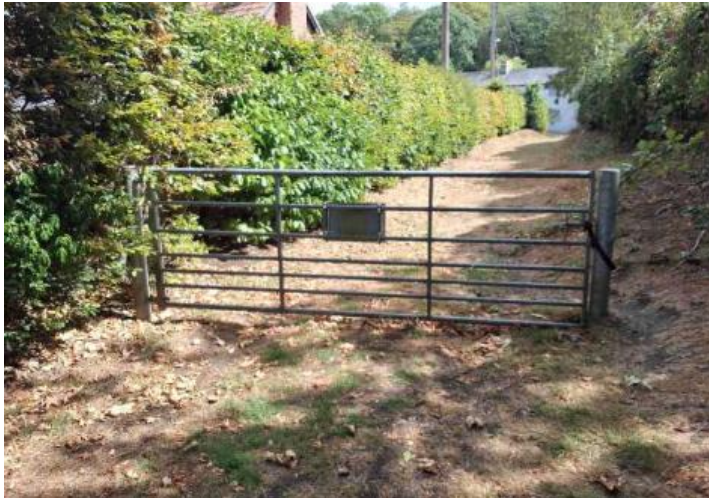
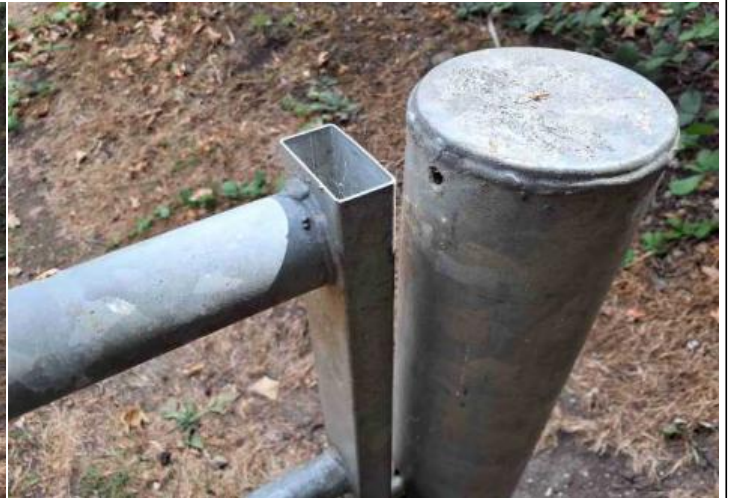
**Finding:** There are projecting bolt thread(s) present

**Action:** Remove excess thread length and deburr or provide cap

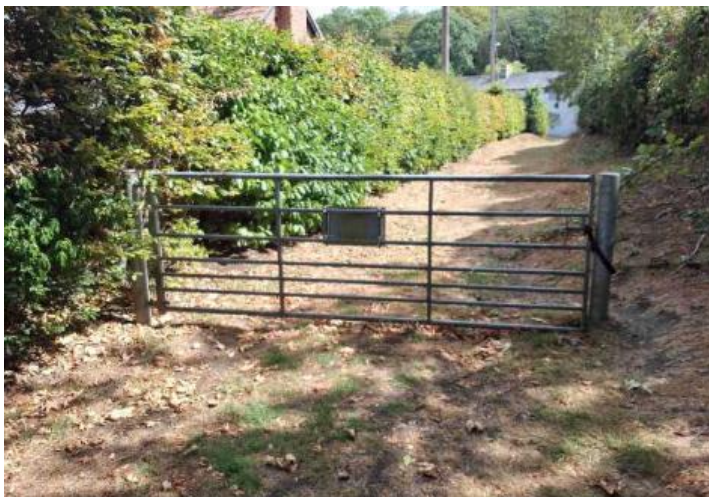
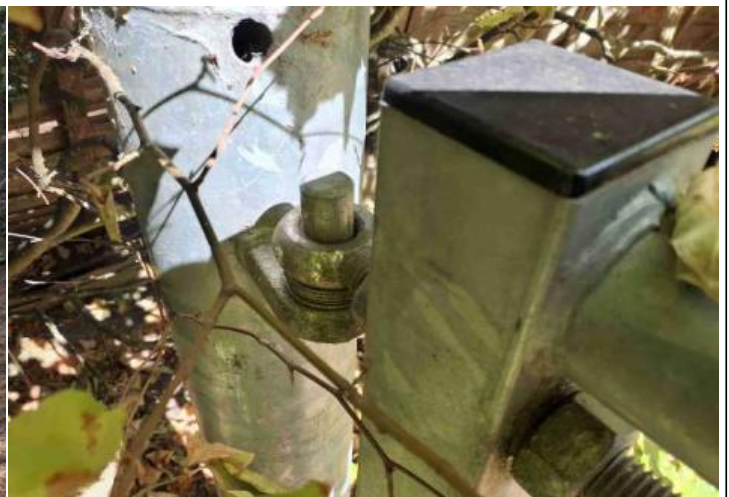
**Finding:** The gate is not secured to the hinges and can be lifted off

**Action:** Secure the gate

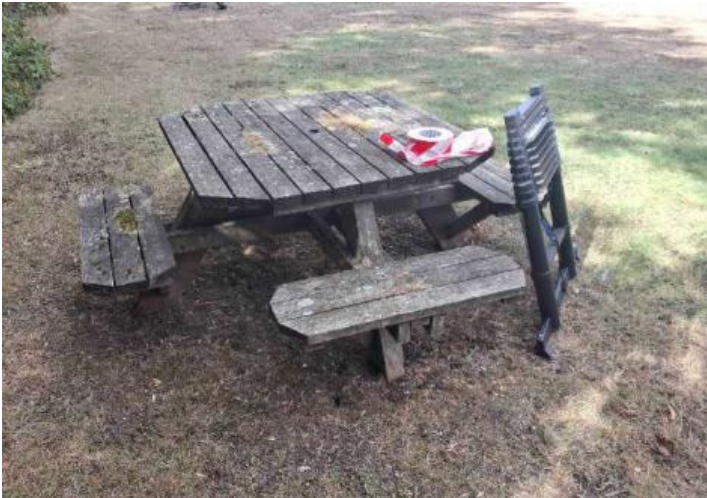
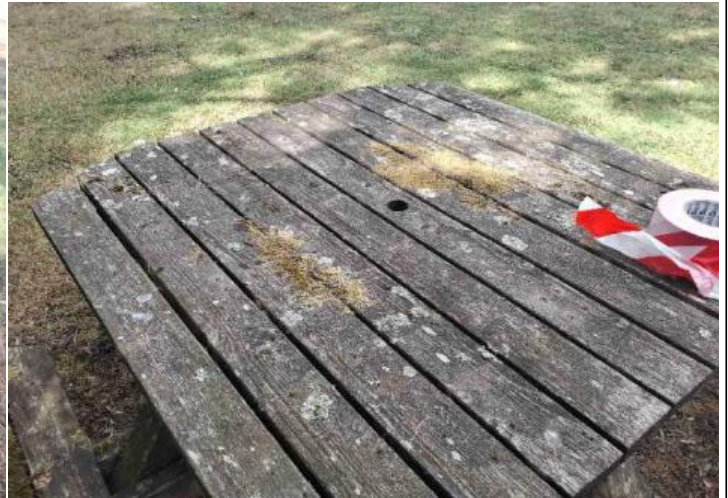
**Finding:** There is algae or moss on the surface of the bench **Action:** Clean and treat appropriately

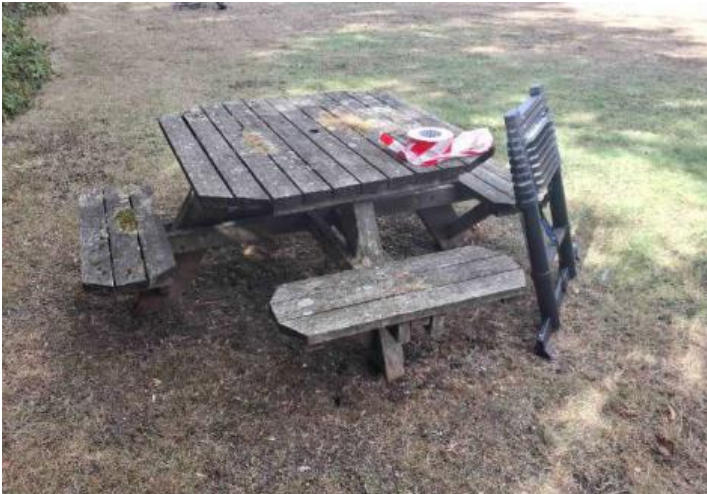
**Finding:** There are areas or parts of the timber on the structure that have rotted

**Action:** Replace all affected timbers

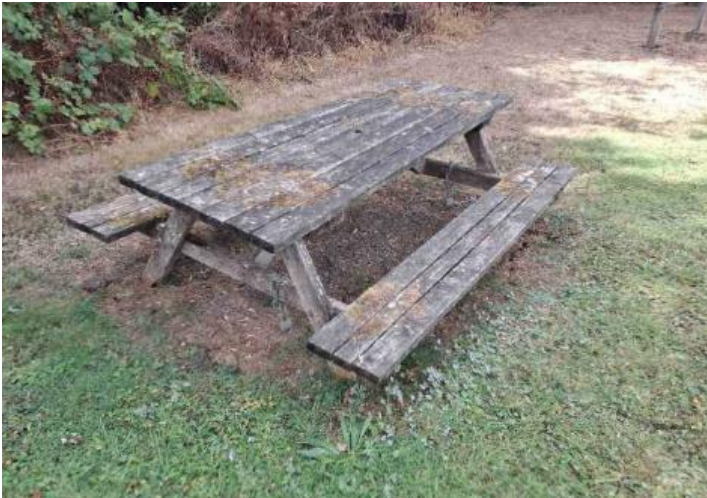
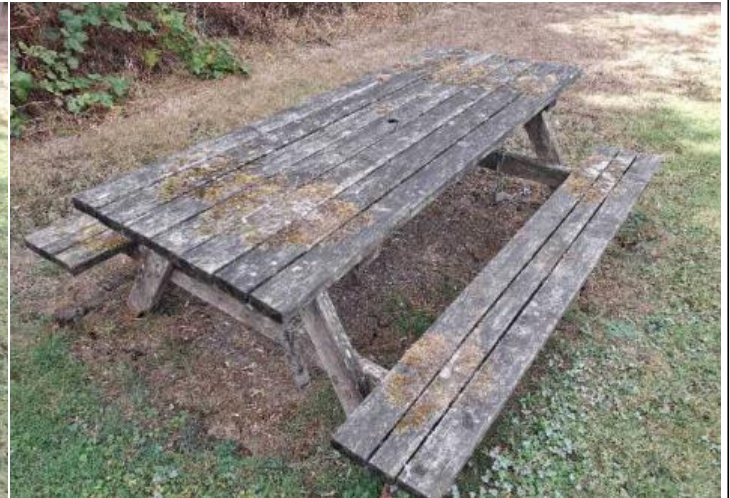
**Finding:** There is algae or moss on the surface of the bench **Action:** Clean and treat appropriately

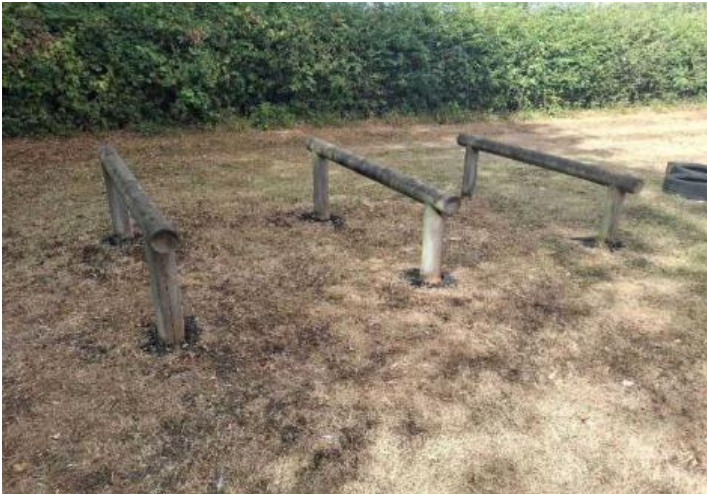
**Finding:** There is some strimmer / machinery damage apparent on the posts, this can penetrate the preservative applied to the timber and accelerate the rotting process

**Action:** Monitor for any deterioration (rot) and replace as required

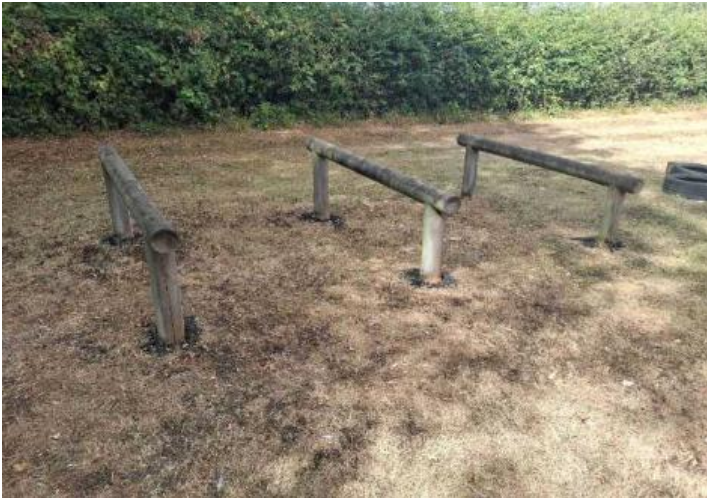
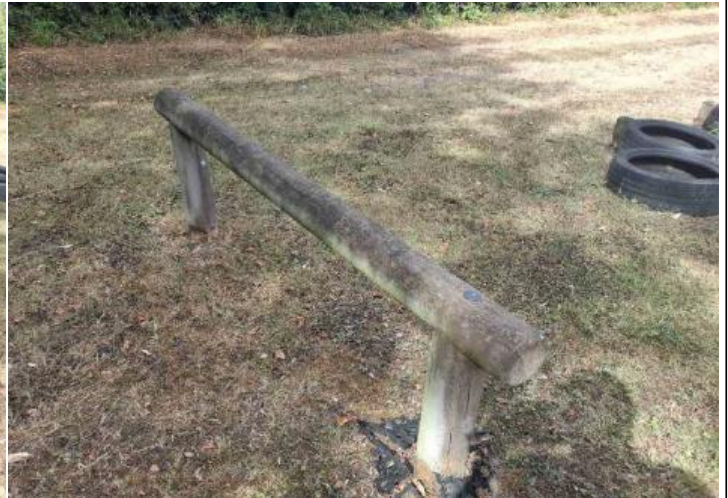
**Finding:** There is algae or moss on the surface of the equipment

**Action:** Clean and treat appropriately

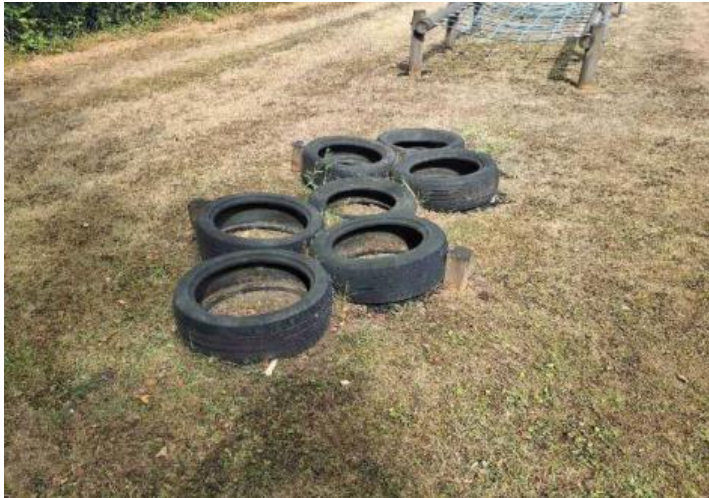
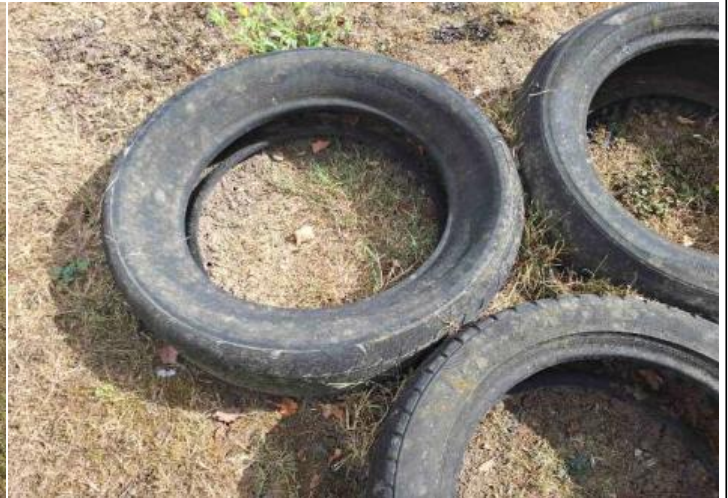
**Finding:** There is algae or moss on the surface of the equipment

**Action:** Clean and treat appropriately

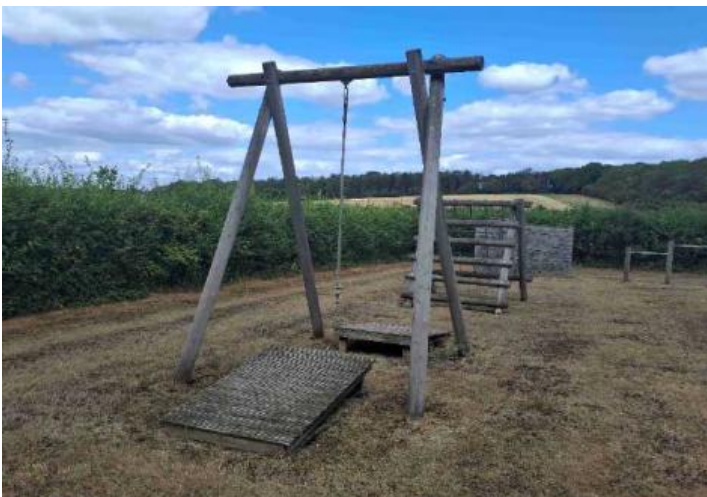
**Finding:** There is some strimmer / machinery damage apparent on the posts, this can penetrate the preservative applied to the timber and accelerate the rotting process

**Action:** Monitor for any deterioration (rot) and replace as required

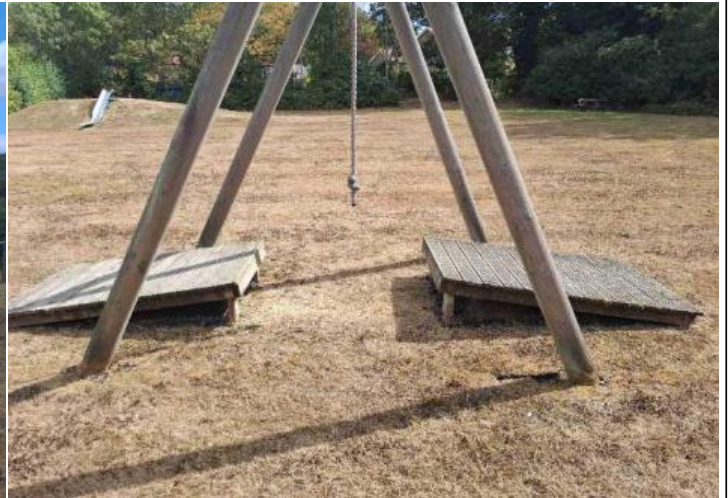
**Finding:** The platforms form a hard object within the impact area of the equipment in contravention of the requirements of BS EN 1176 Part 1

**Action:** Monitor use and consider the provision of an impact attenuating surface

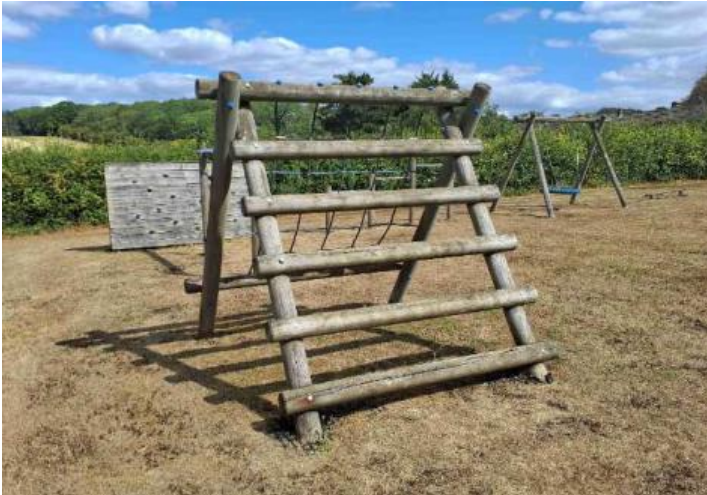
**Finding:** There are areas or parts of the timber on the structure that have rotted

**Action:** Replace all affected timbers

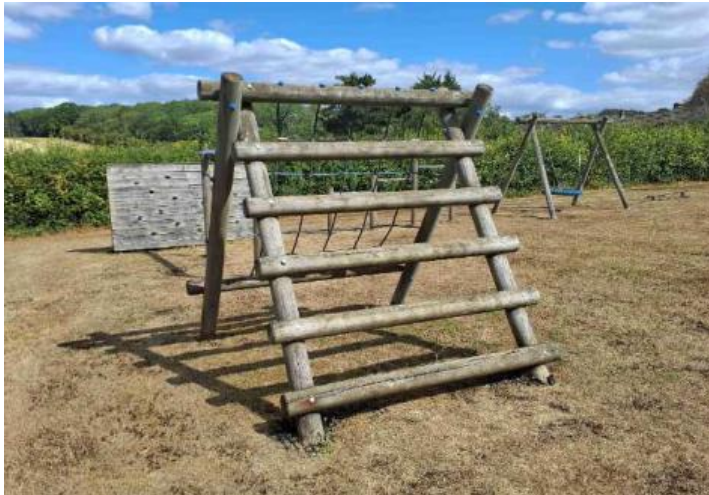
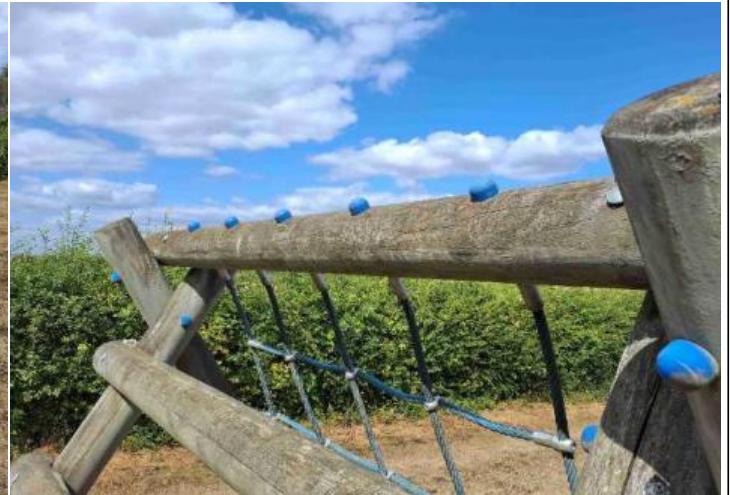
**Item:** Activity Equipment - A Frame Climber  
**Manufacturer:** Not Identified

**Risk Level:** L - Low Risk  
**Surface:** Grass Matrix Tiles

**Finding:** There is algae or moss on the surface of the equipment

**Action:** Clean and treat appropriately

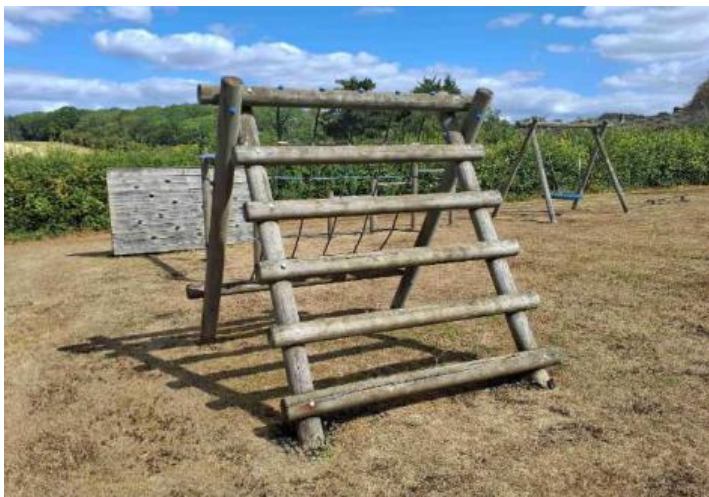
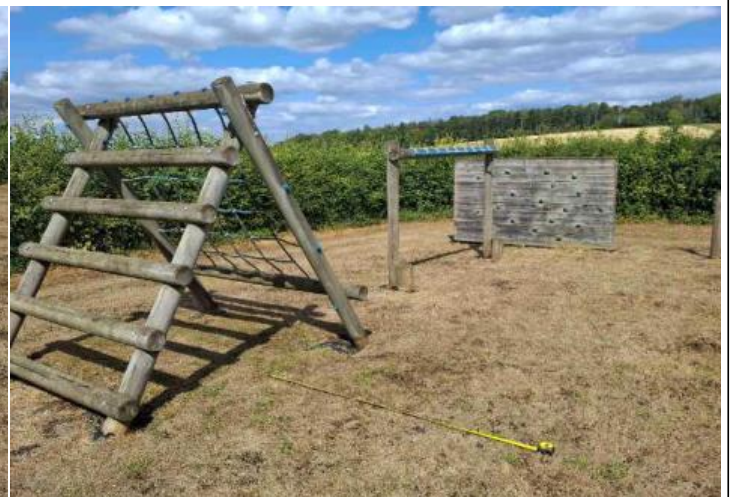
**Item:** Activity Equipment - A Frame Climber  
**Manufacturer:** Not Identified

**Risk Level:** V - Very Low Risk  
**Surface:** Grass Matrix Tiles

**Finding:** The surfacing dimensions are short and do not meet with the requirements of the current applicable standard

**Action:** Monitor - No action given the risk assessment

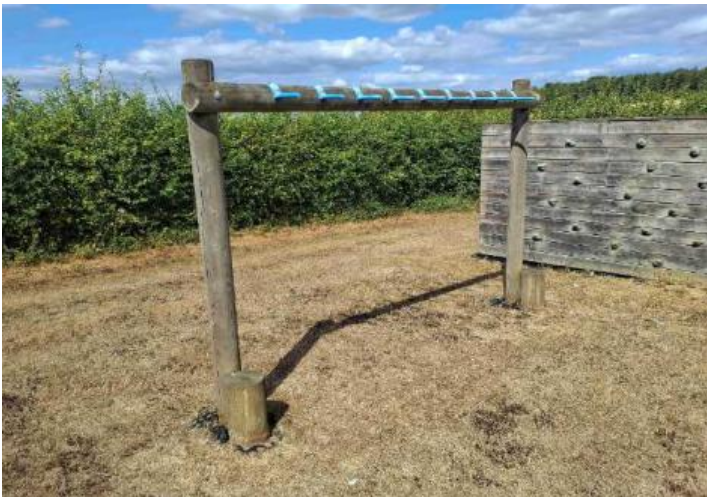
**Item:** Activity Equipment - Monkey Bars  
**Manufacturer:** Not Identified

**Risk Level:** L - Low Risk  
**Surface:** Grass Matrix Tiles

**Finding:** The item is slightly loose in its foundations

**Action:** Monitor for any further deterioration and repair as required

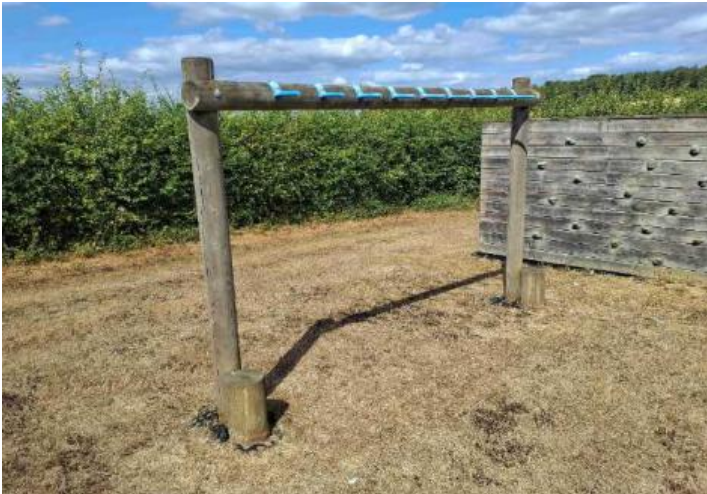
**Item:** Activity Equipment - Monkey Bars  
**Manufacturer:** Not Identified

**Risk Level:** L - Low Risk  
**Surface:** Grass Matrix Tiles

**Finding:** A number of fixing(s) have worked loose

**Action:** Secure all loose fixings

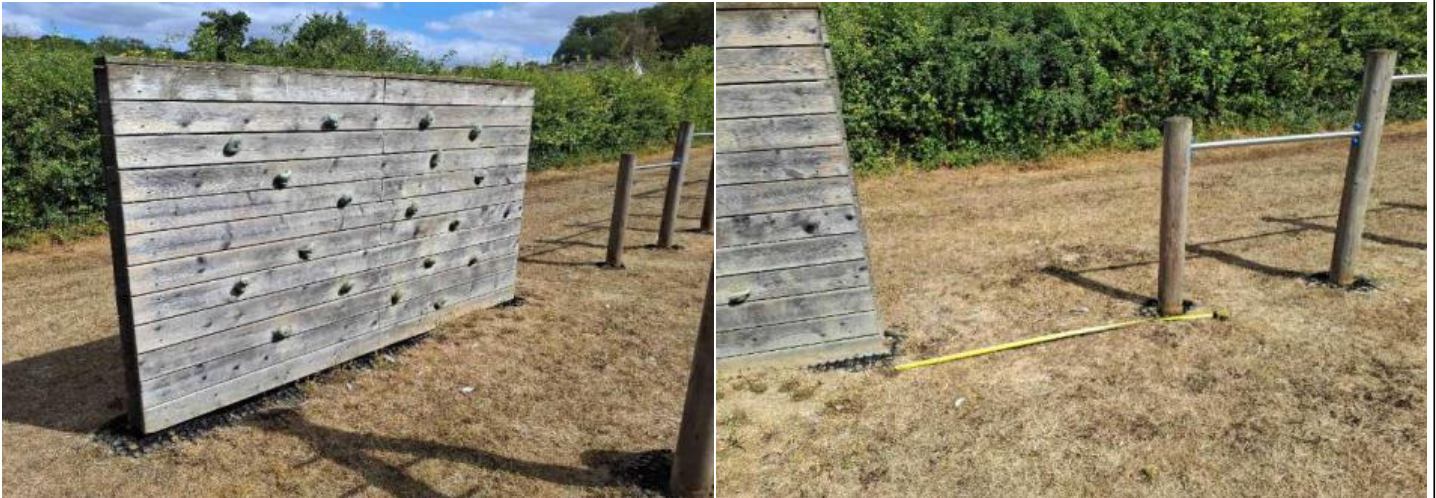
**Item:** Activity Equipment - Climbing Wall  
**Manufacturer:** Not Identified

**Risk Level:** V - Very Low Risk  
**Surface:** Grass Matrix Tiles

**Finding:** The adjacent item forms a projecting obstacle / hard object within the falling space of the equipment, in contravention of the requirements of BS EN 1176 Part 1

**Action:** Monitor - No action given the risk assessment

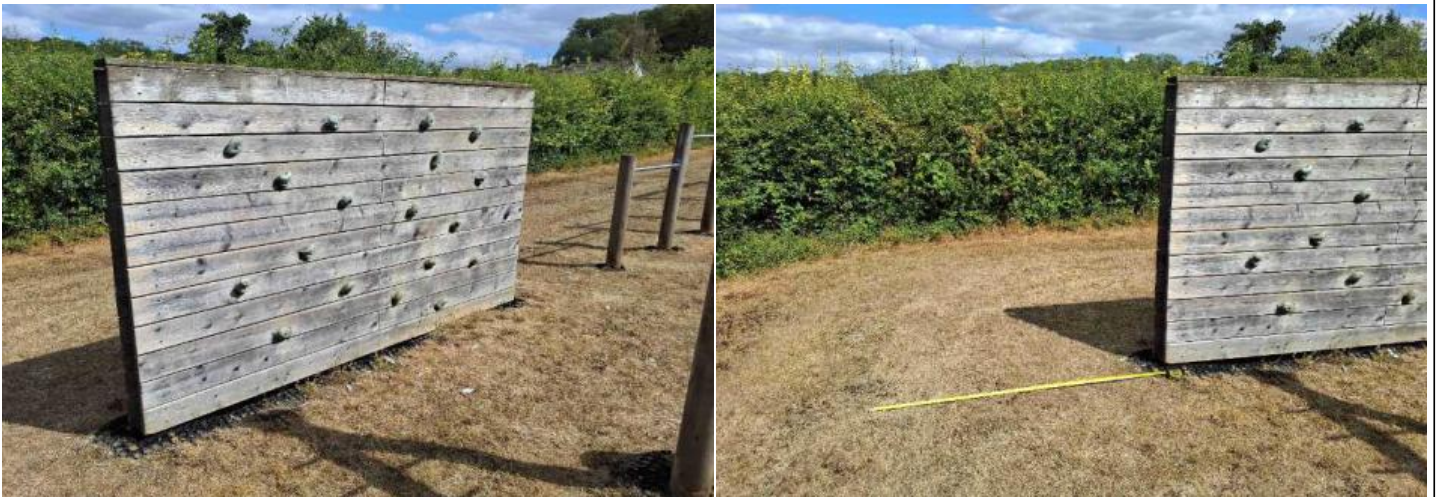
**Item:** Activity Equipment - Climbing Wall  
**Manufacturer:** Not Identified

**Risk Level:** V - Very Low Risk  
**Surface:** Grass Matrix Tiles

**Finding:** The surfacing dimensions are short and do not meet with the requirements of the current applicable standard

**Action:** Monitor - No action given the risk assessment

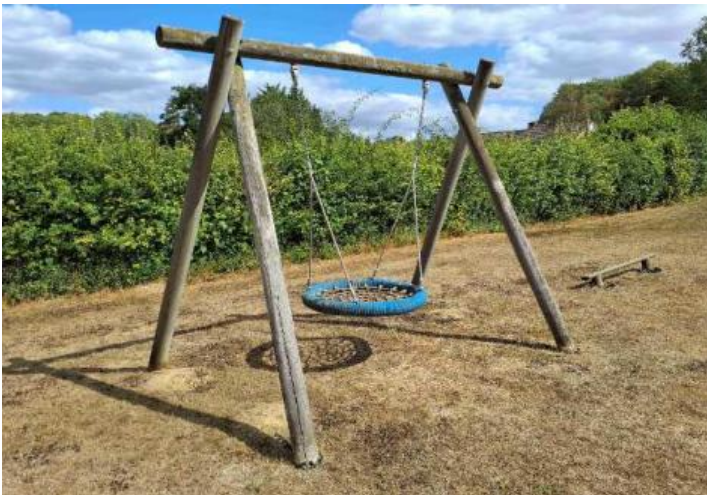
**Item:** Swings - Basket Swing - Type 1  
**Manufacturer:** Not Identified

**Risk Level:** L - Low Risk  
**Surface:** Grass Matrix Tiles

**Finding:** Swings of this design should have a secondary safety device fitted to prevent collapse of the seat in the event of a joint failure to meet the requirements of BS EN 1176 Part 2

**Action:** Consult with manufacturer and consider providing a secondary safety device where possible

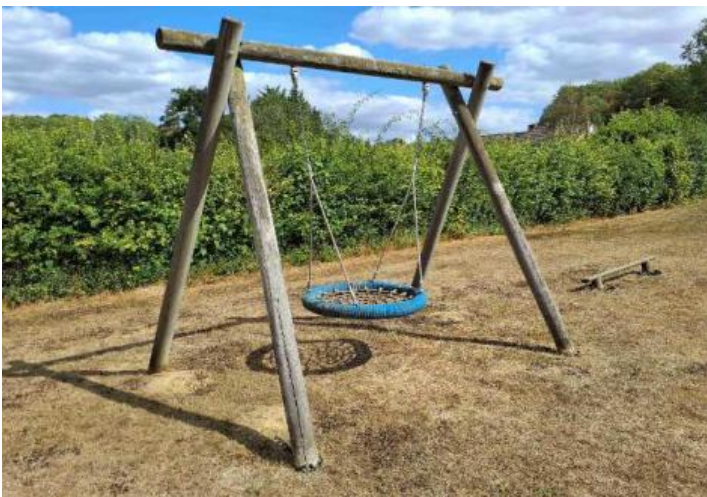
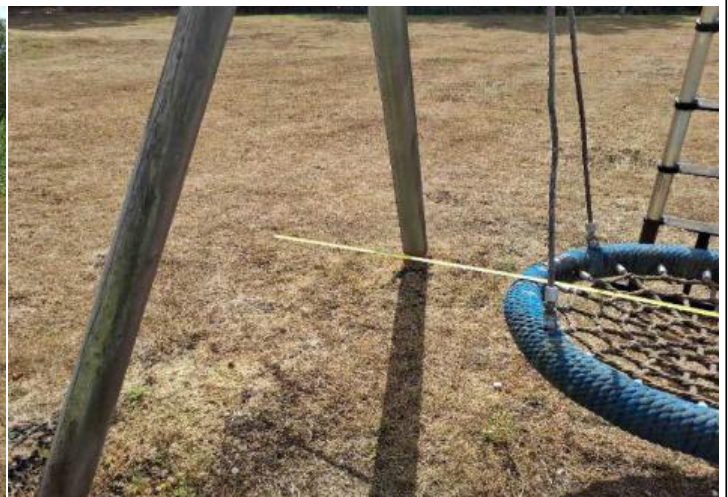
**Item:** Swings - Basket Swing - Type 1  
**Manufacturer:** Not Identified

**Risk Level:** L - Low Risk  
**Surface:** Grass Matrix Tiles

**Finding:** The seat/s is / are too close to the frame as defined in BS EN 1176 Part 2

**Action:** Monitor - No action given the risk assessment

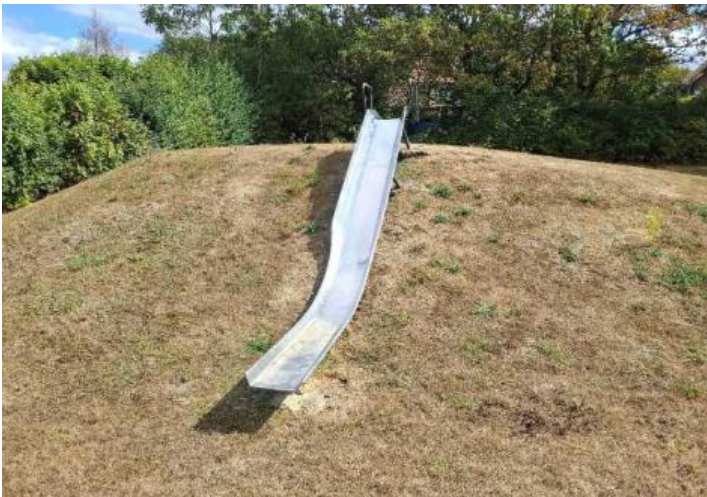
**Item:** Other - Embankment Slide  
**Manufacturer:** Not Identified

**Risk Level:** L - Low Risk  
**Surface:** Grass

**Finding:** The start section is leaning in its foundations

**Action:** Monitor for any further deterioration and repair or replace as required

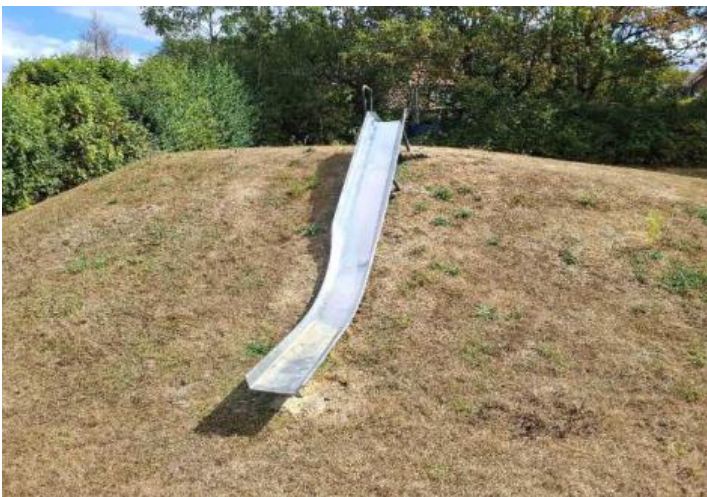
**Item:** Other - Embankment Slide  
**Manufacturer:** Not Identified

**Risk Level:** L - Low Risk  
**Surface:** Grass

**Finding:** The side of the slide is damaged

**Action:** Monitor for any further deterioration and repair as required

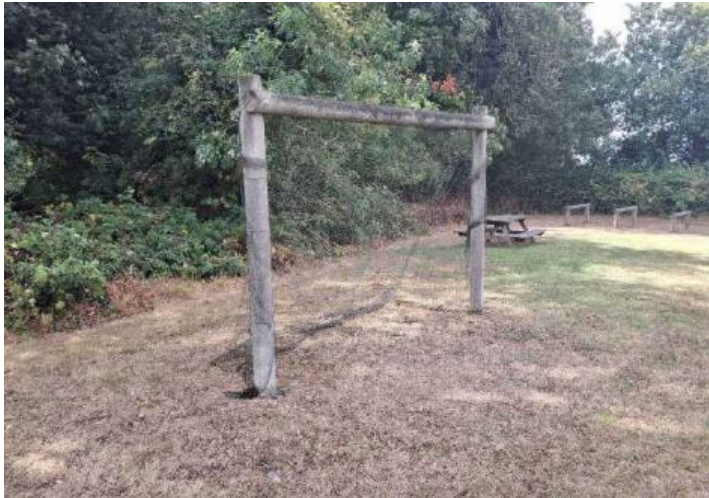
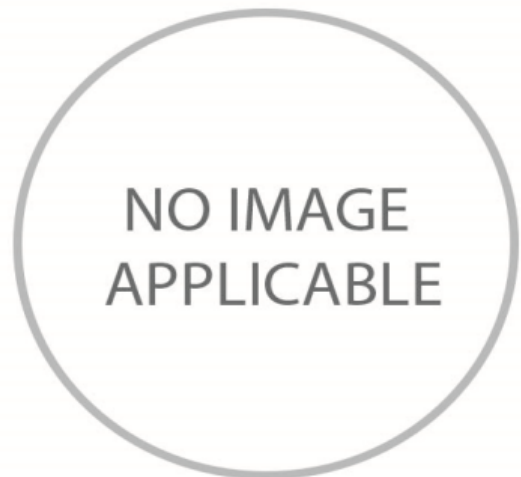
**Item:** Multi Use Games Area - Football Goal  
**Manufacturer:** Not Identified

**Finding:** NB: We have undertaken a maintenance inspection only of the football goal(s); full load testing falls outside the scope of our inspection.

**Action:** Implement load testing as required

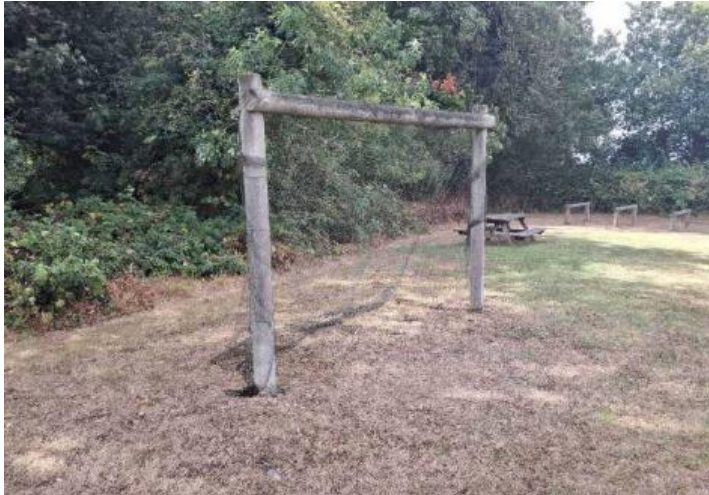
**Item:** Multi Use Games Area - Football Goal  
**Manufacturer:** Not Identified

**Risk Level:** L - Low Risk  
**Surface:** Grass

**Finding:** The net has been damaged

**Action:** Repair or replace the item
